Appendix E:

MoDOT Bridge Inspection Report

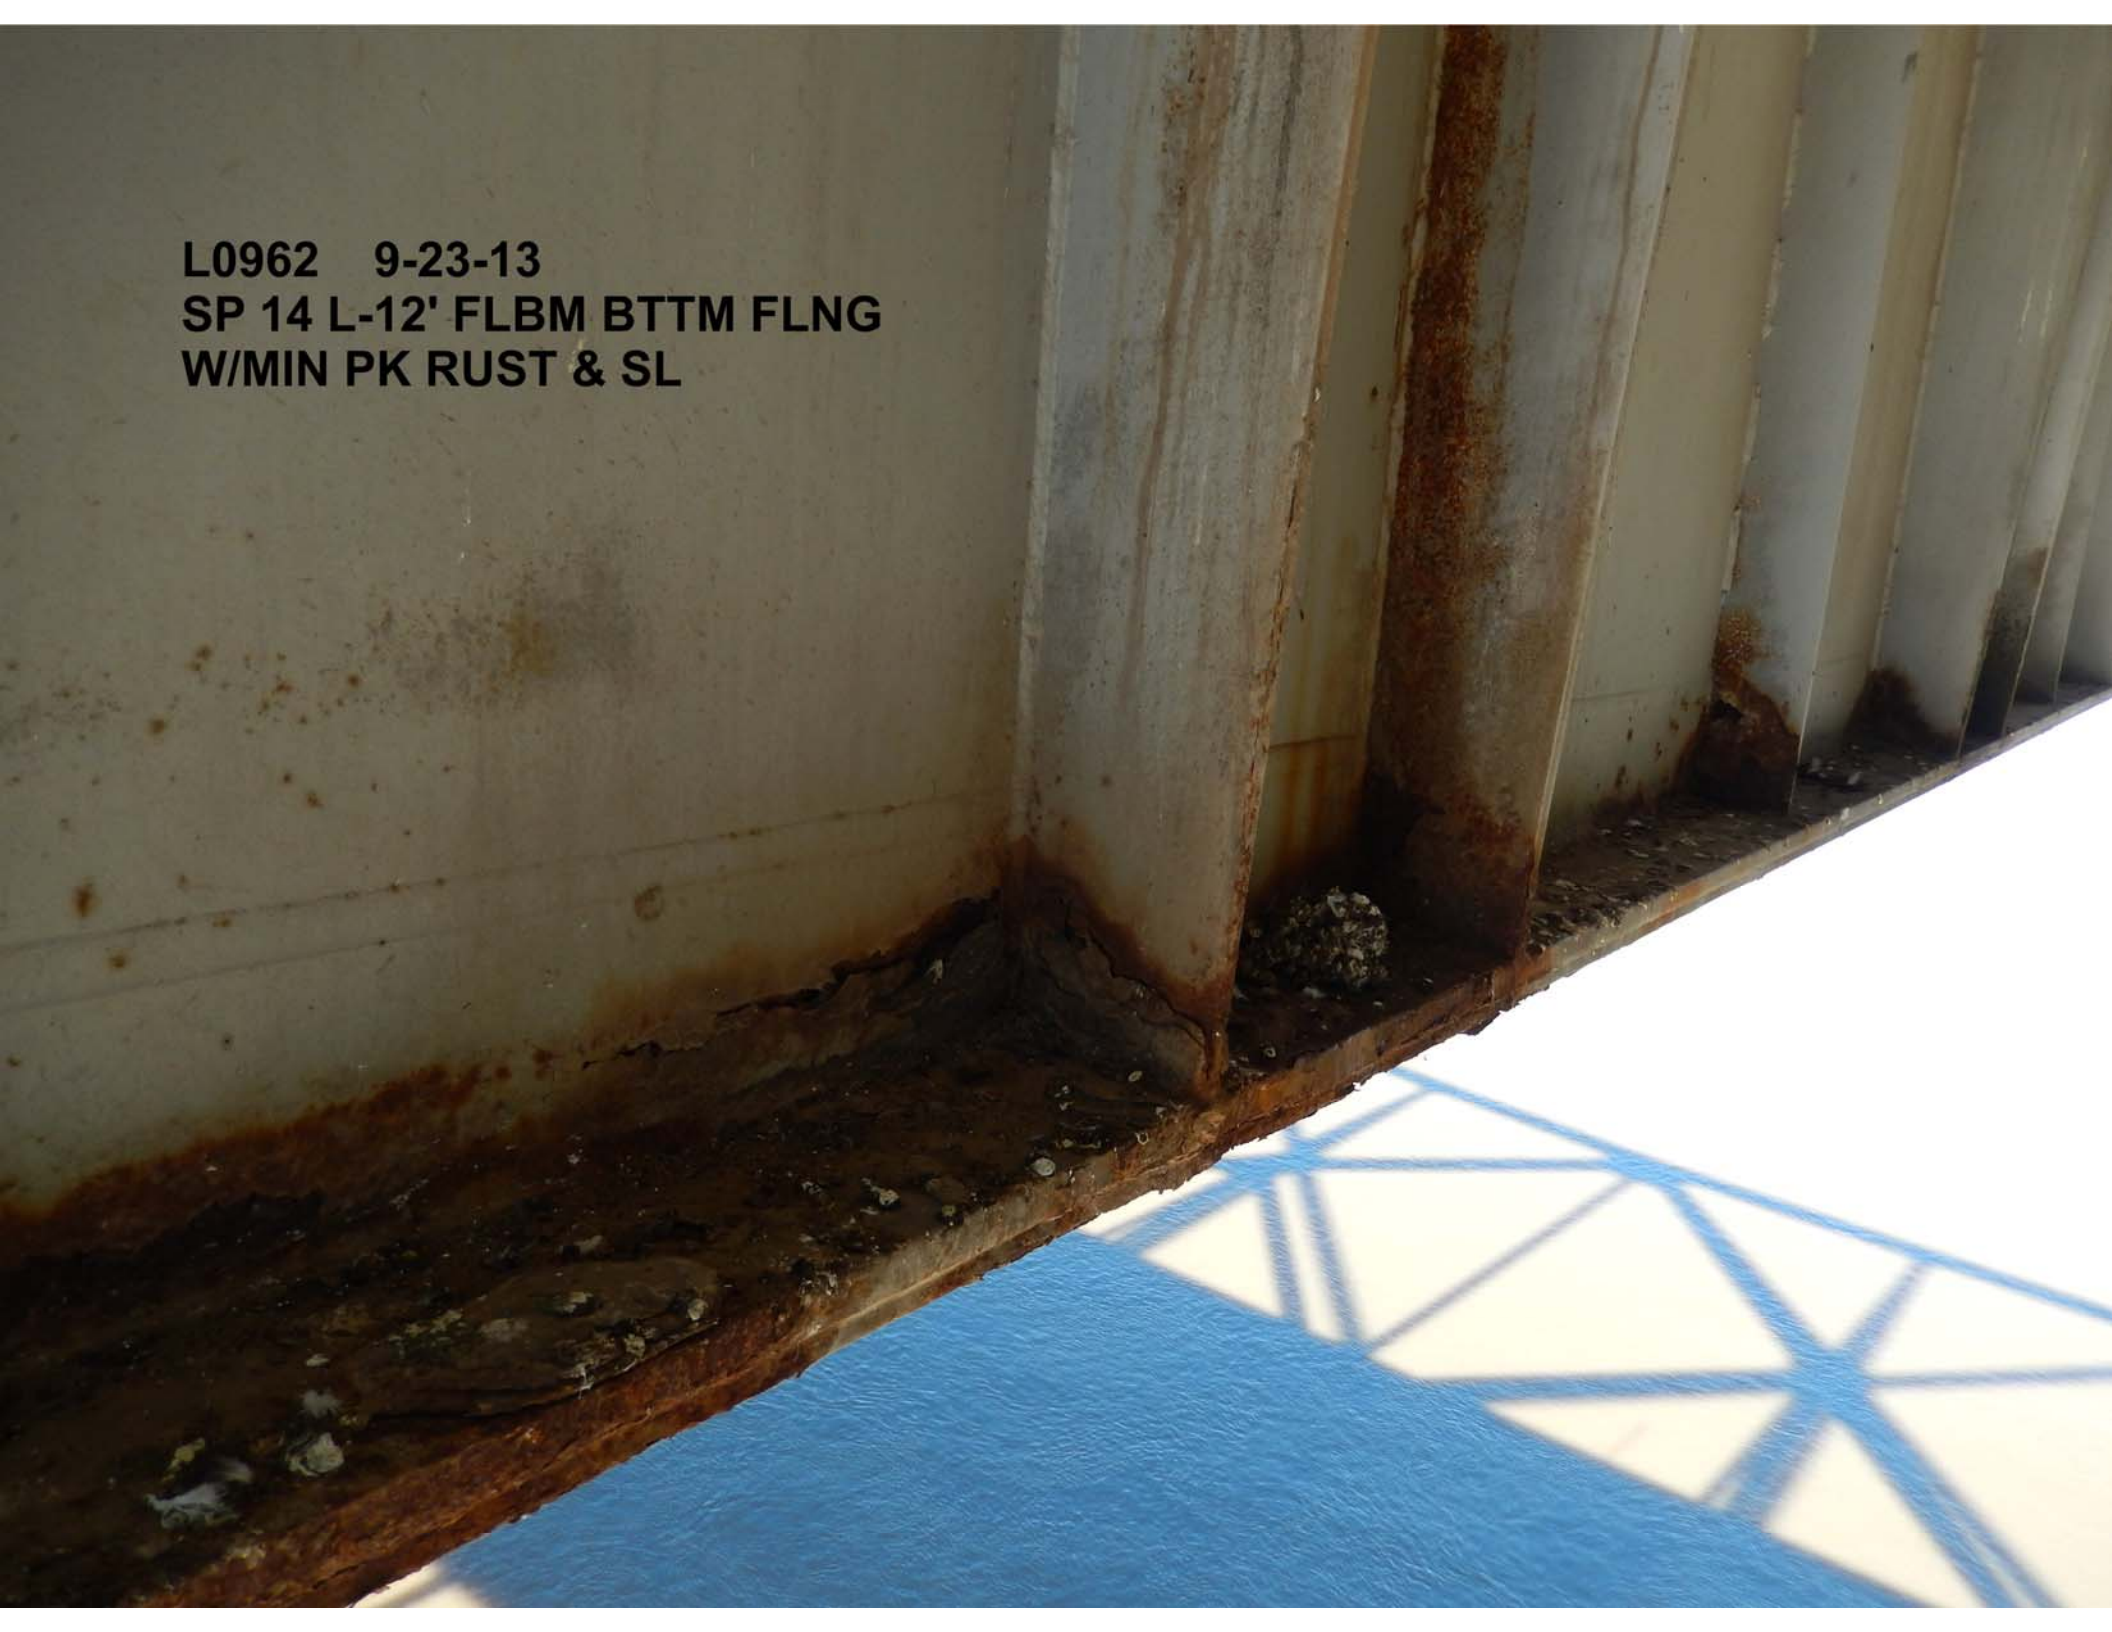
L0962 9-23-13
SP 14 L-12' FLBM BTTM FLNG
W/MIN PK RUST & SL

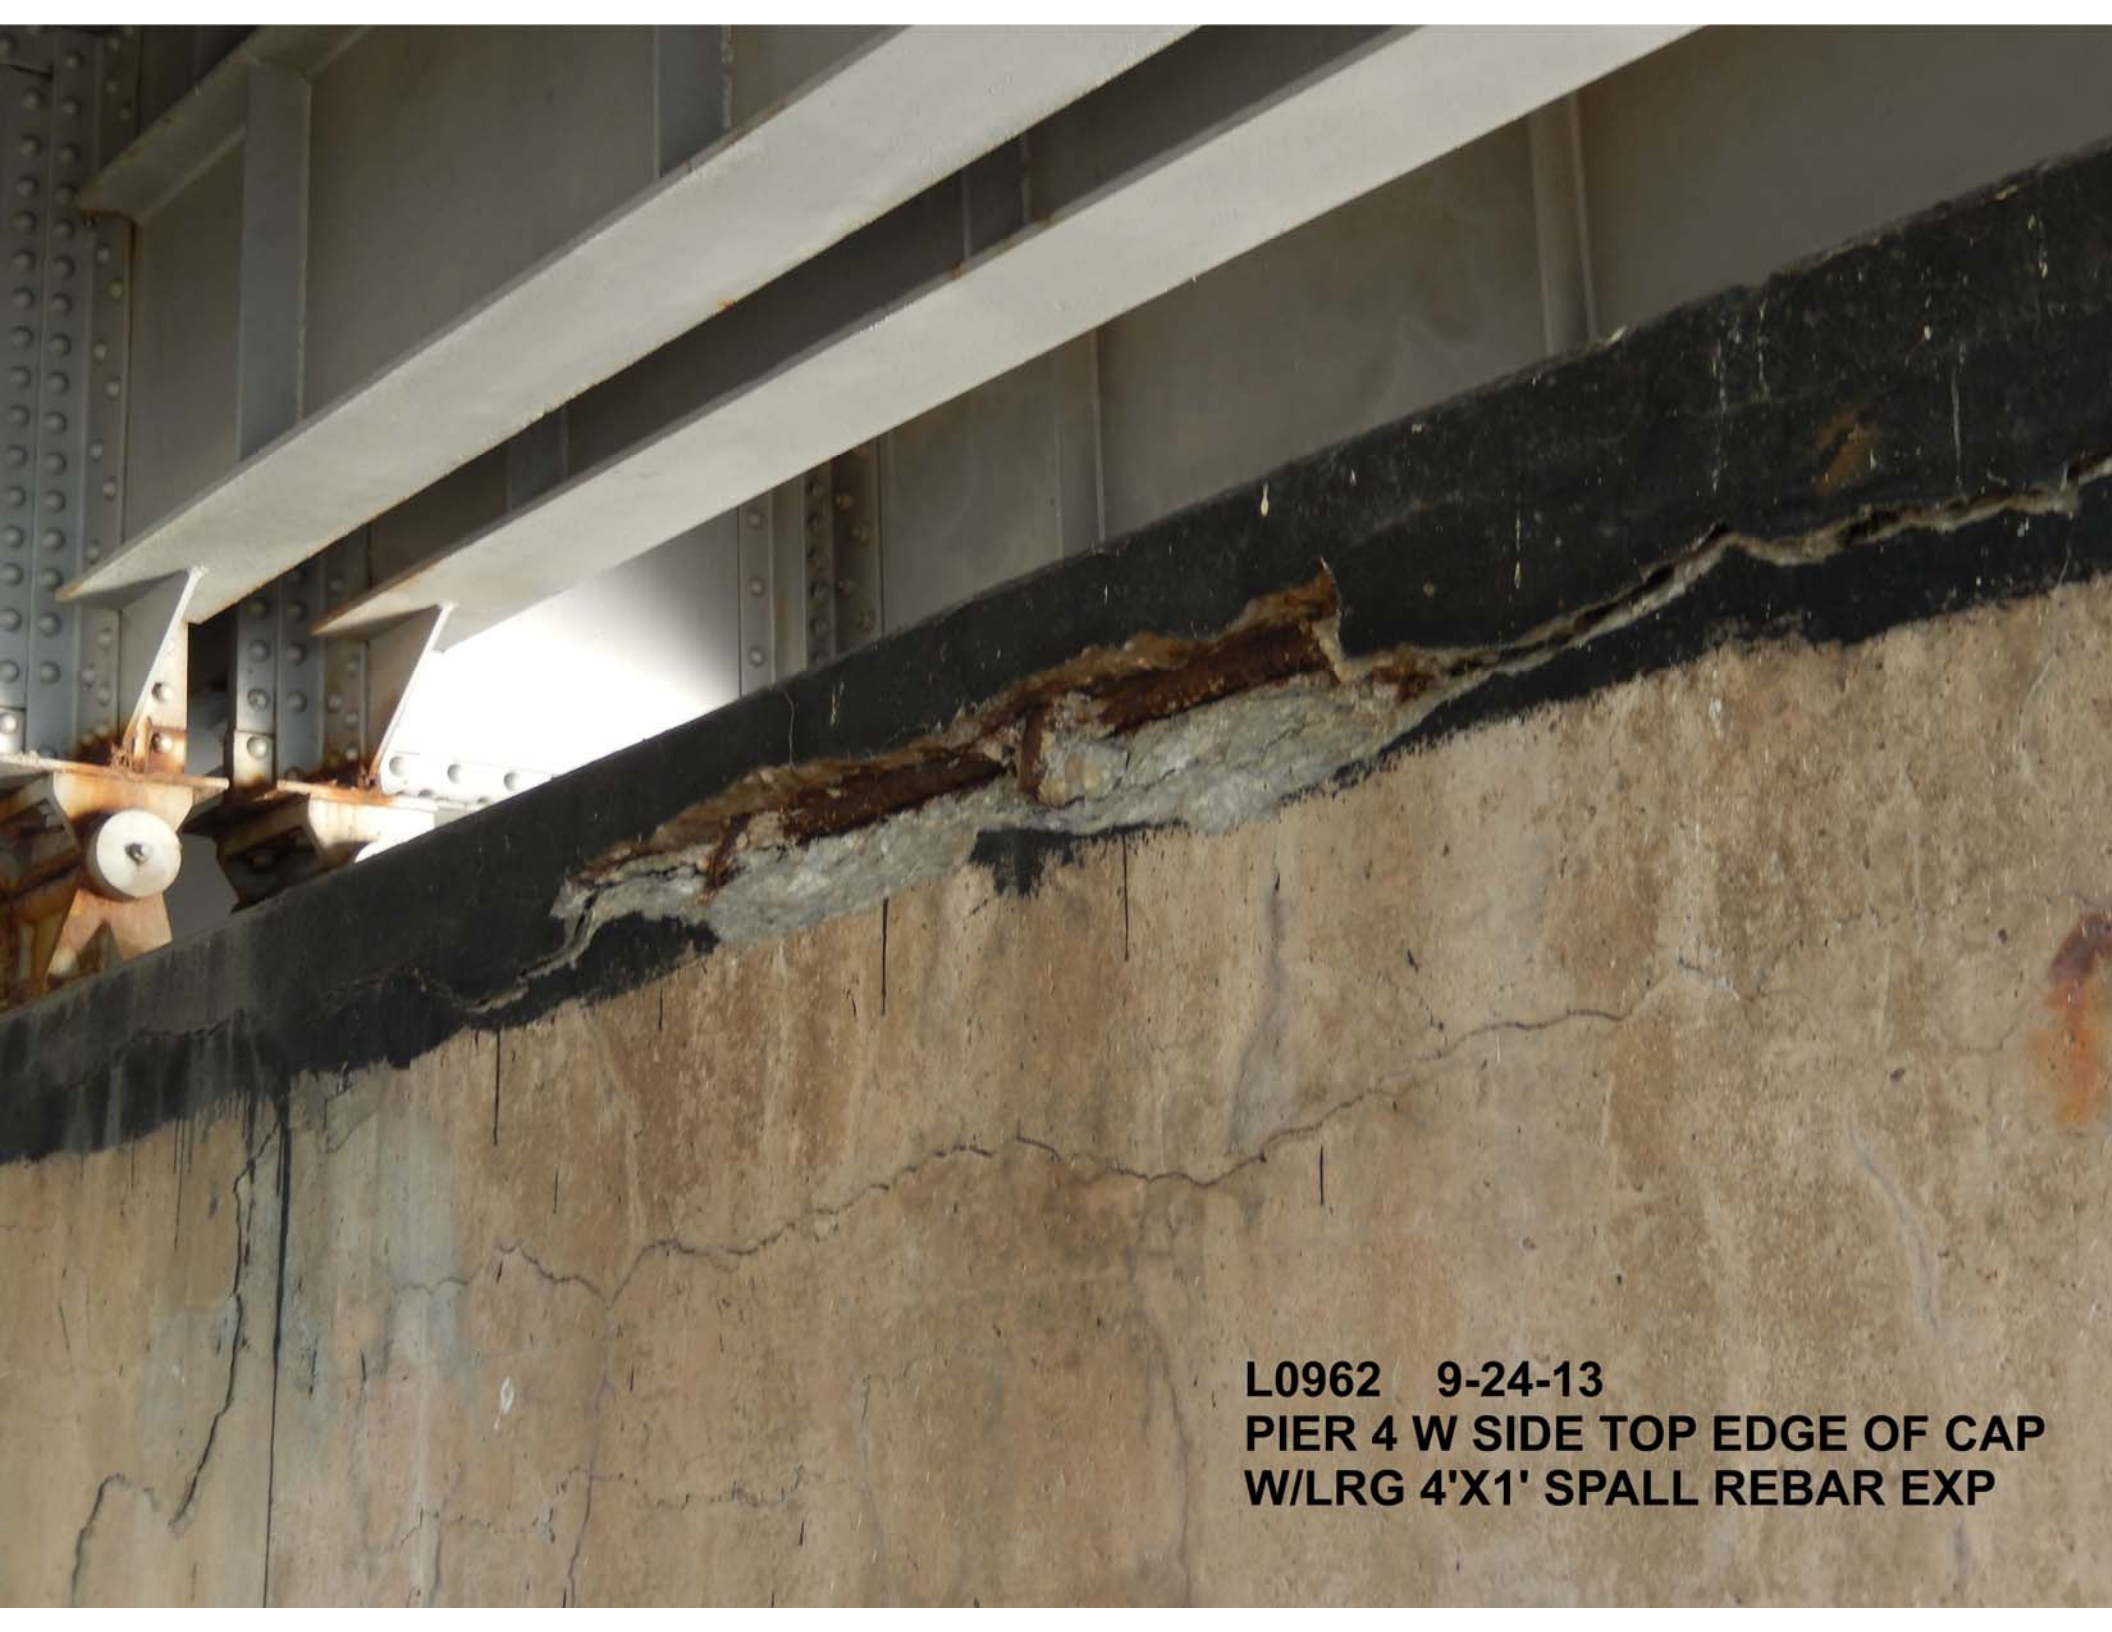
L0962 9-24-13
PIER 4 W SIDE TOP EDGE OF CAP
W/LRG 4'X1' SPALL REBAR EXP

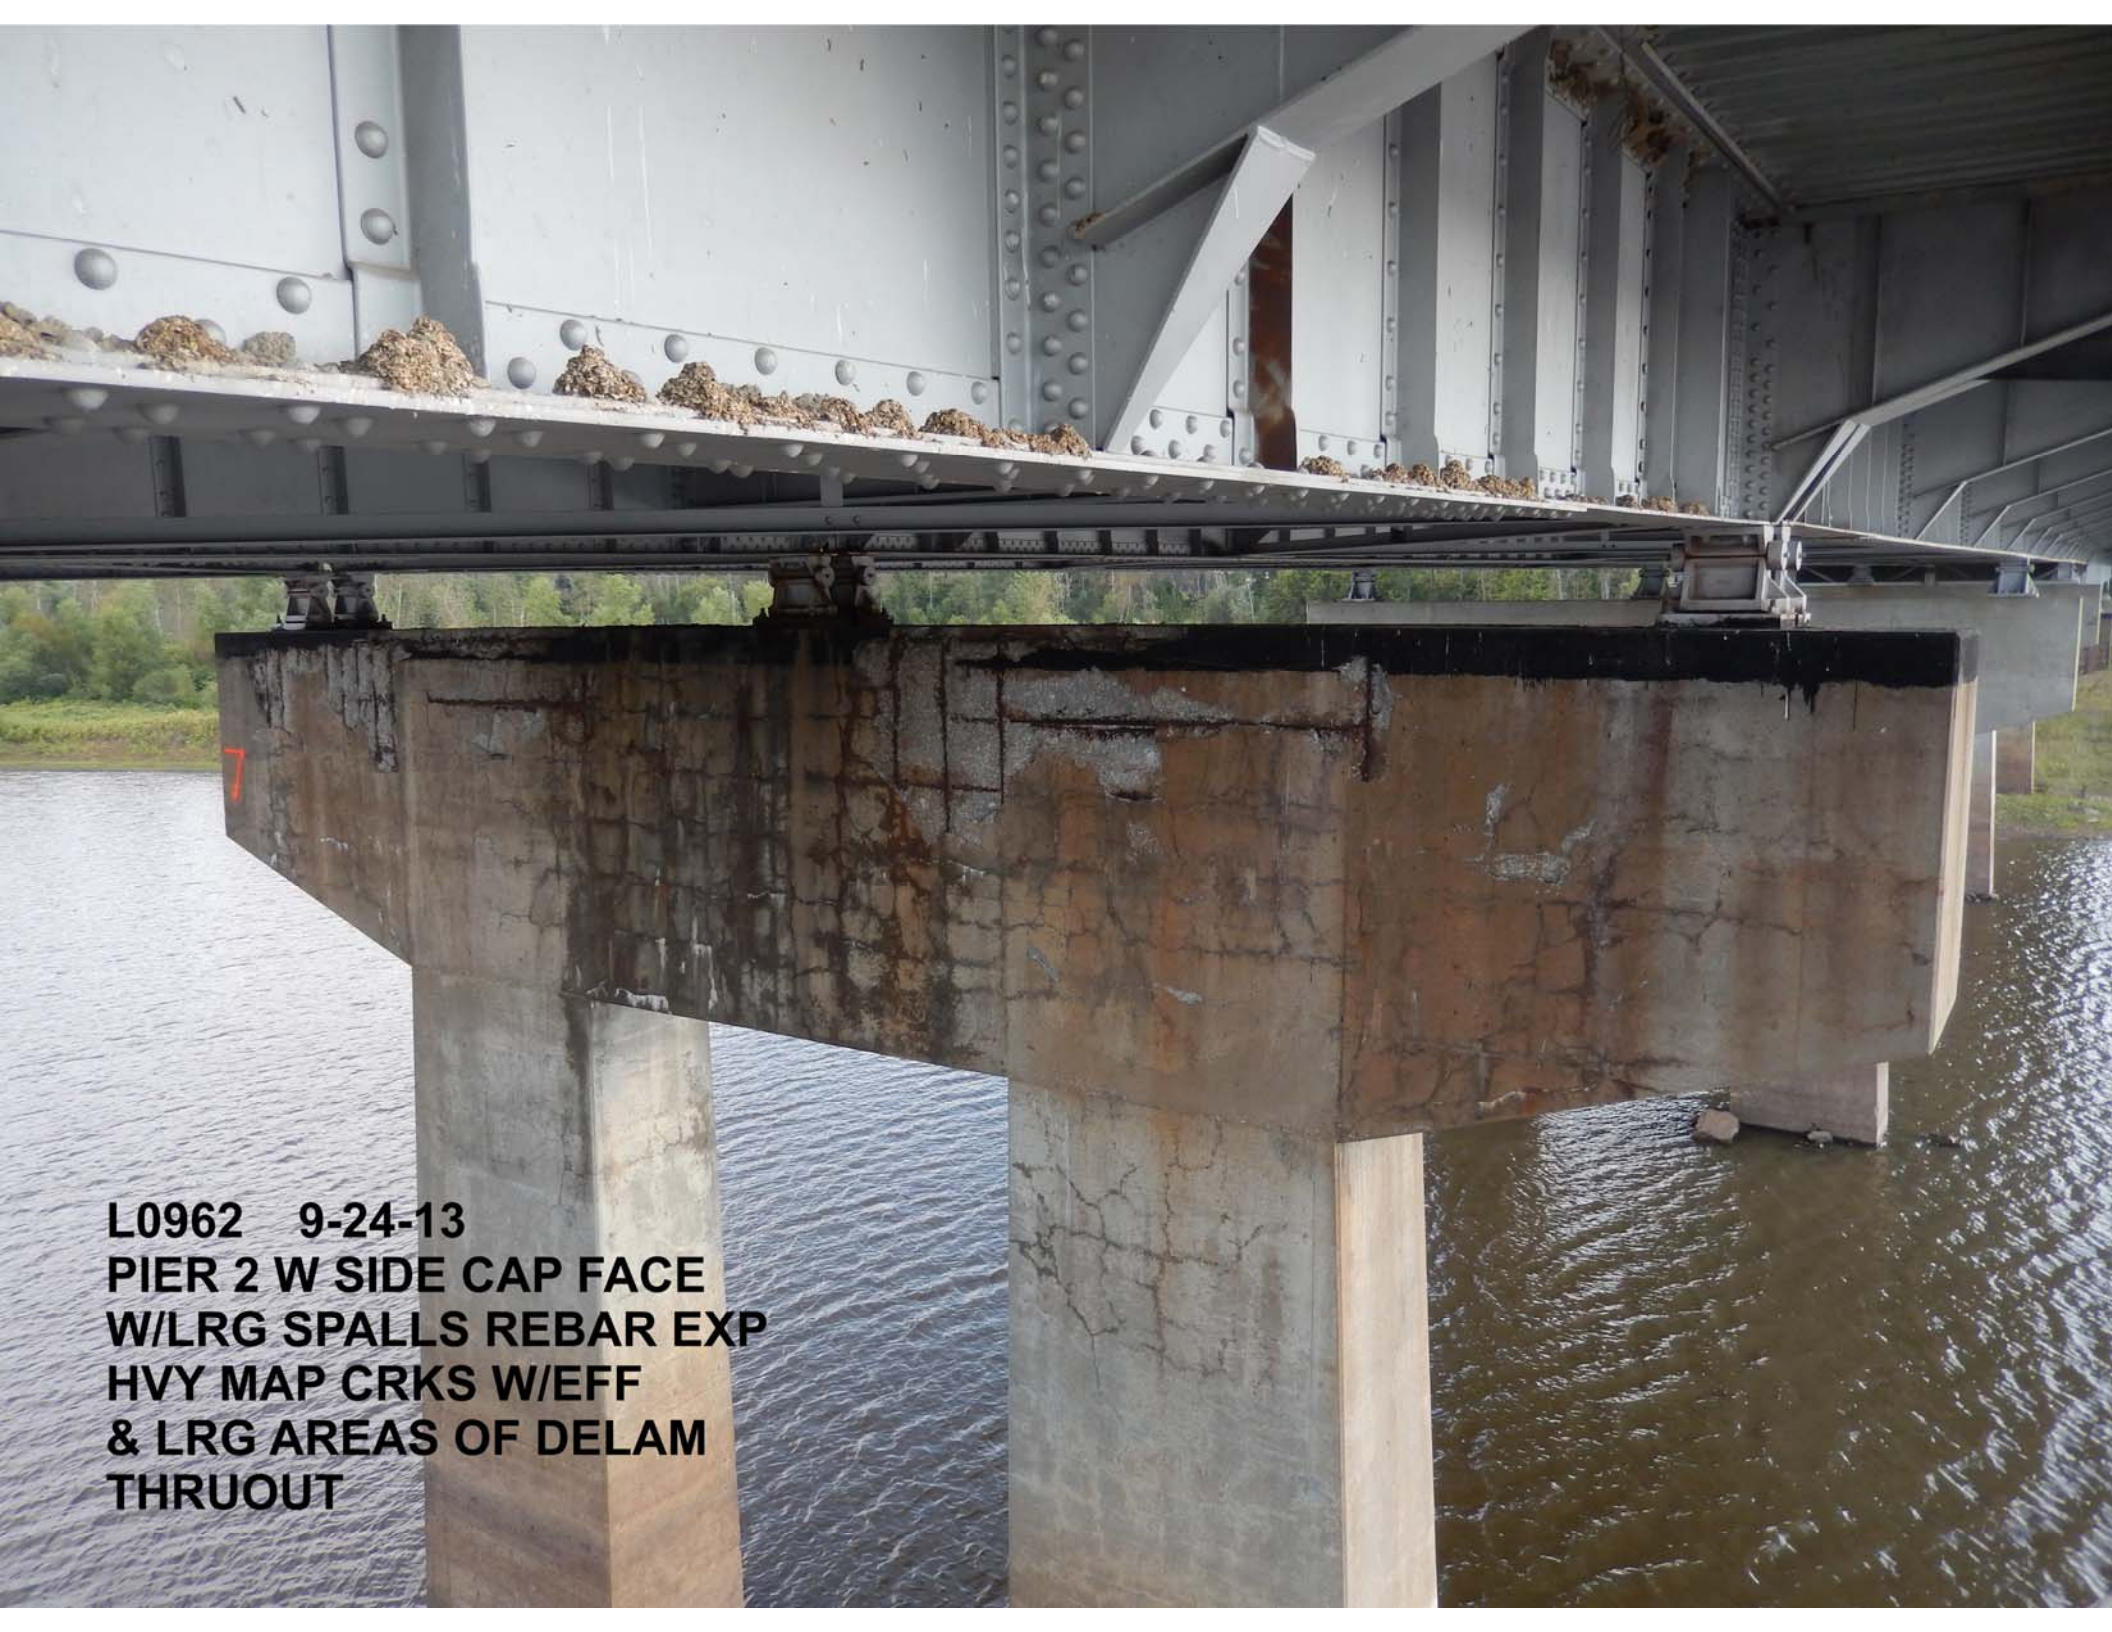
**L0962 9-24-13
PIER 2 W SIDE CAP FACE
W/LRG SPALLS REBAR EXP
HVY MAP CRKS W/EFF
& LRG AREAS OF DELAM
THRUOUT**

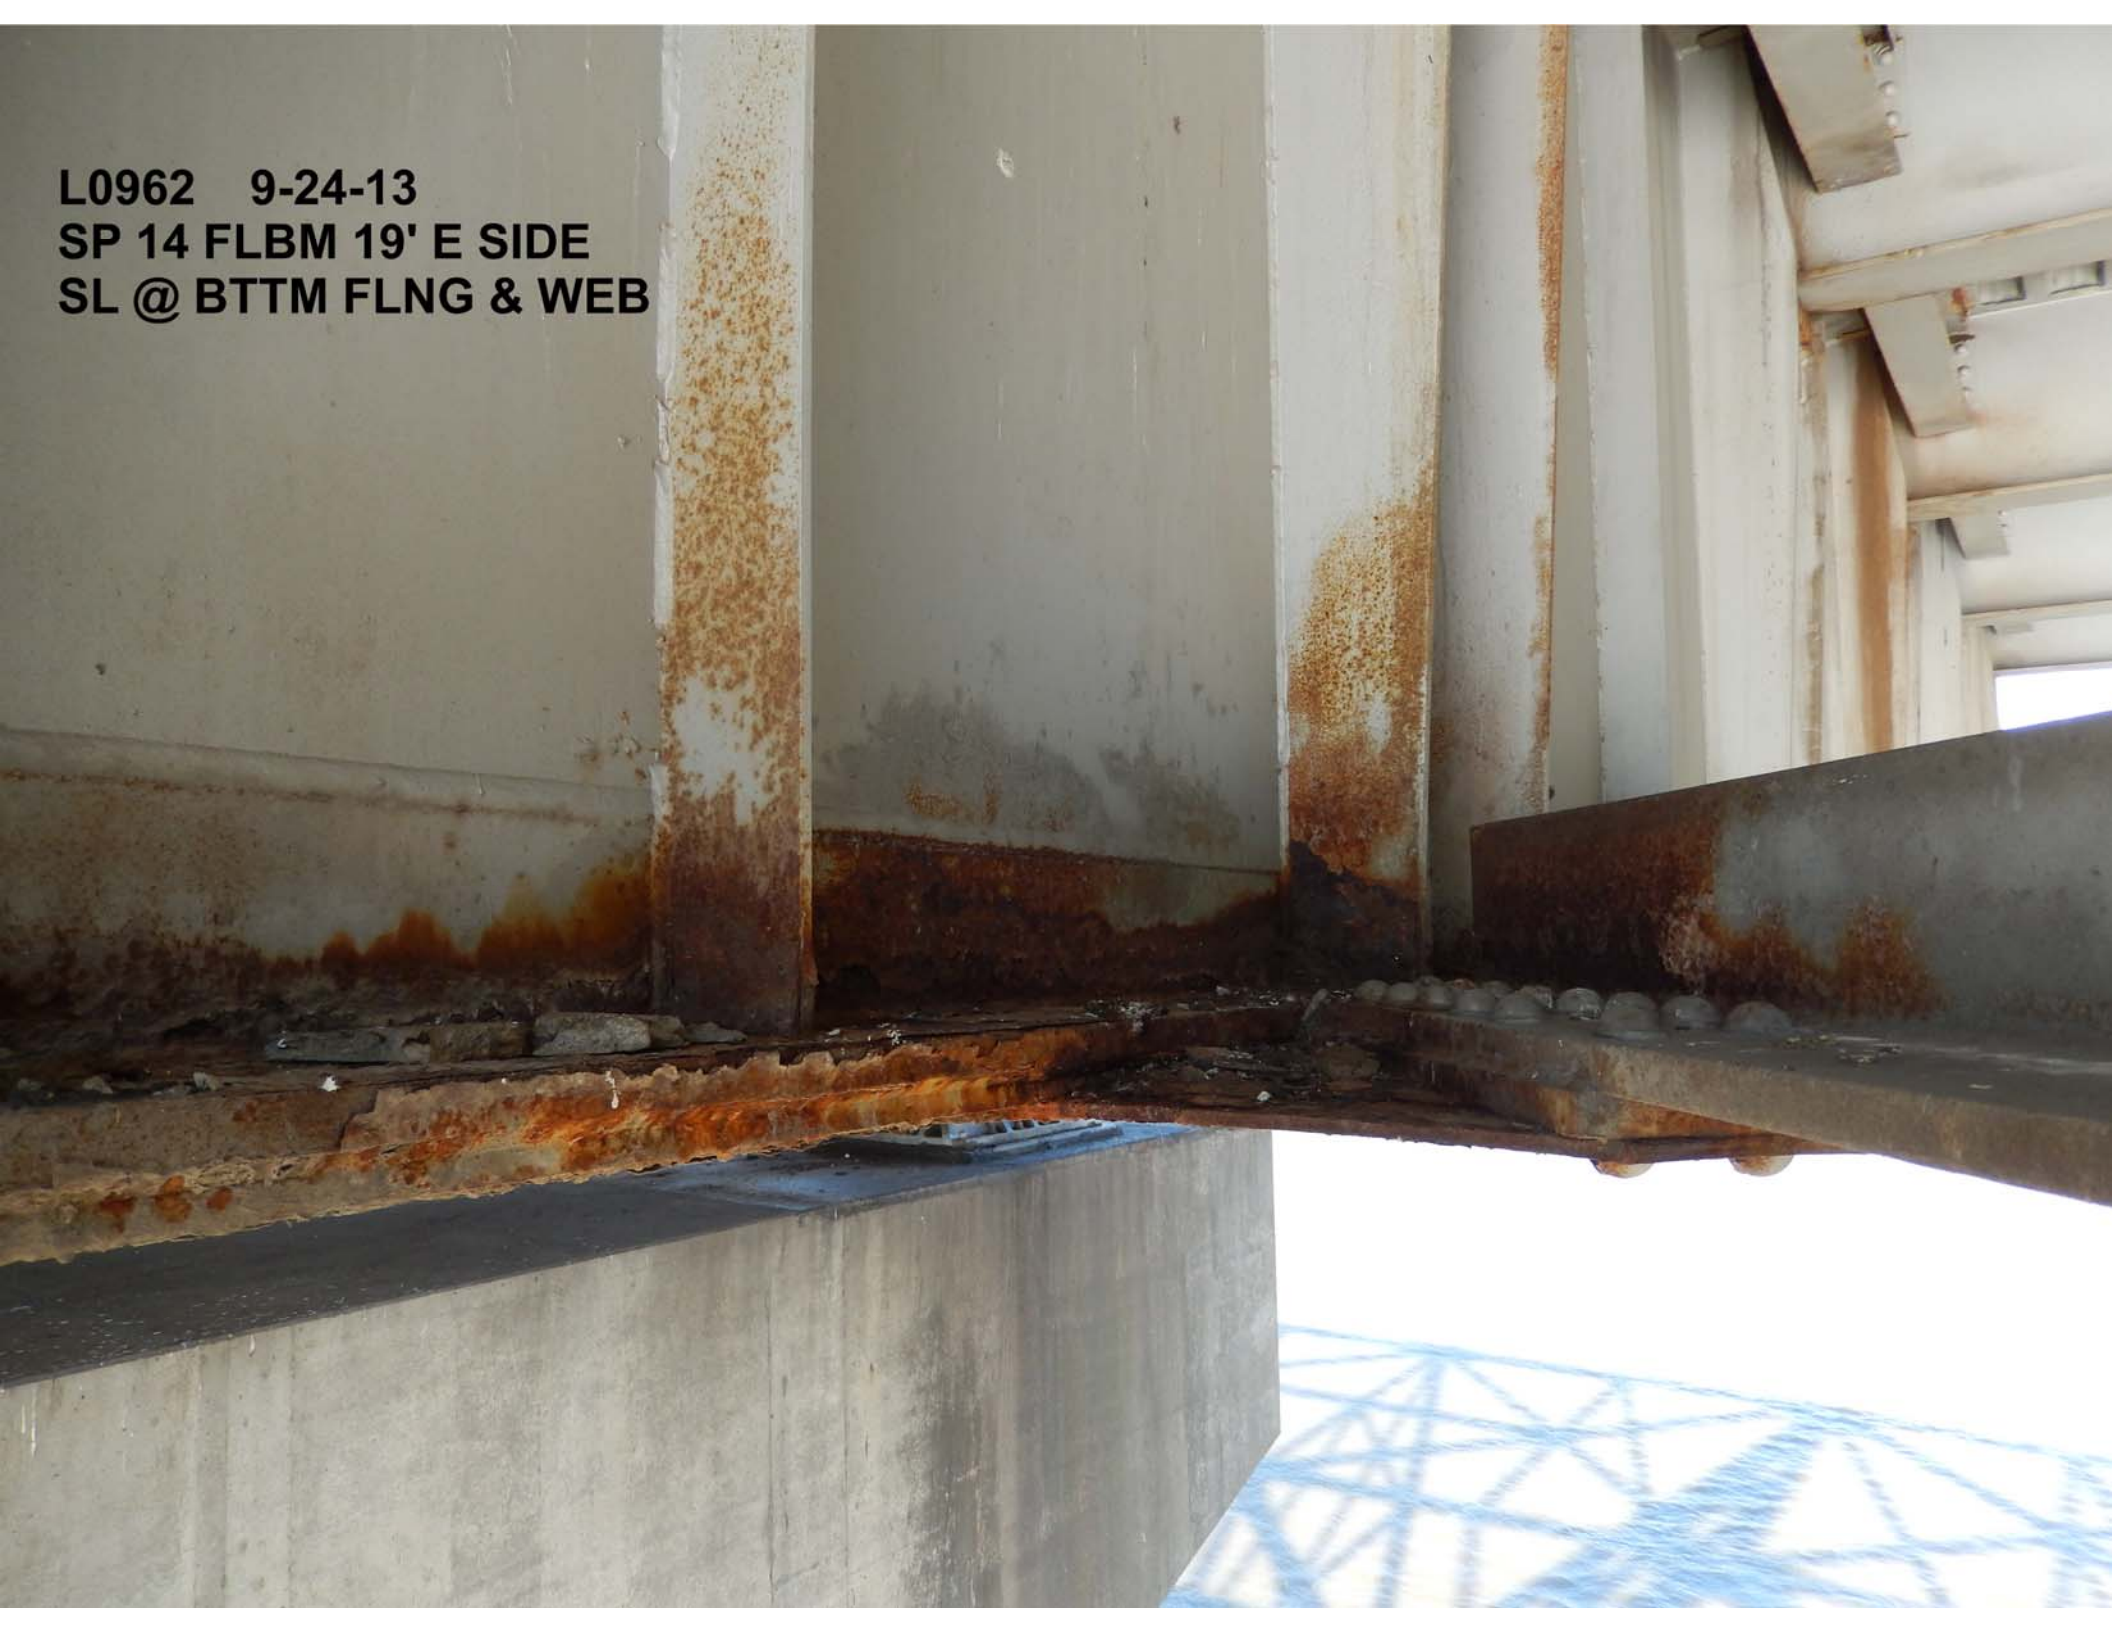
L0962 9-24-13
SP 14 FLBM 19' E SIDE
SL @ BTTM FLNG & WEB

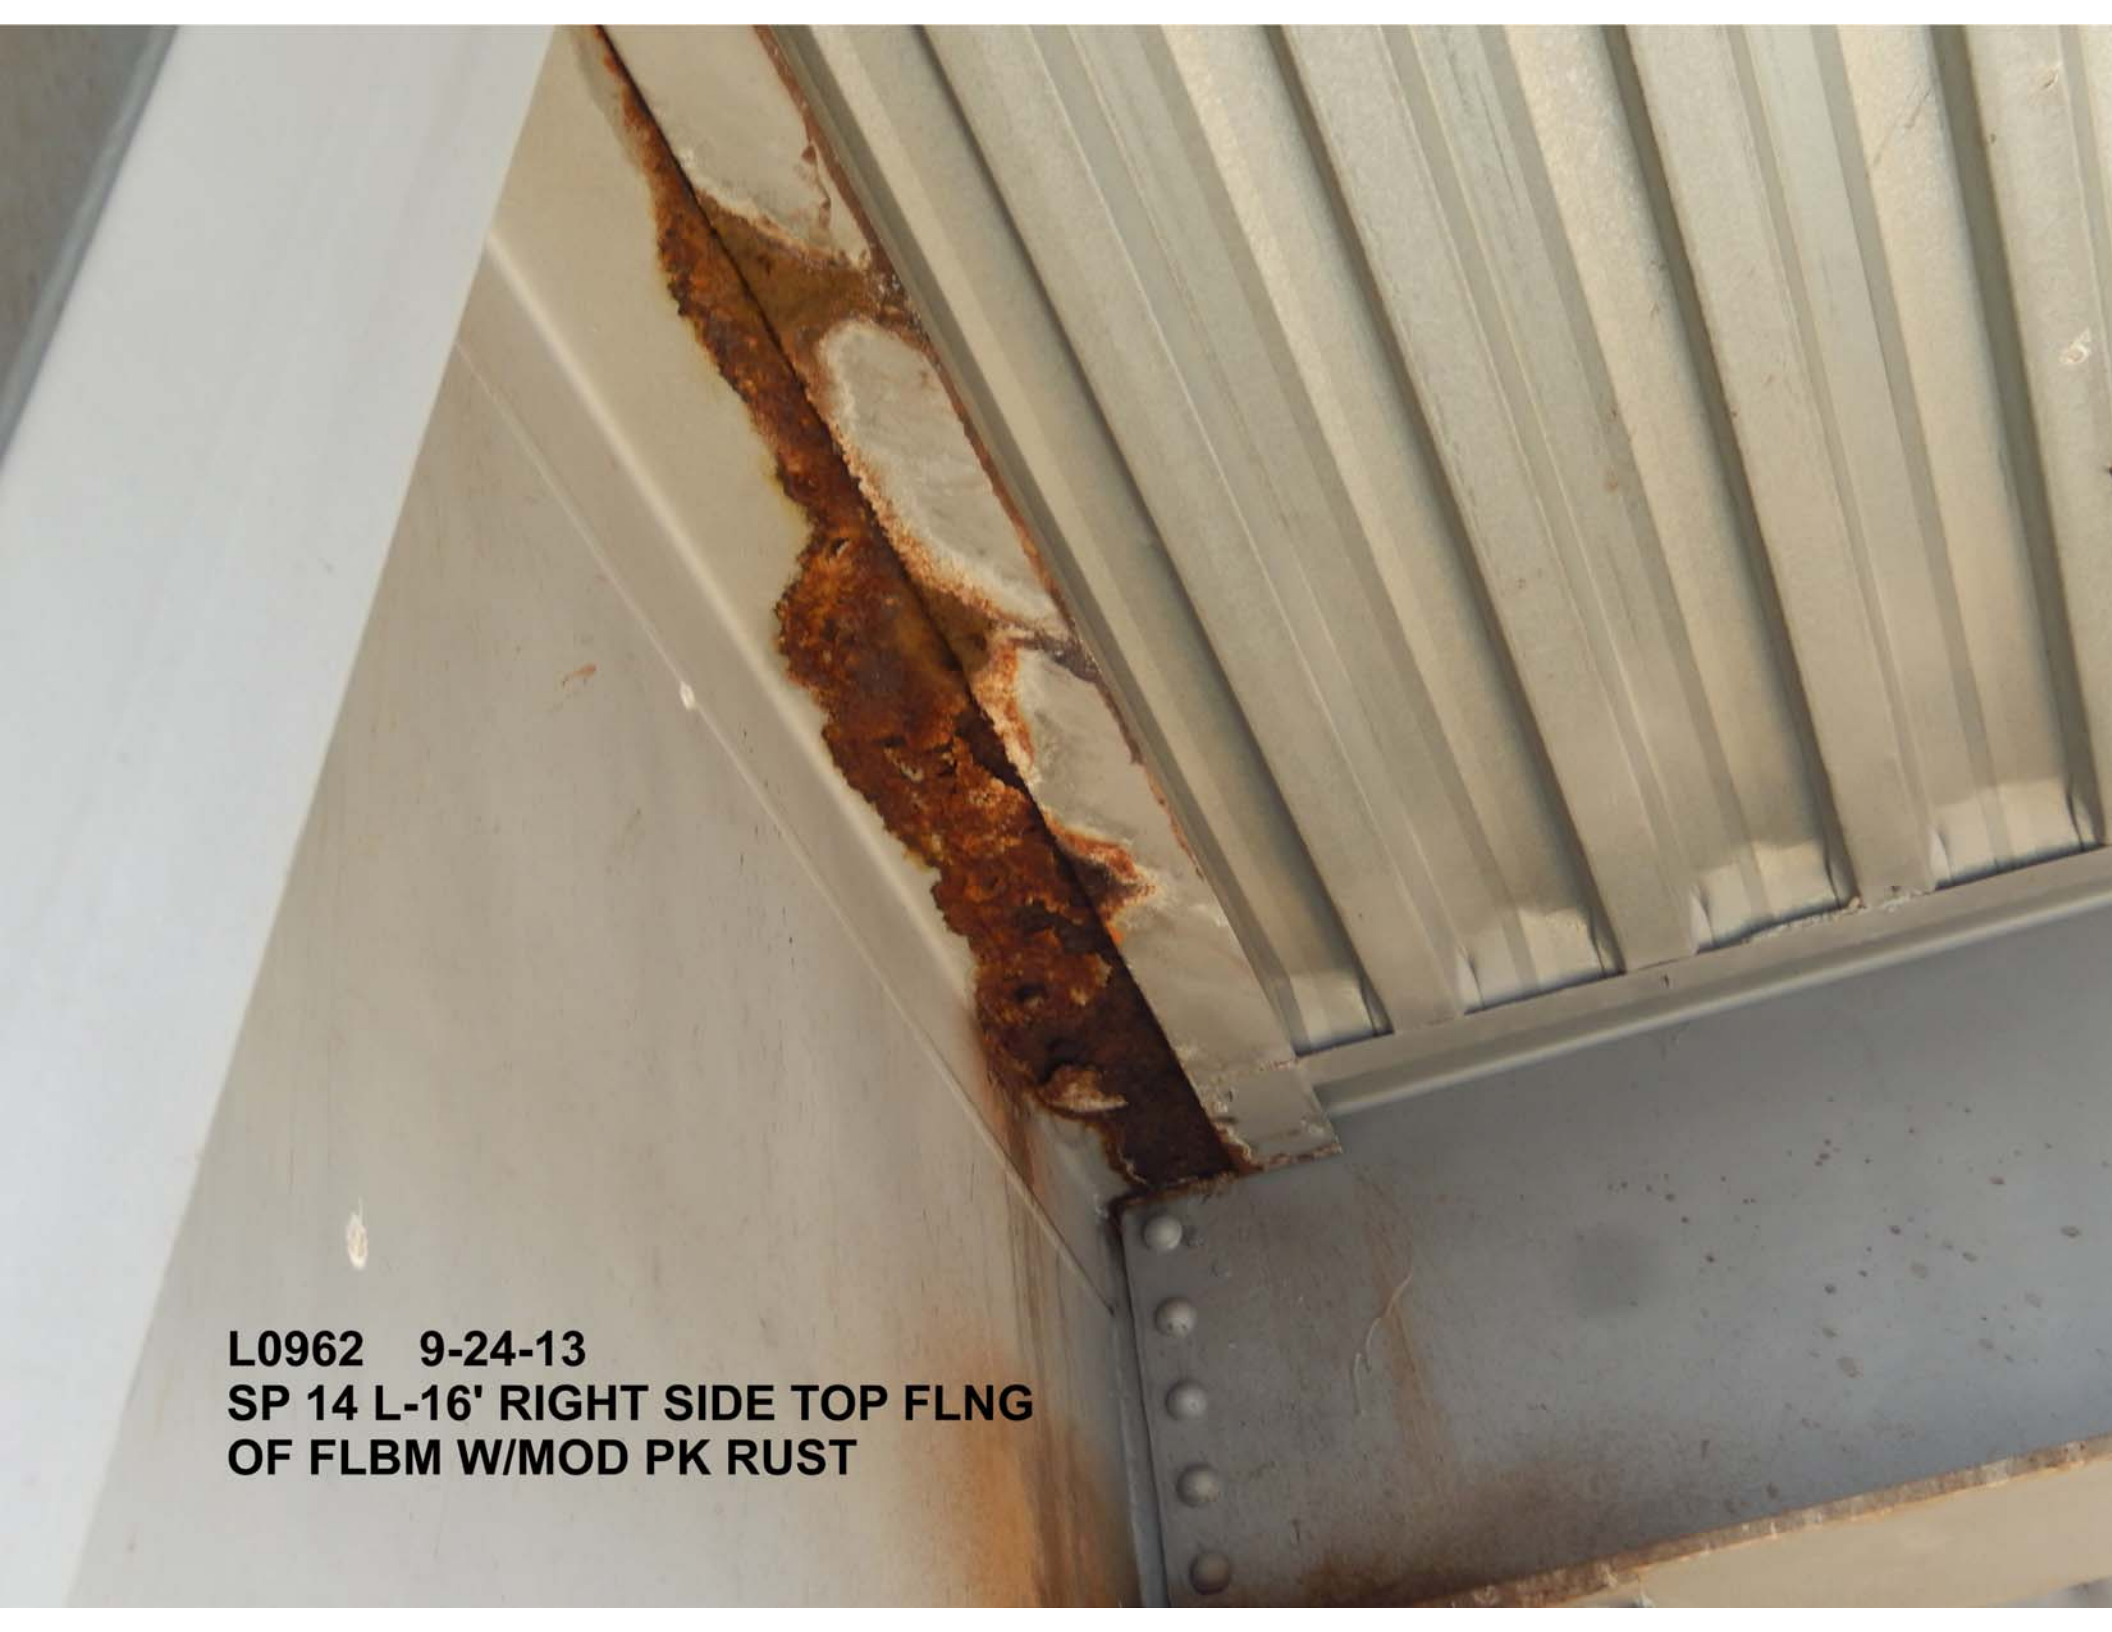
L0962 9-24-13
SP 14 L-16' RIGHT SIDE TOP FLNG
OF FLBM W/MOD PK RUST

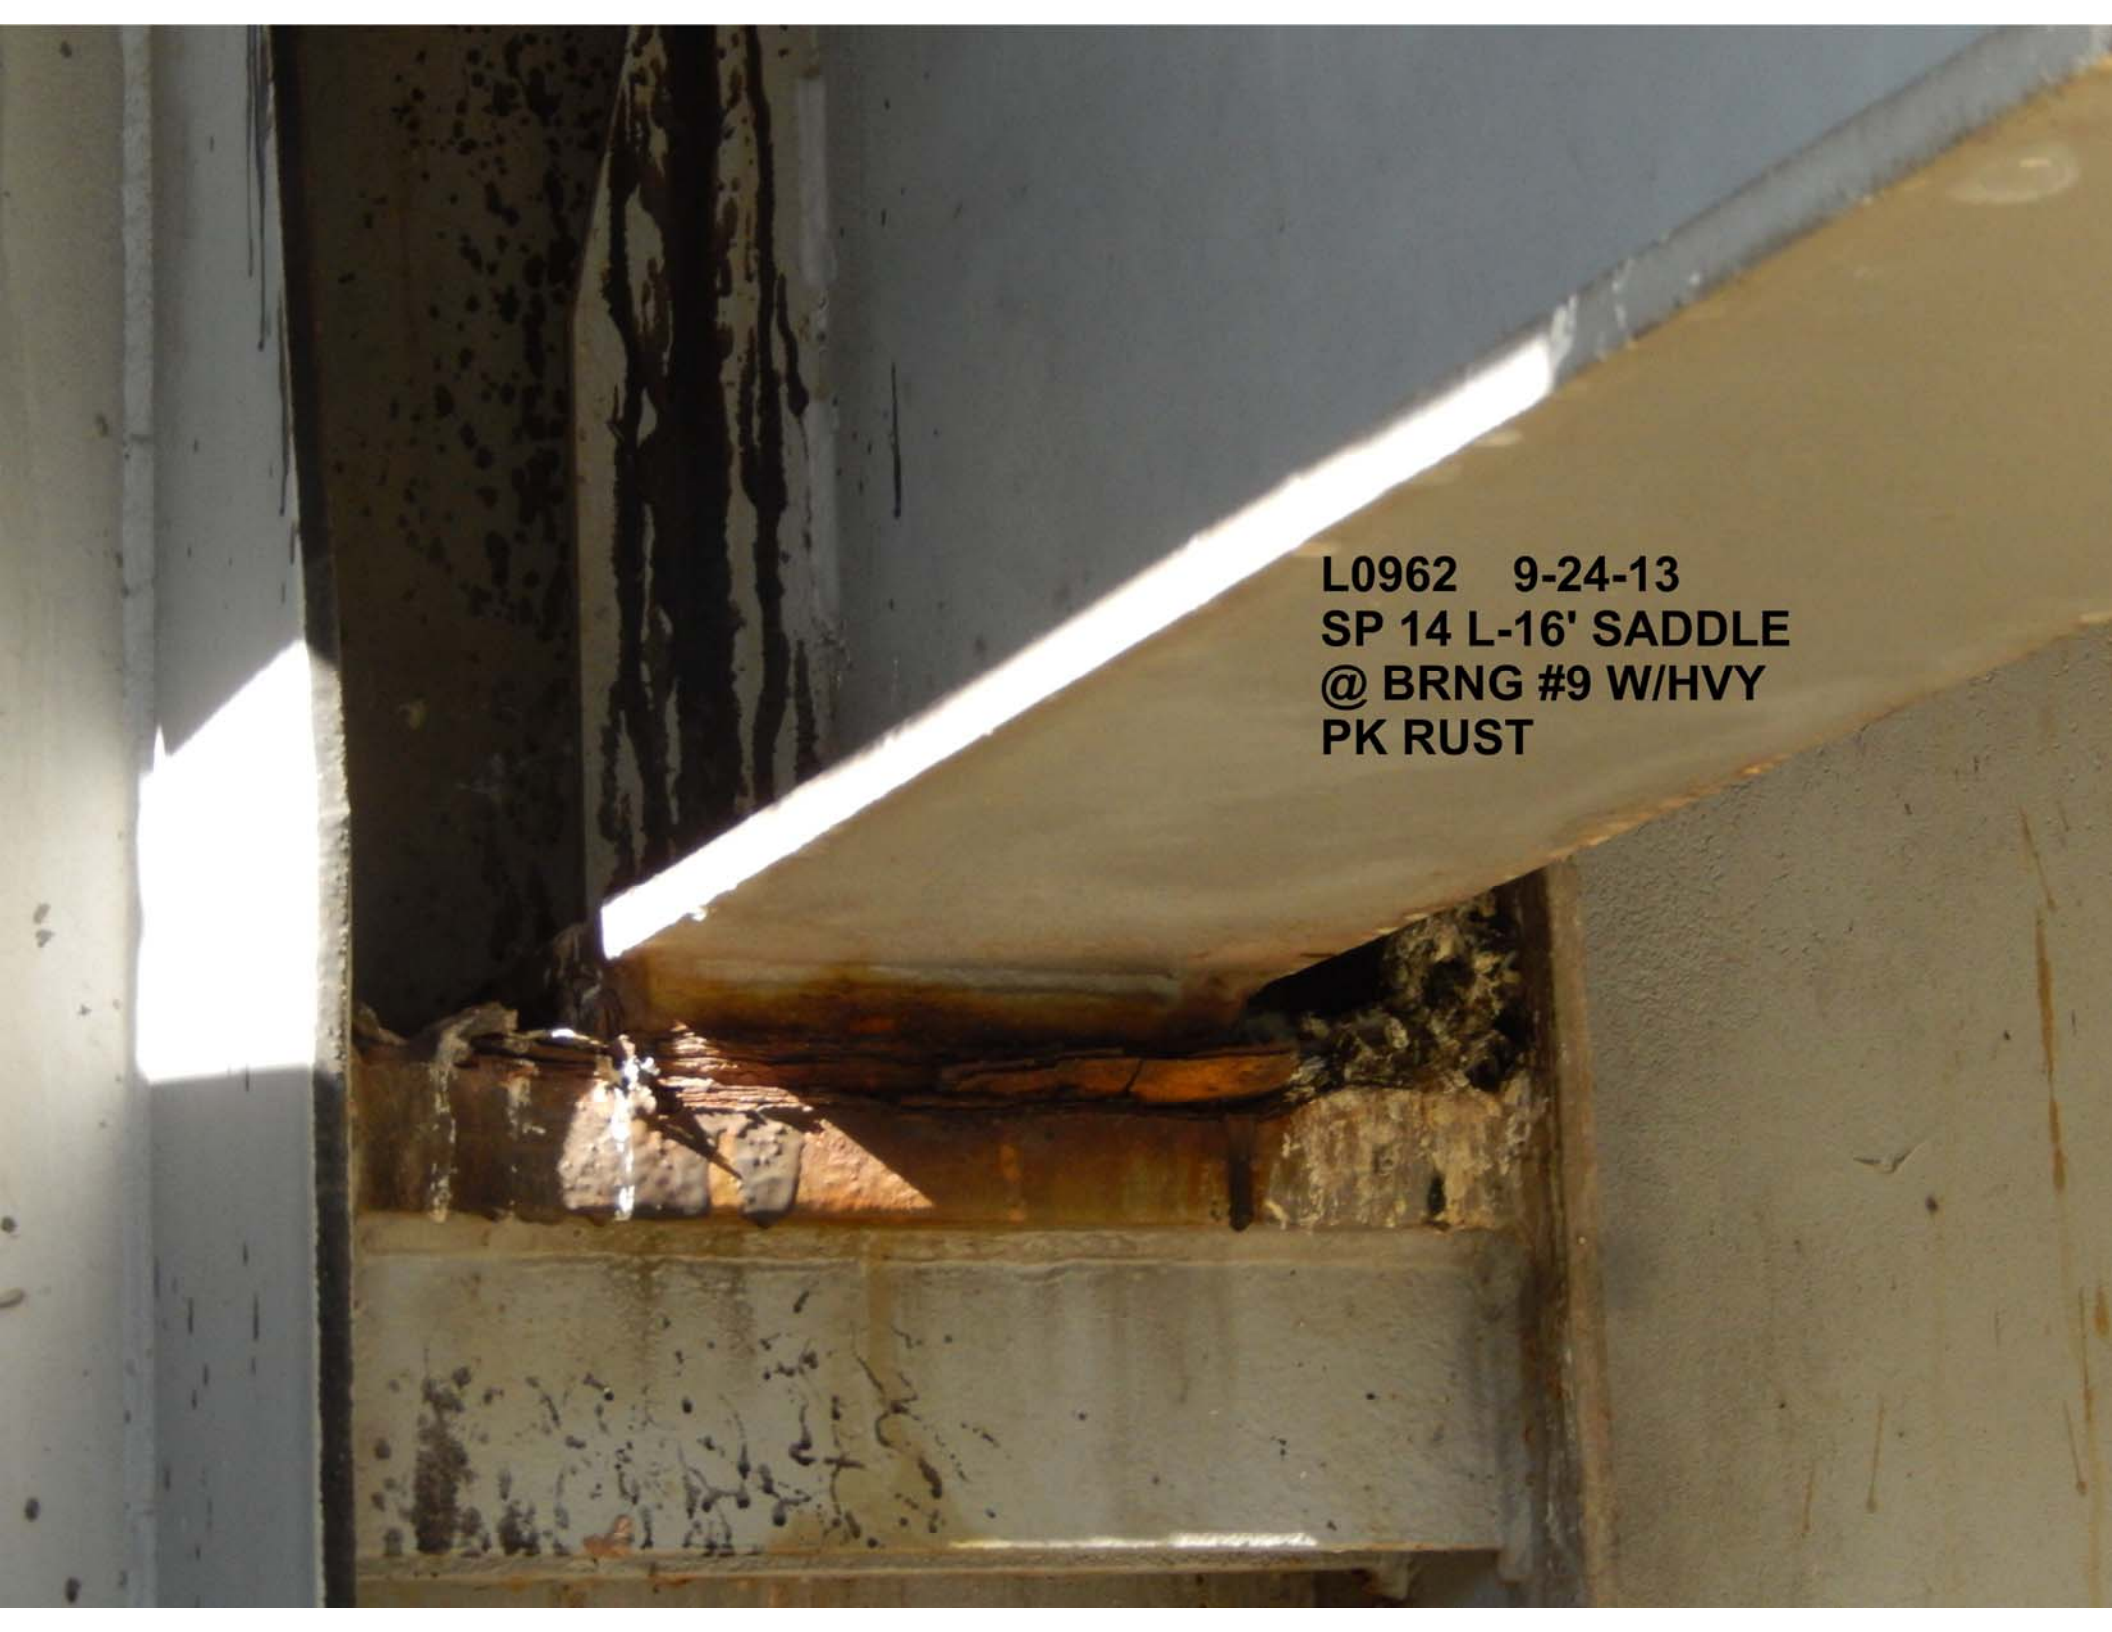
A close-up photograph of a metal saddle on a steel beam. The saddle is a curved metal piece that fits over the top of the beam. The area around the saddle shows significant rust and damage to the concrete structure. The concrete is cracked and crumbling, and there is a large amount of rust on the steel beam and the saddle. The lighting is bright, highlighting the textures of the metal, concrete, and rust.
