Appendix E:

MoDOT Bridge Inspection Report

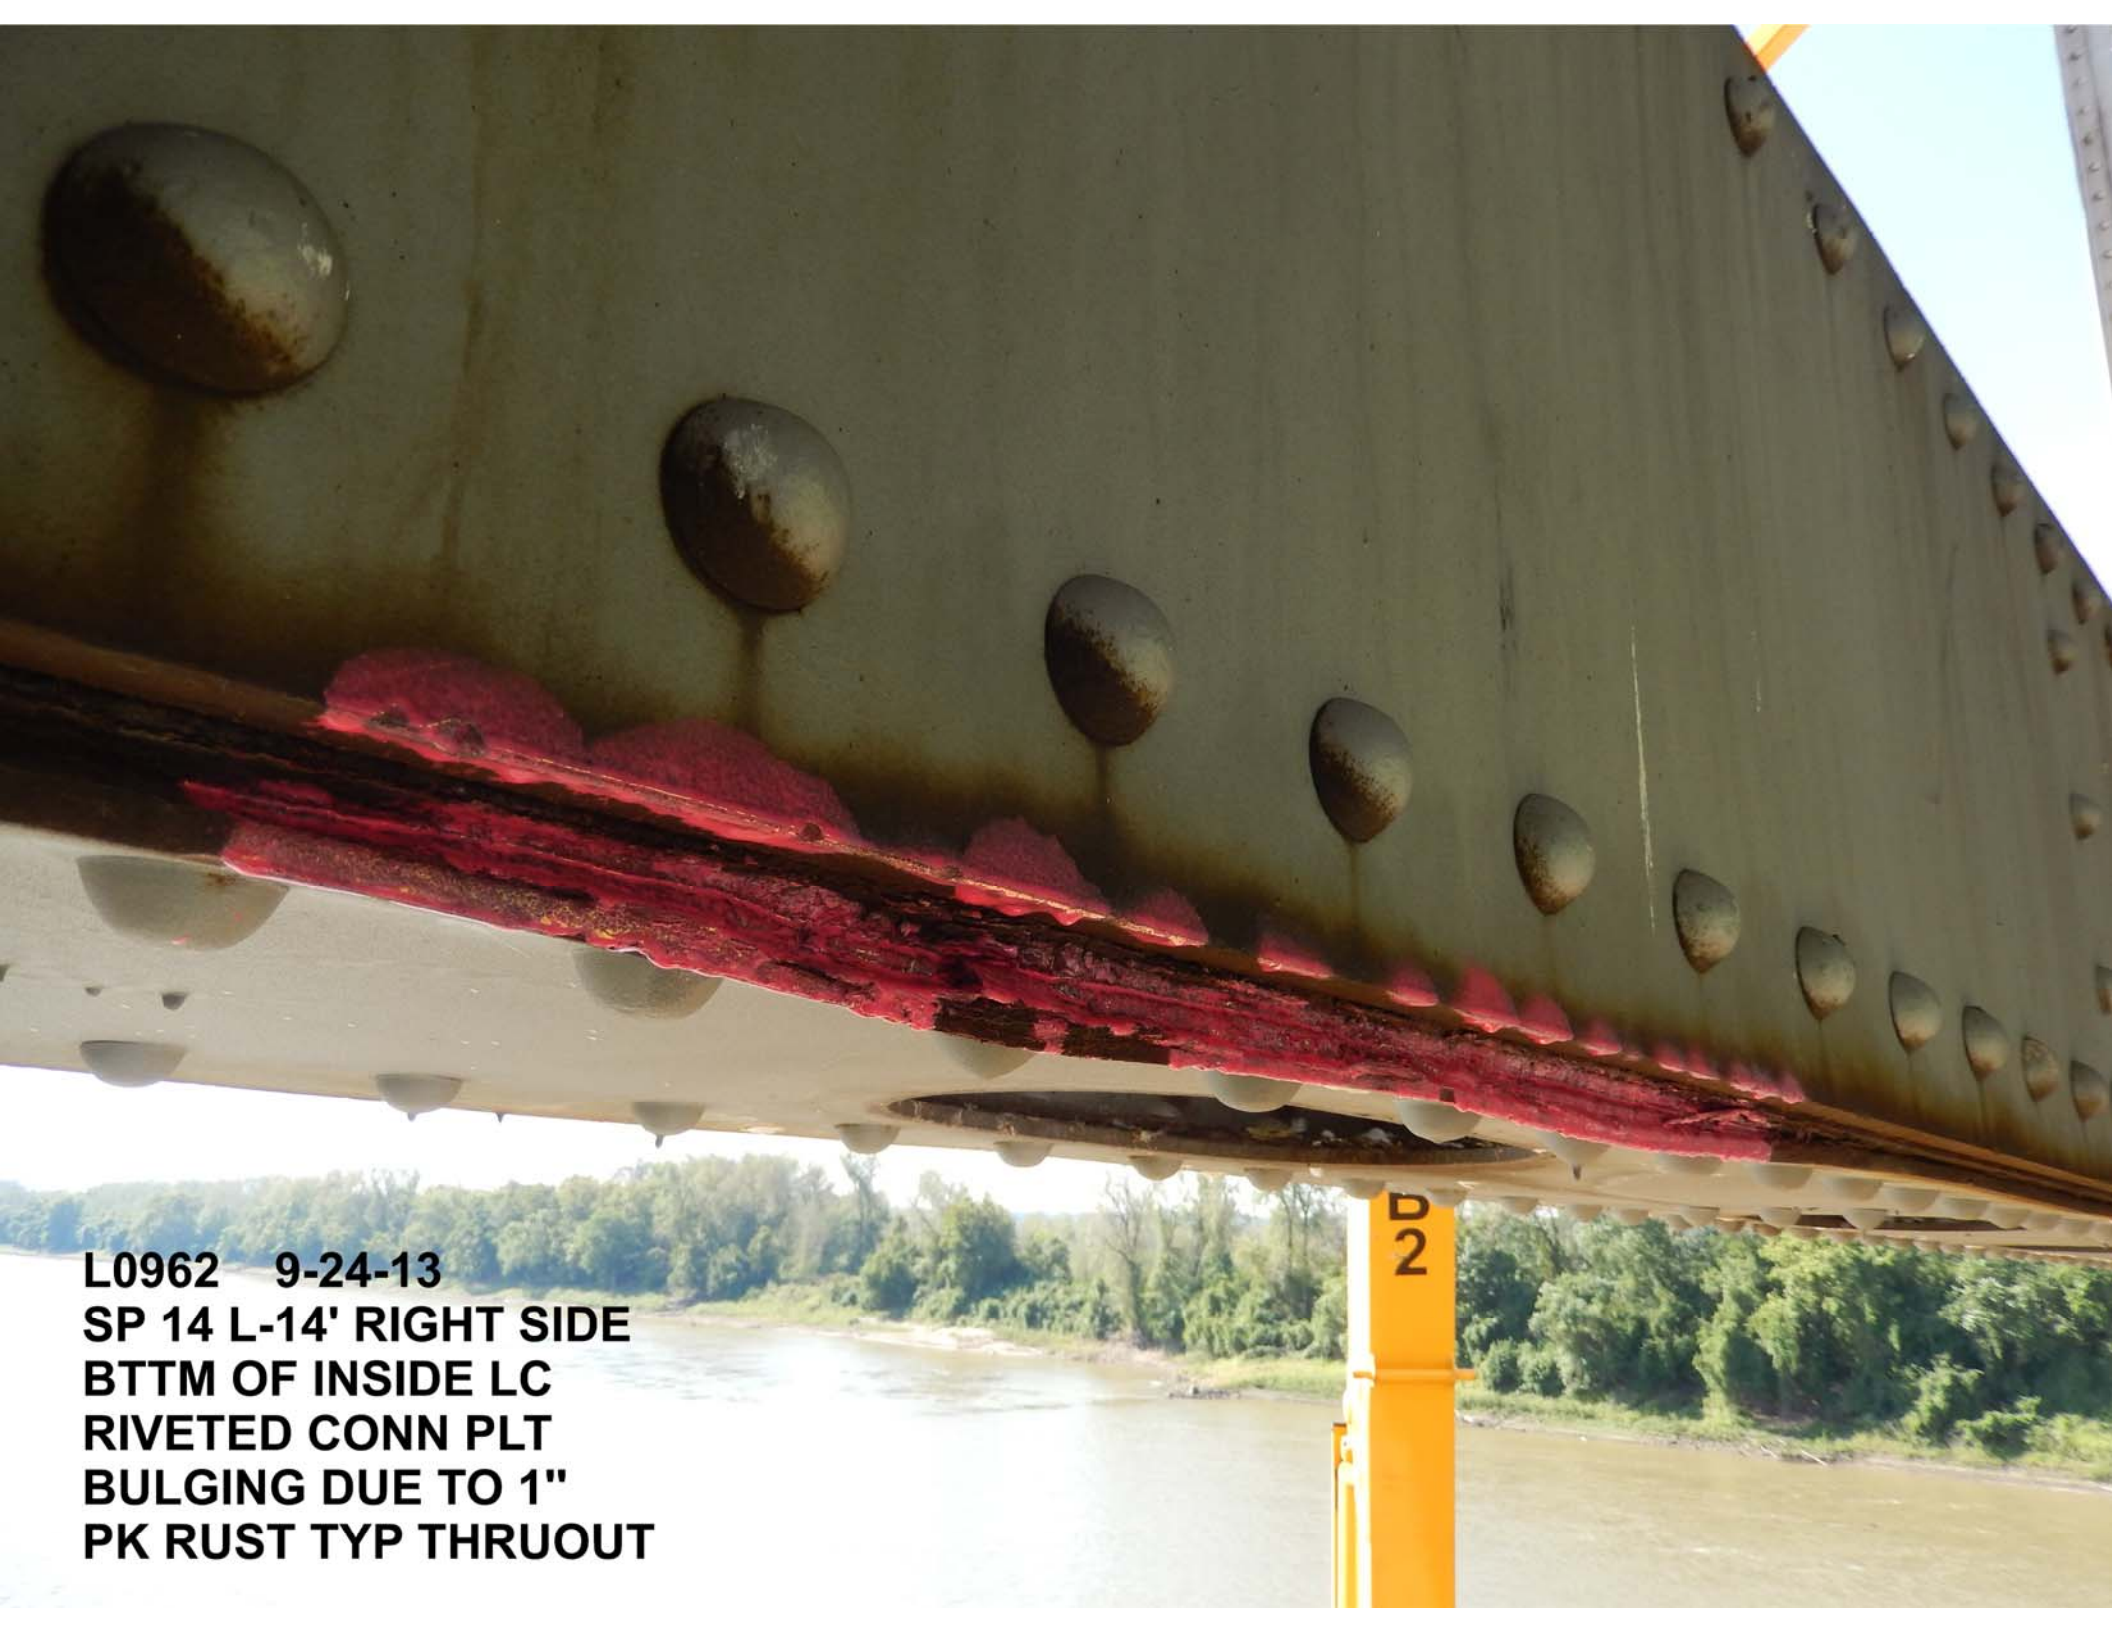
L0962 9-24-13
SP 14 L-14' RIGHT SIDE
BTTM OF INSIDE LC
RIVETED CONN PLT
BULGING DUE TO 1"
PK RUST TYP THRUOUT

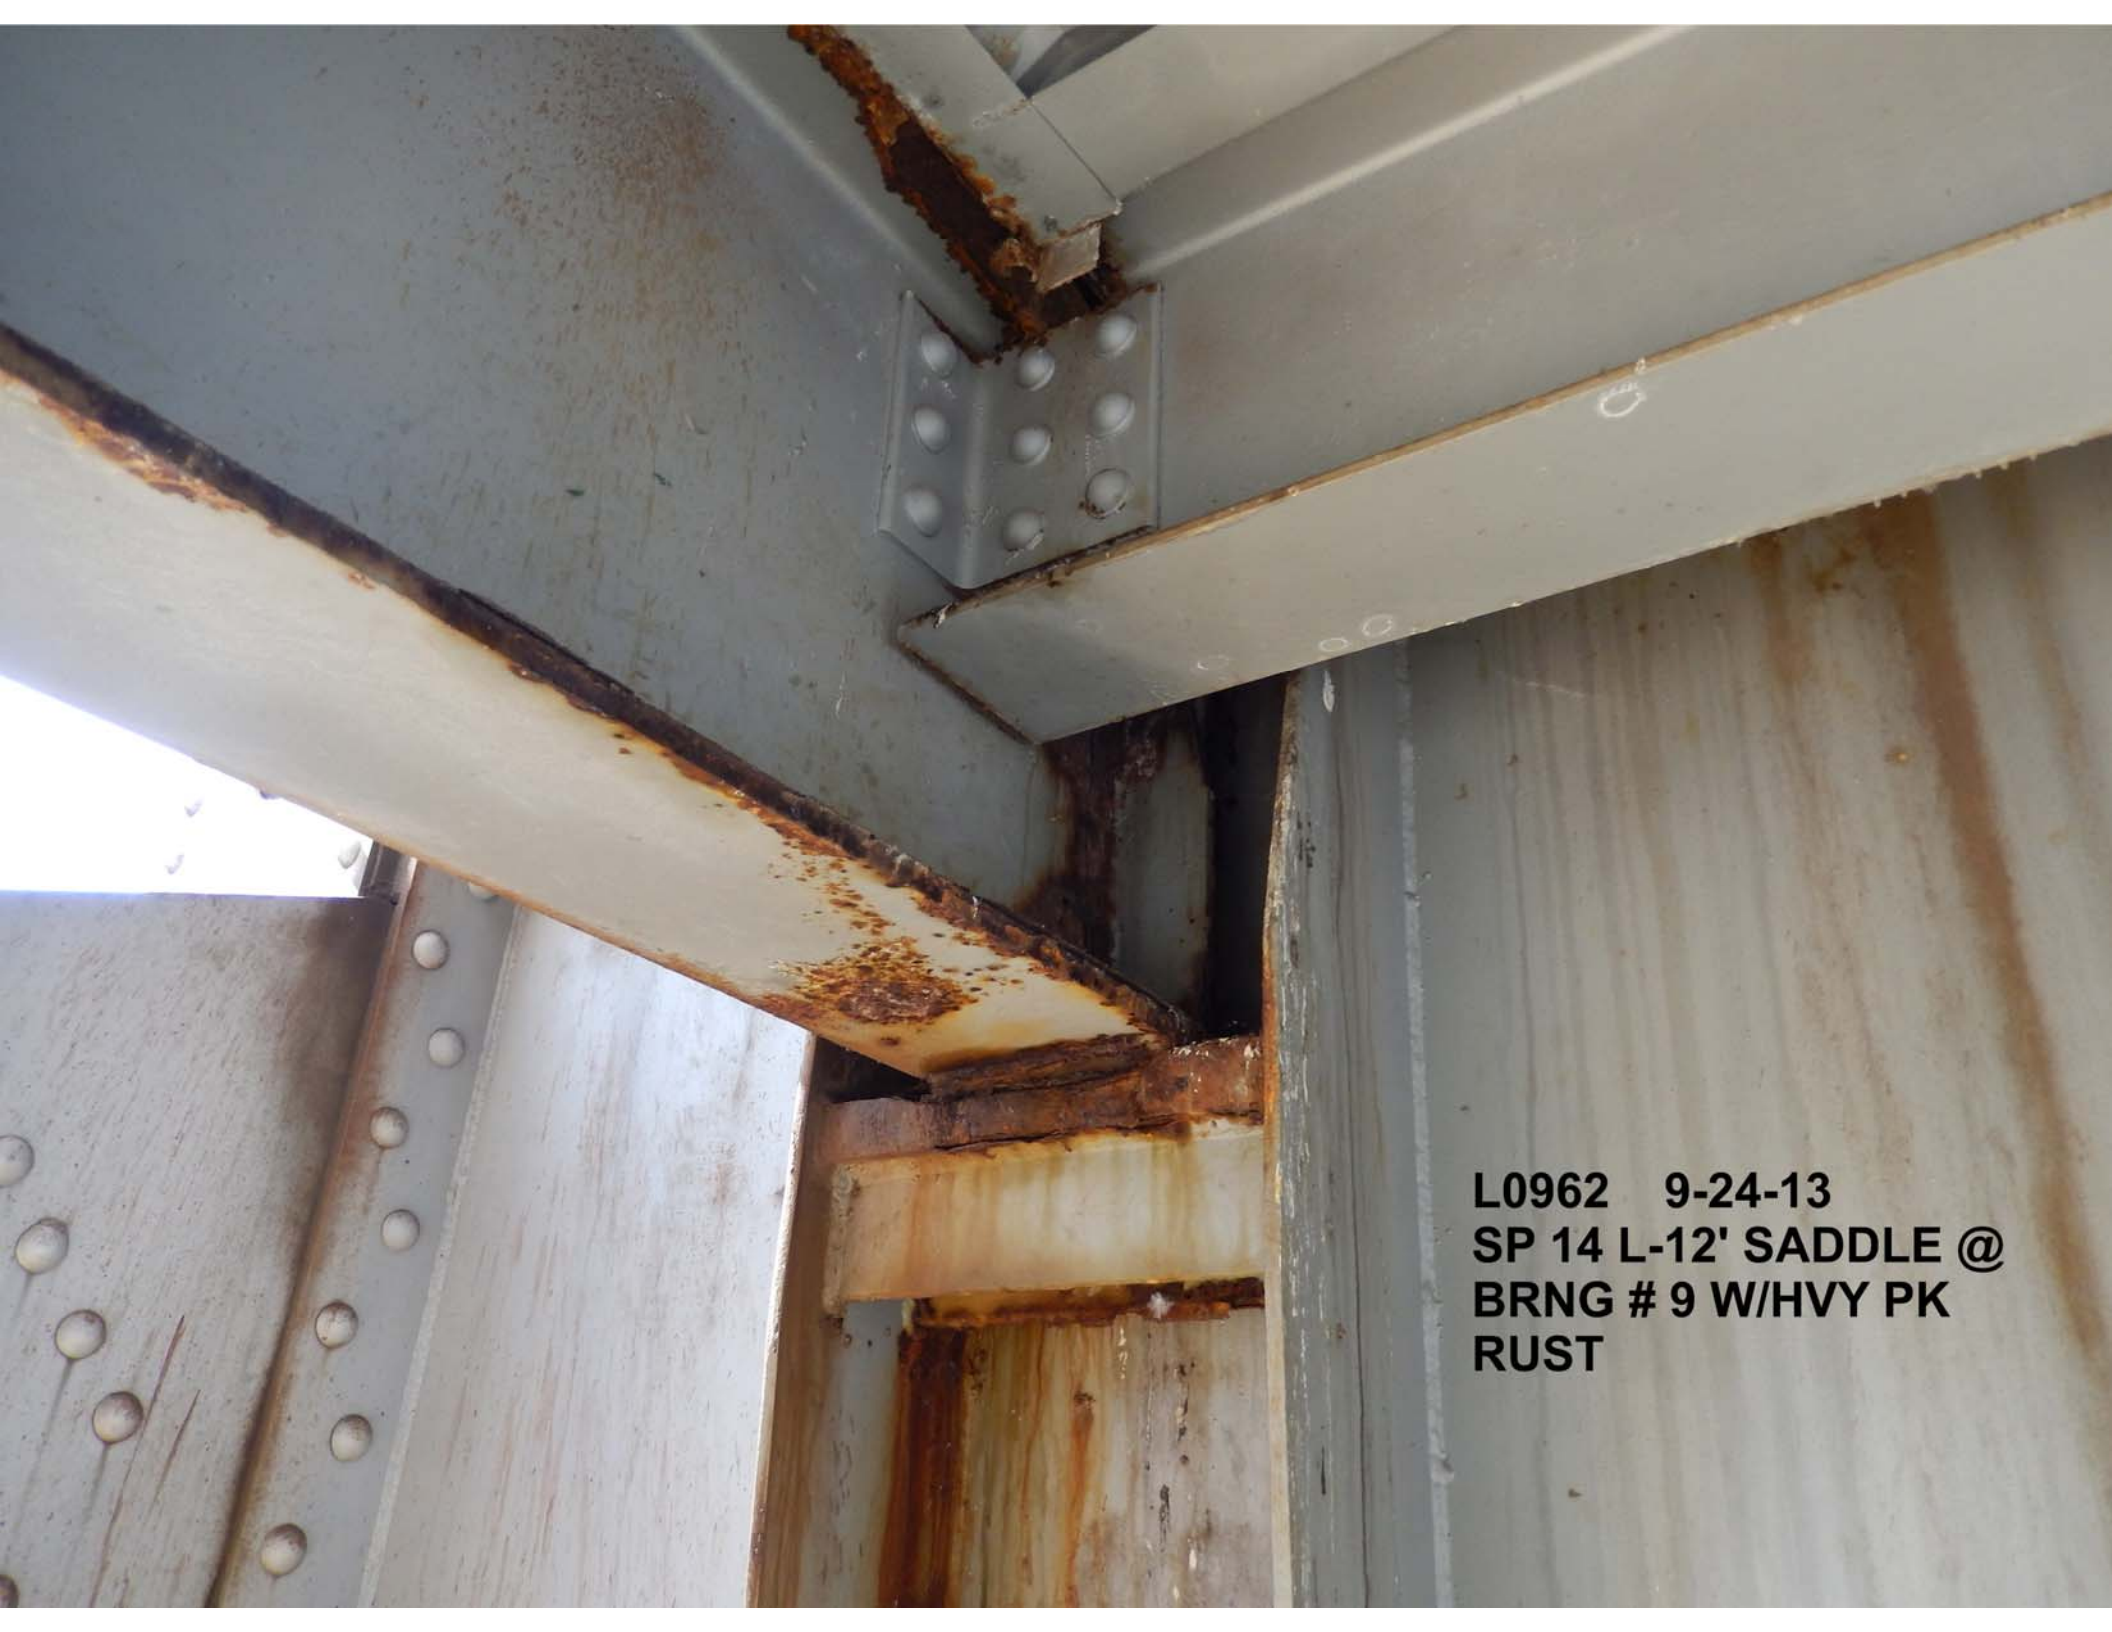
L0962 9-24-13
SP 14 L-12' SADDLE @
BRNG # 9 W/HVY PK
RUST

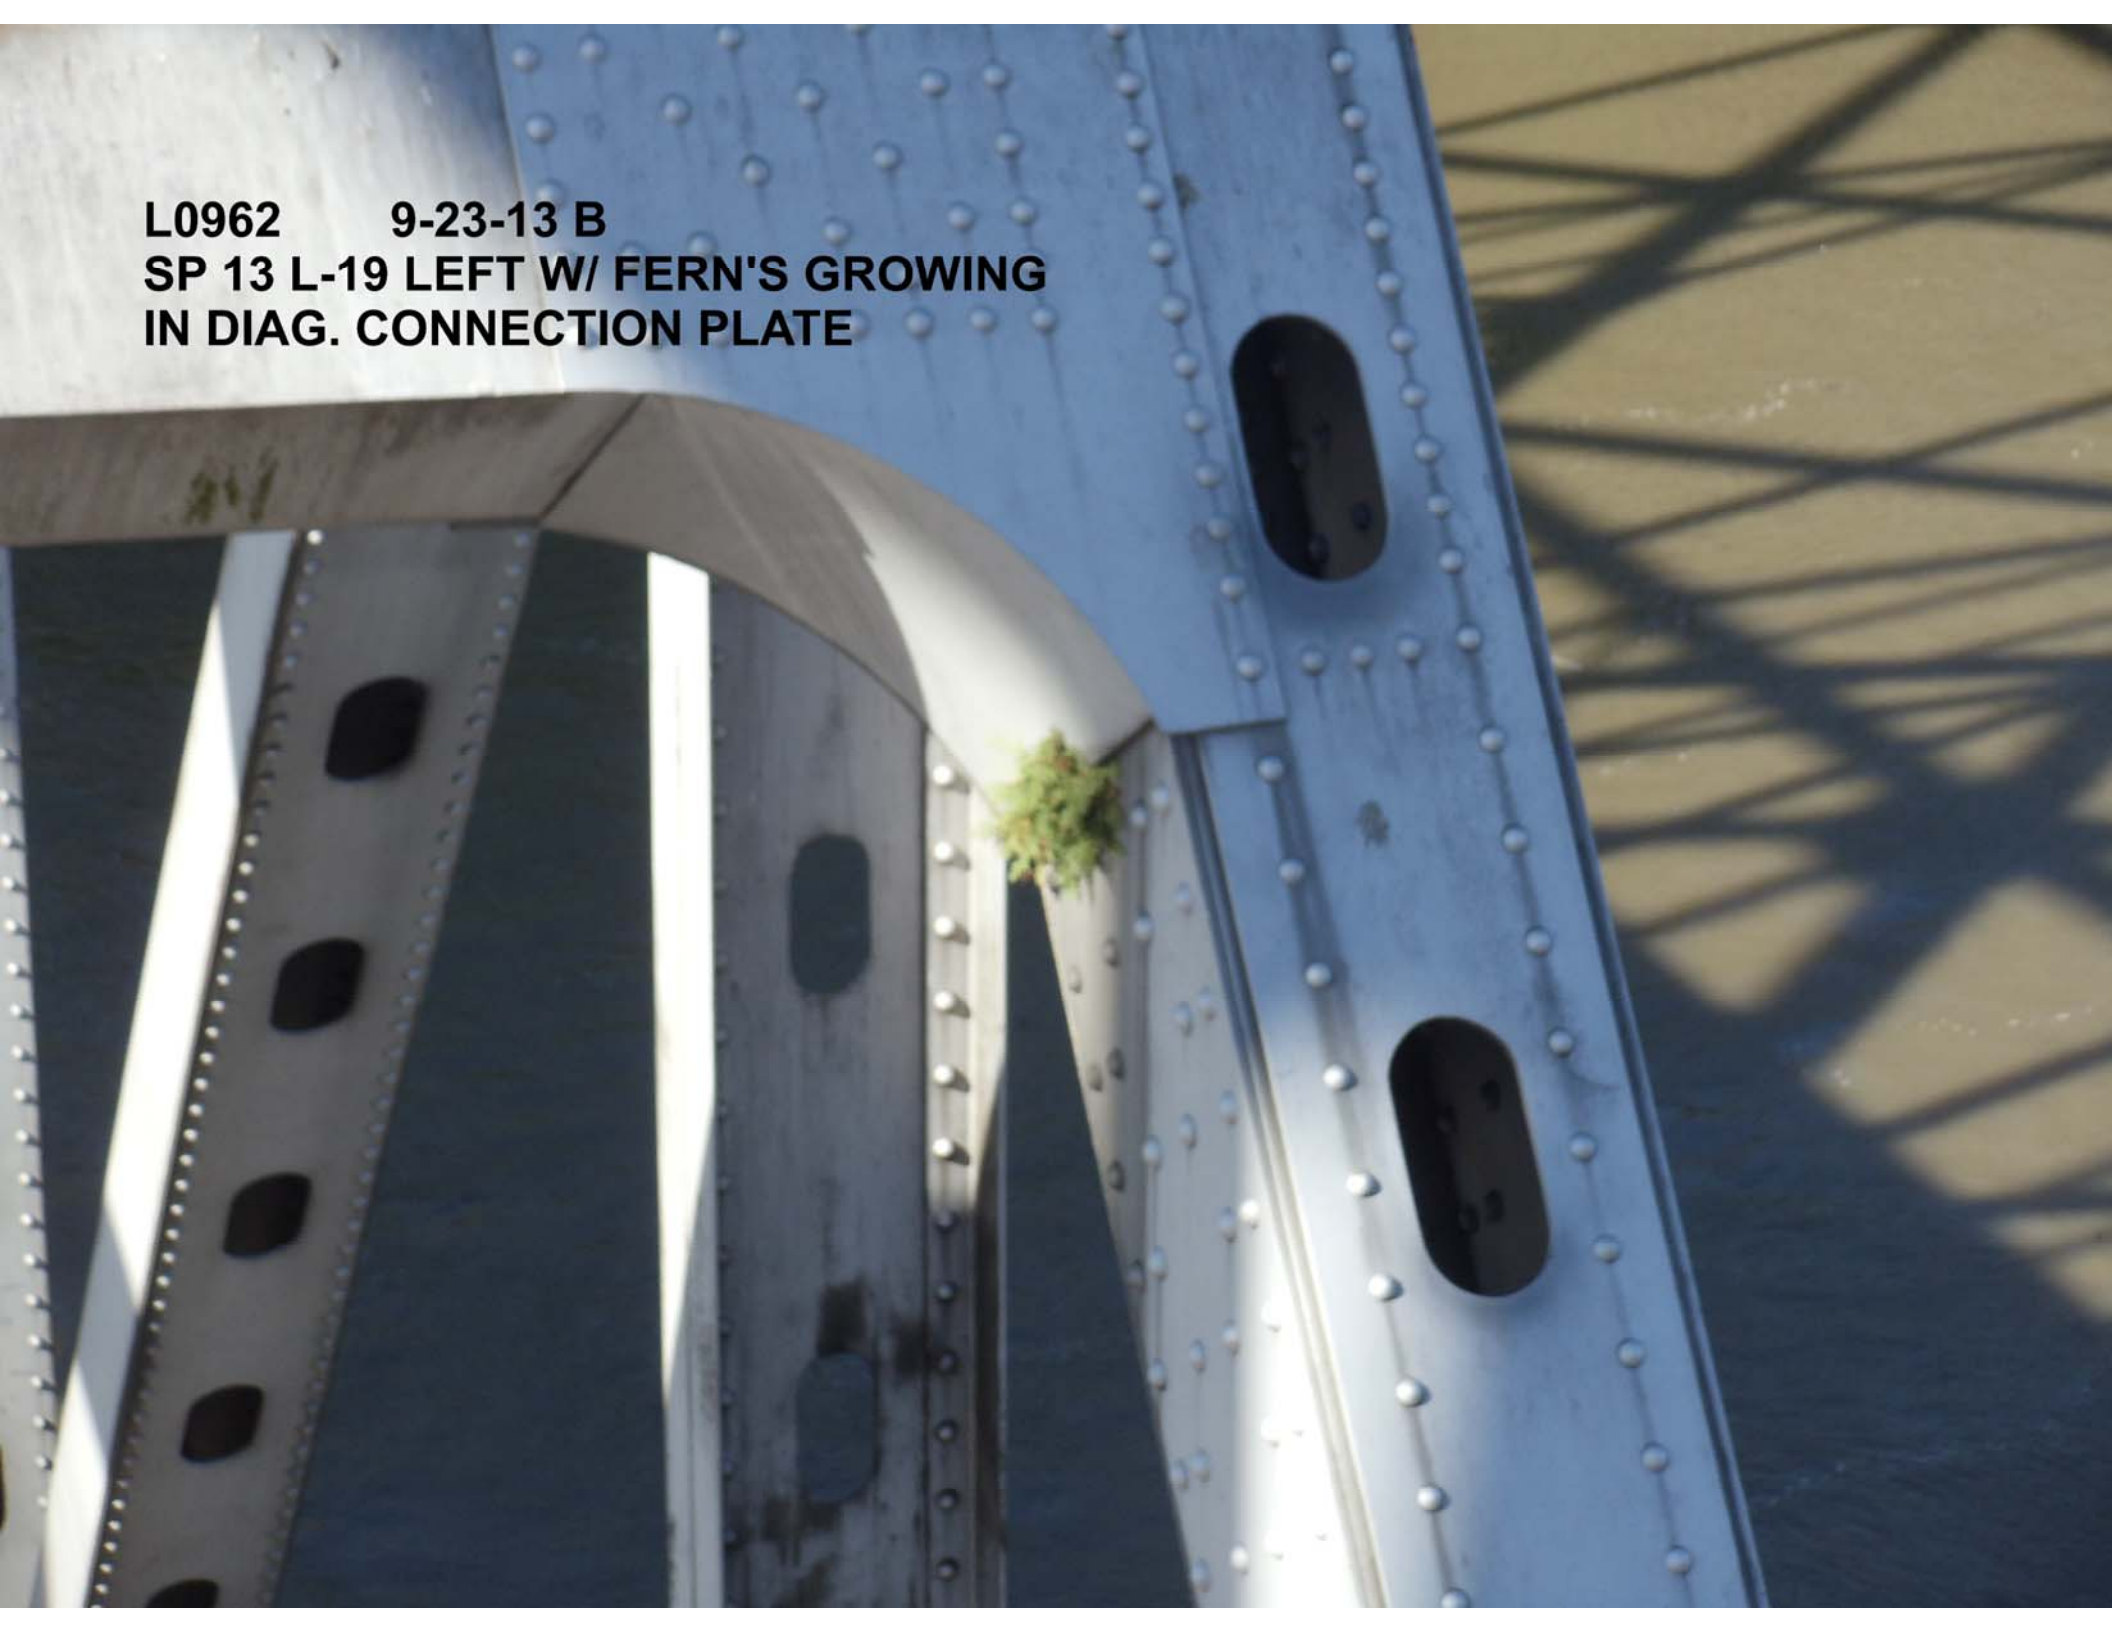
L0962 9-23-13 B
SP 13 U-10 LEFT TOP GUSS
W/ MINOR DISTORTION

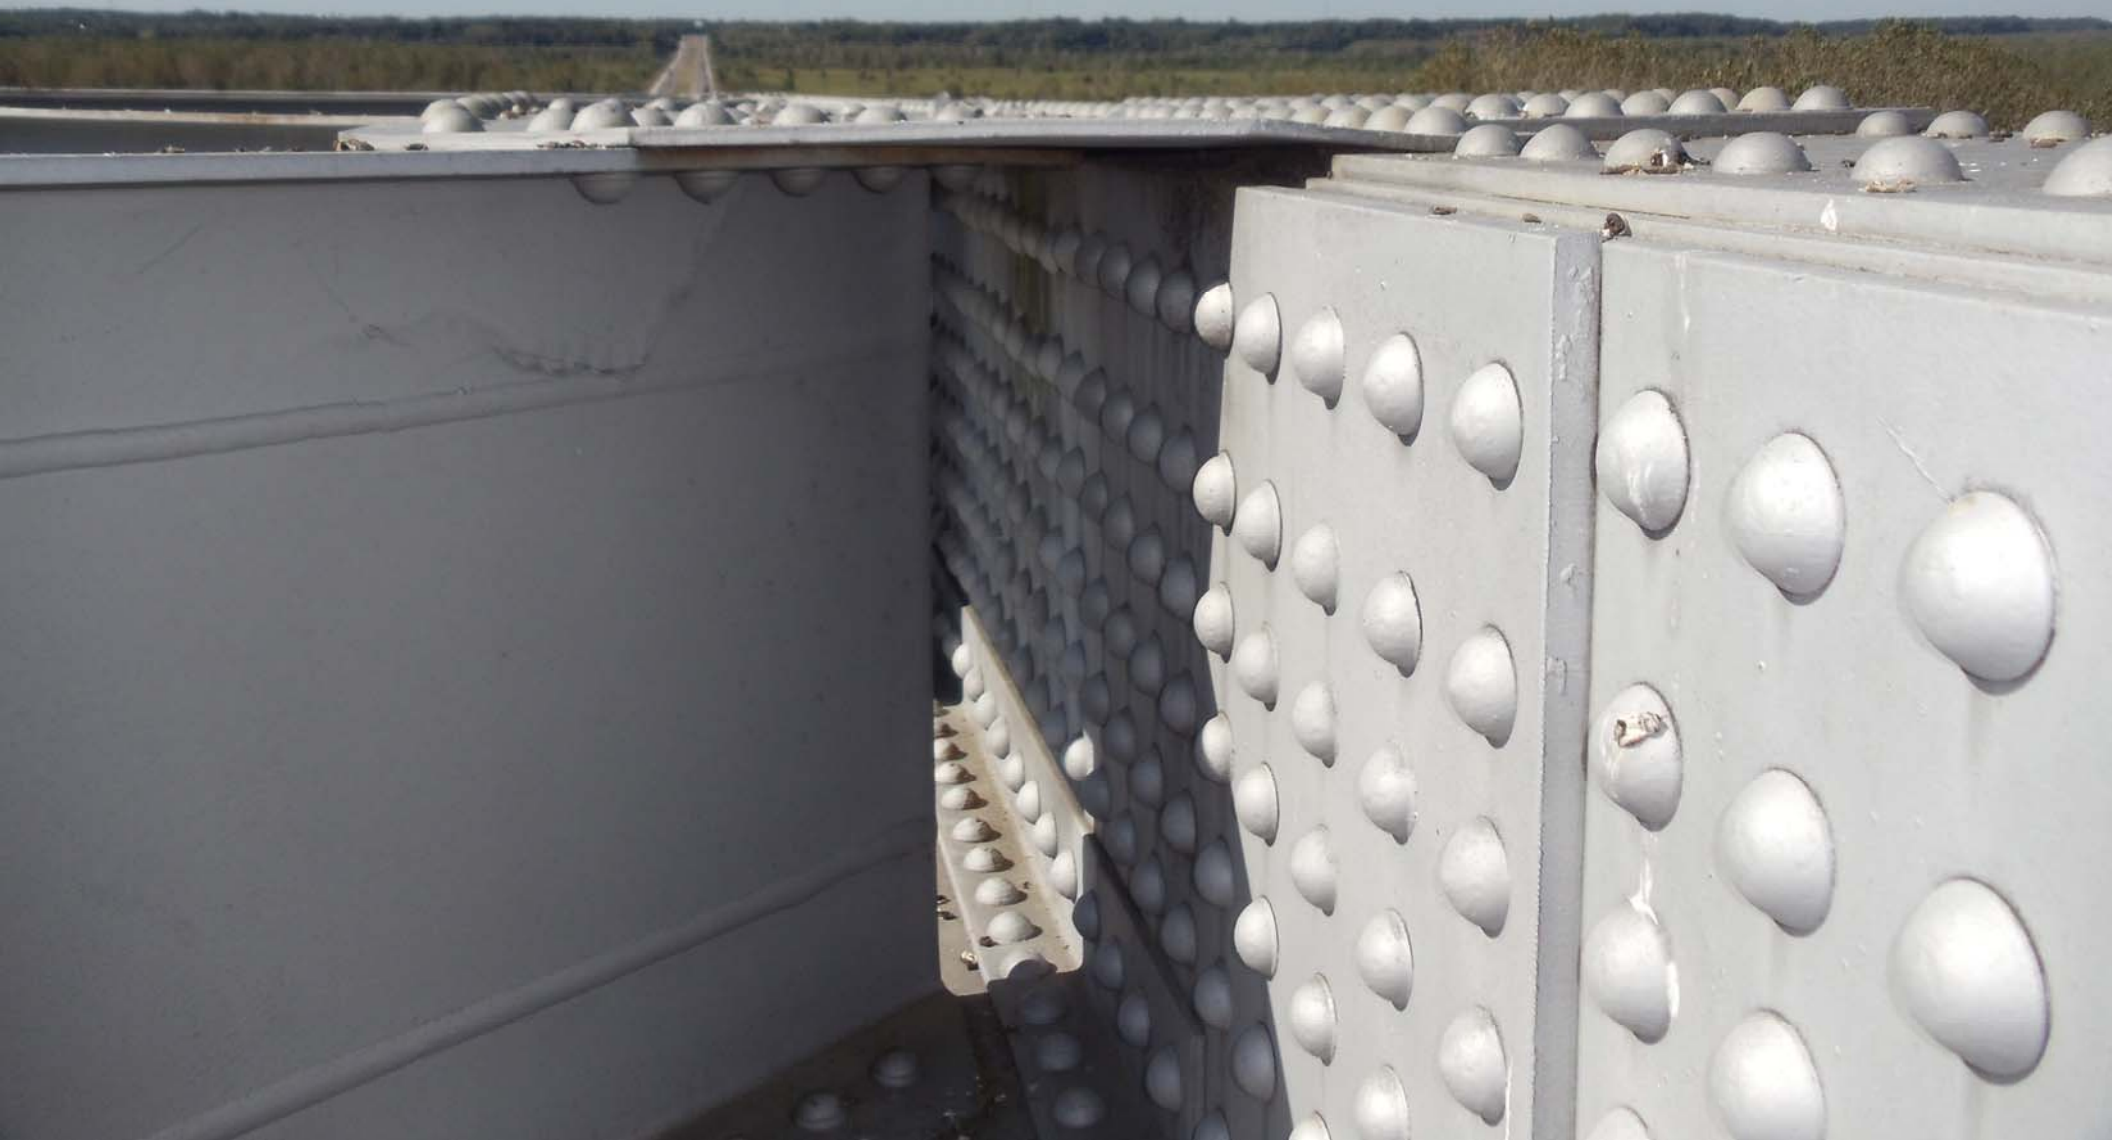
L0962 9-23-13 B
SP 13 U-7 LEFT W/ 3" RIP IN TOP GUSS
NO CRK BEYOND DAMAGED AREA

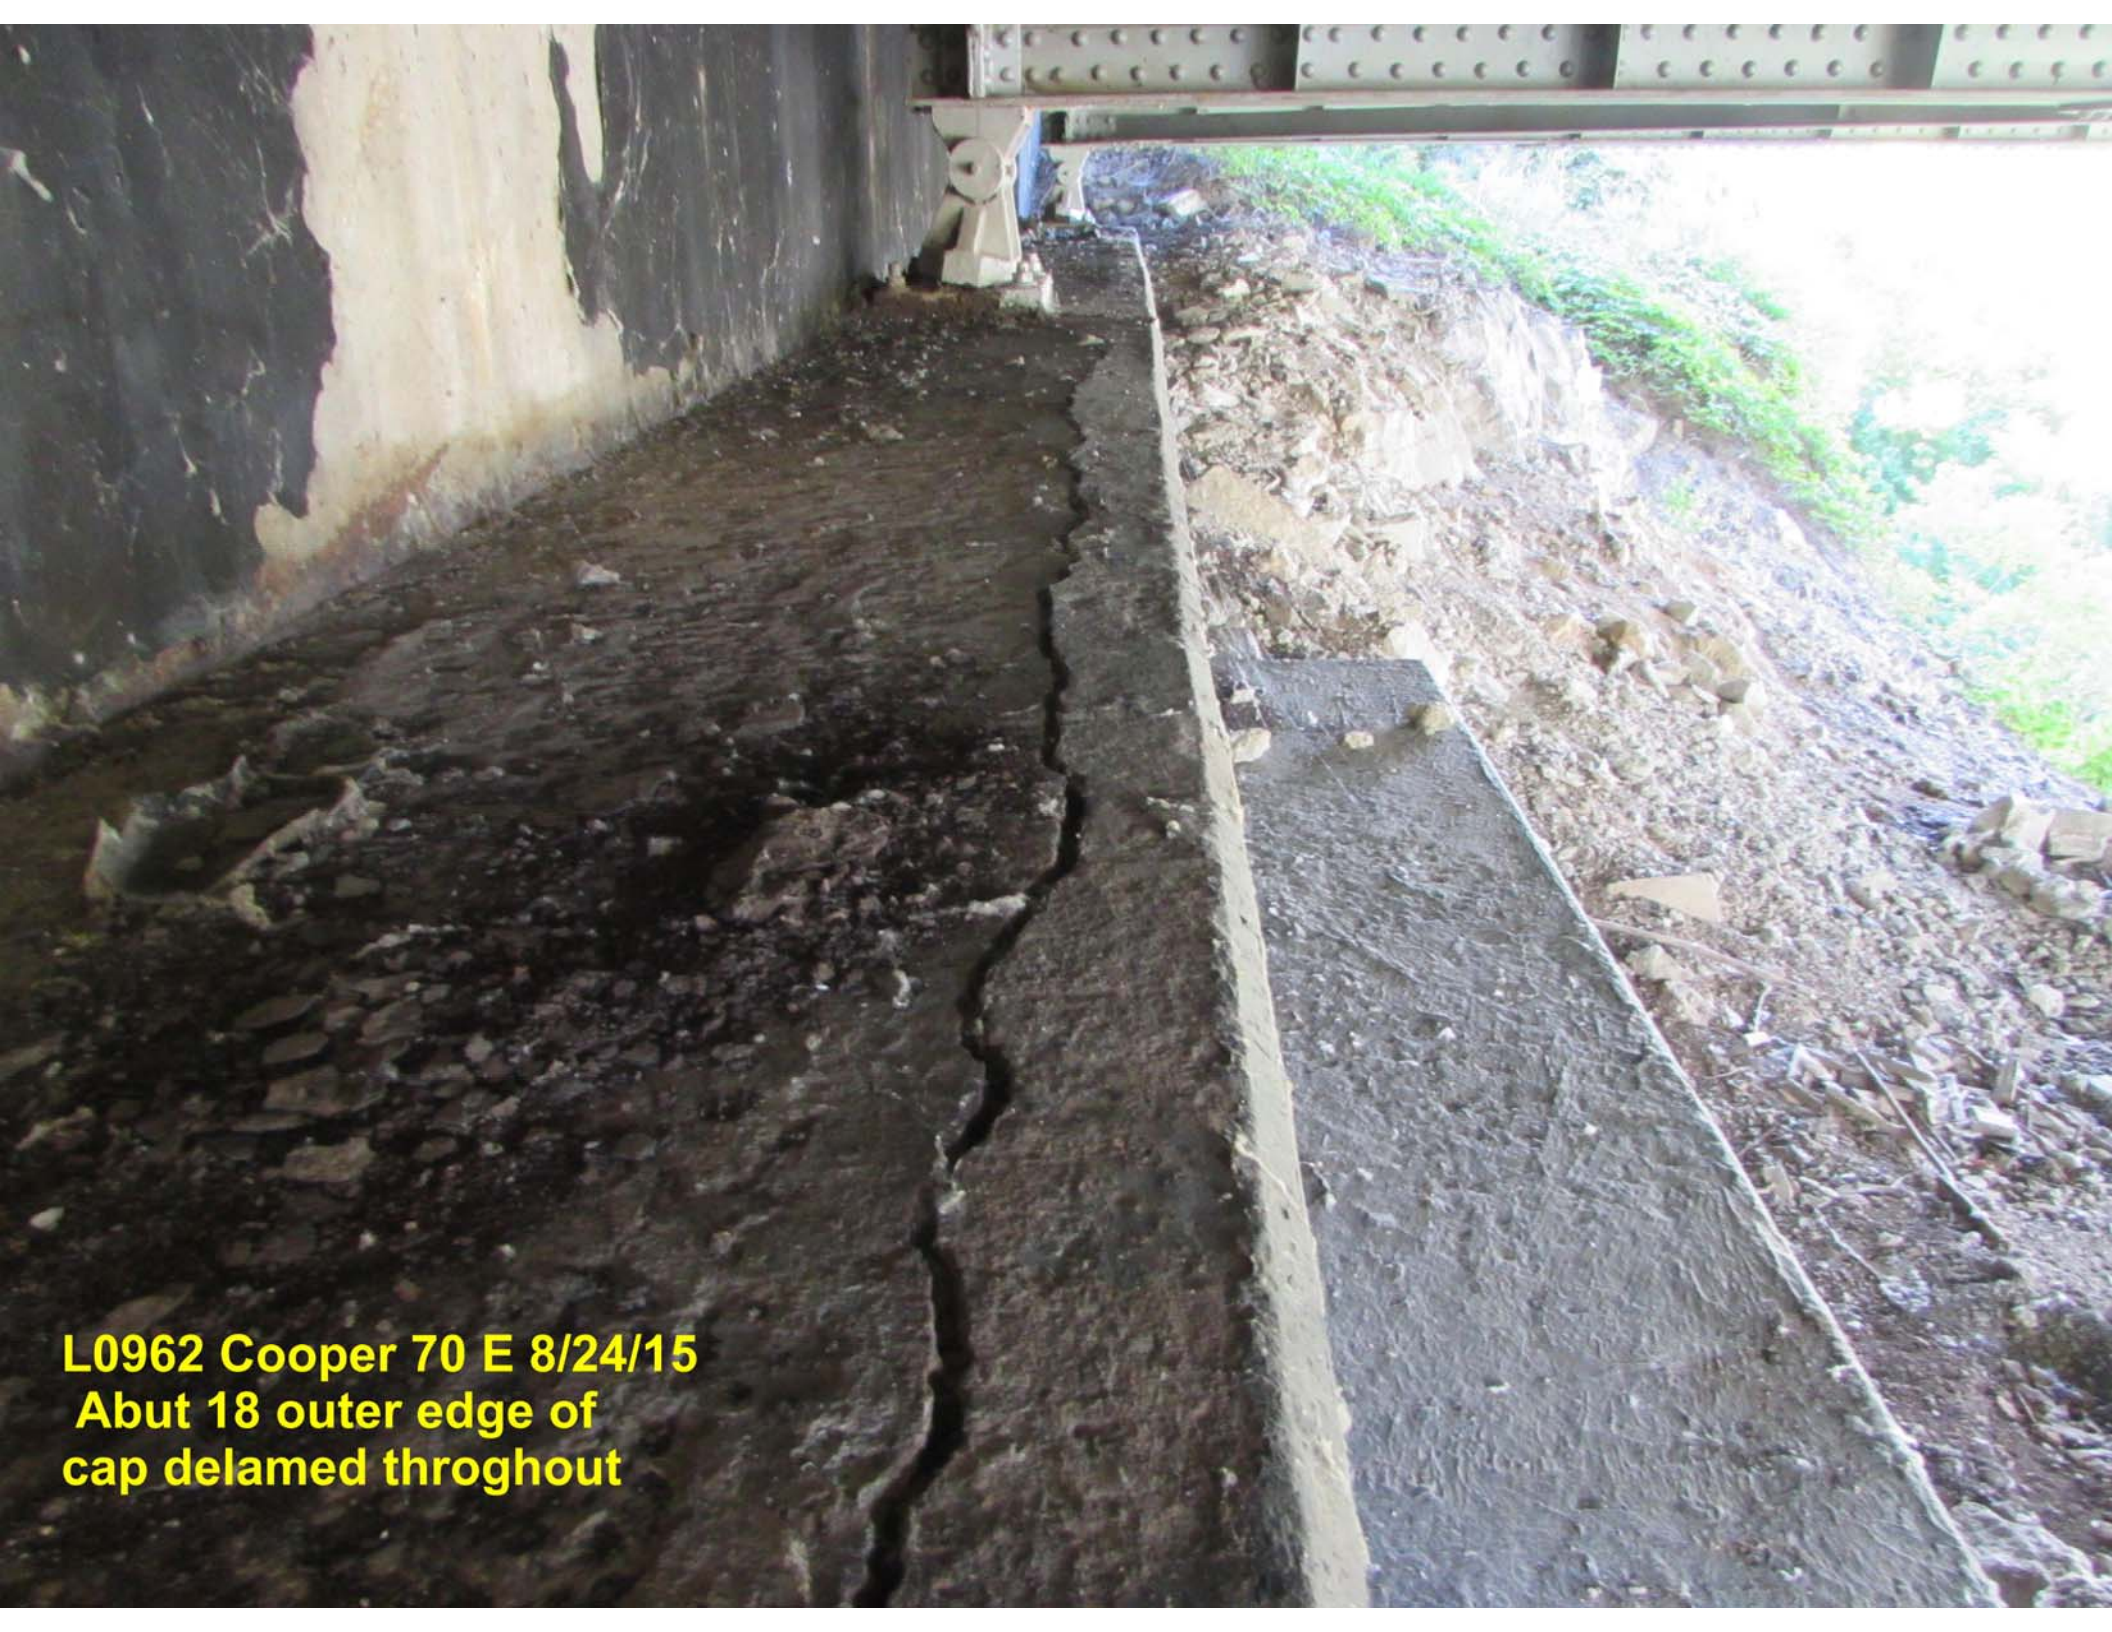
**L0962 Cooper 70 E 8/24/15
Abut 18 outer edge of
cap delamed throughtout**

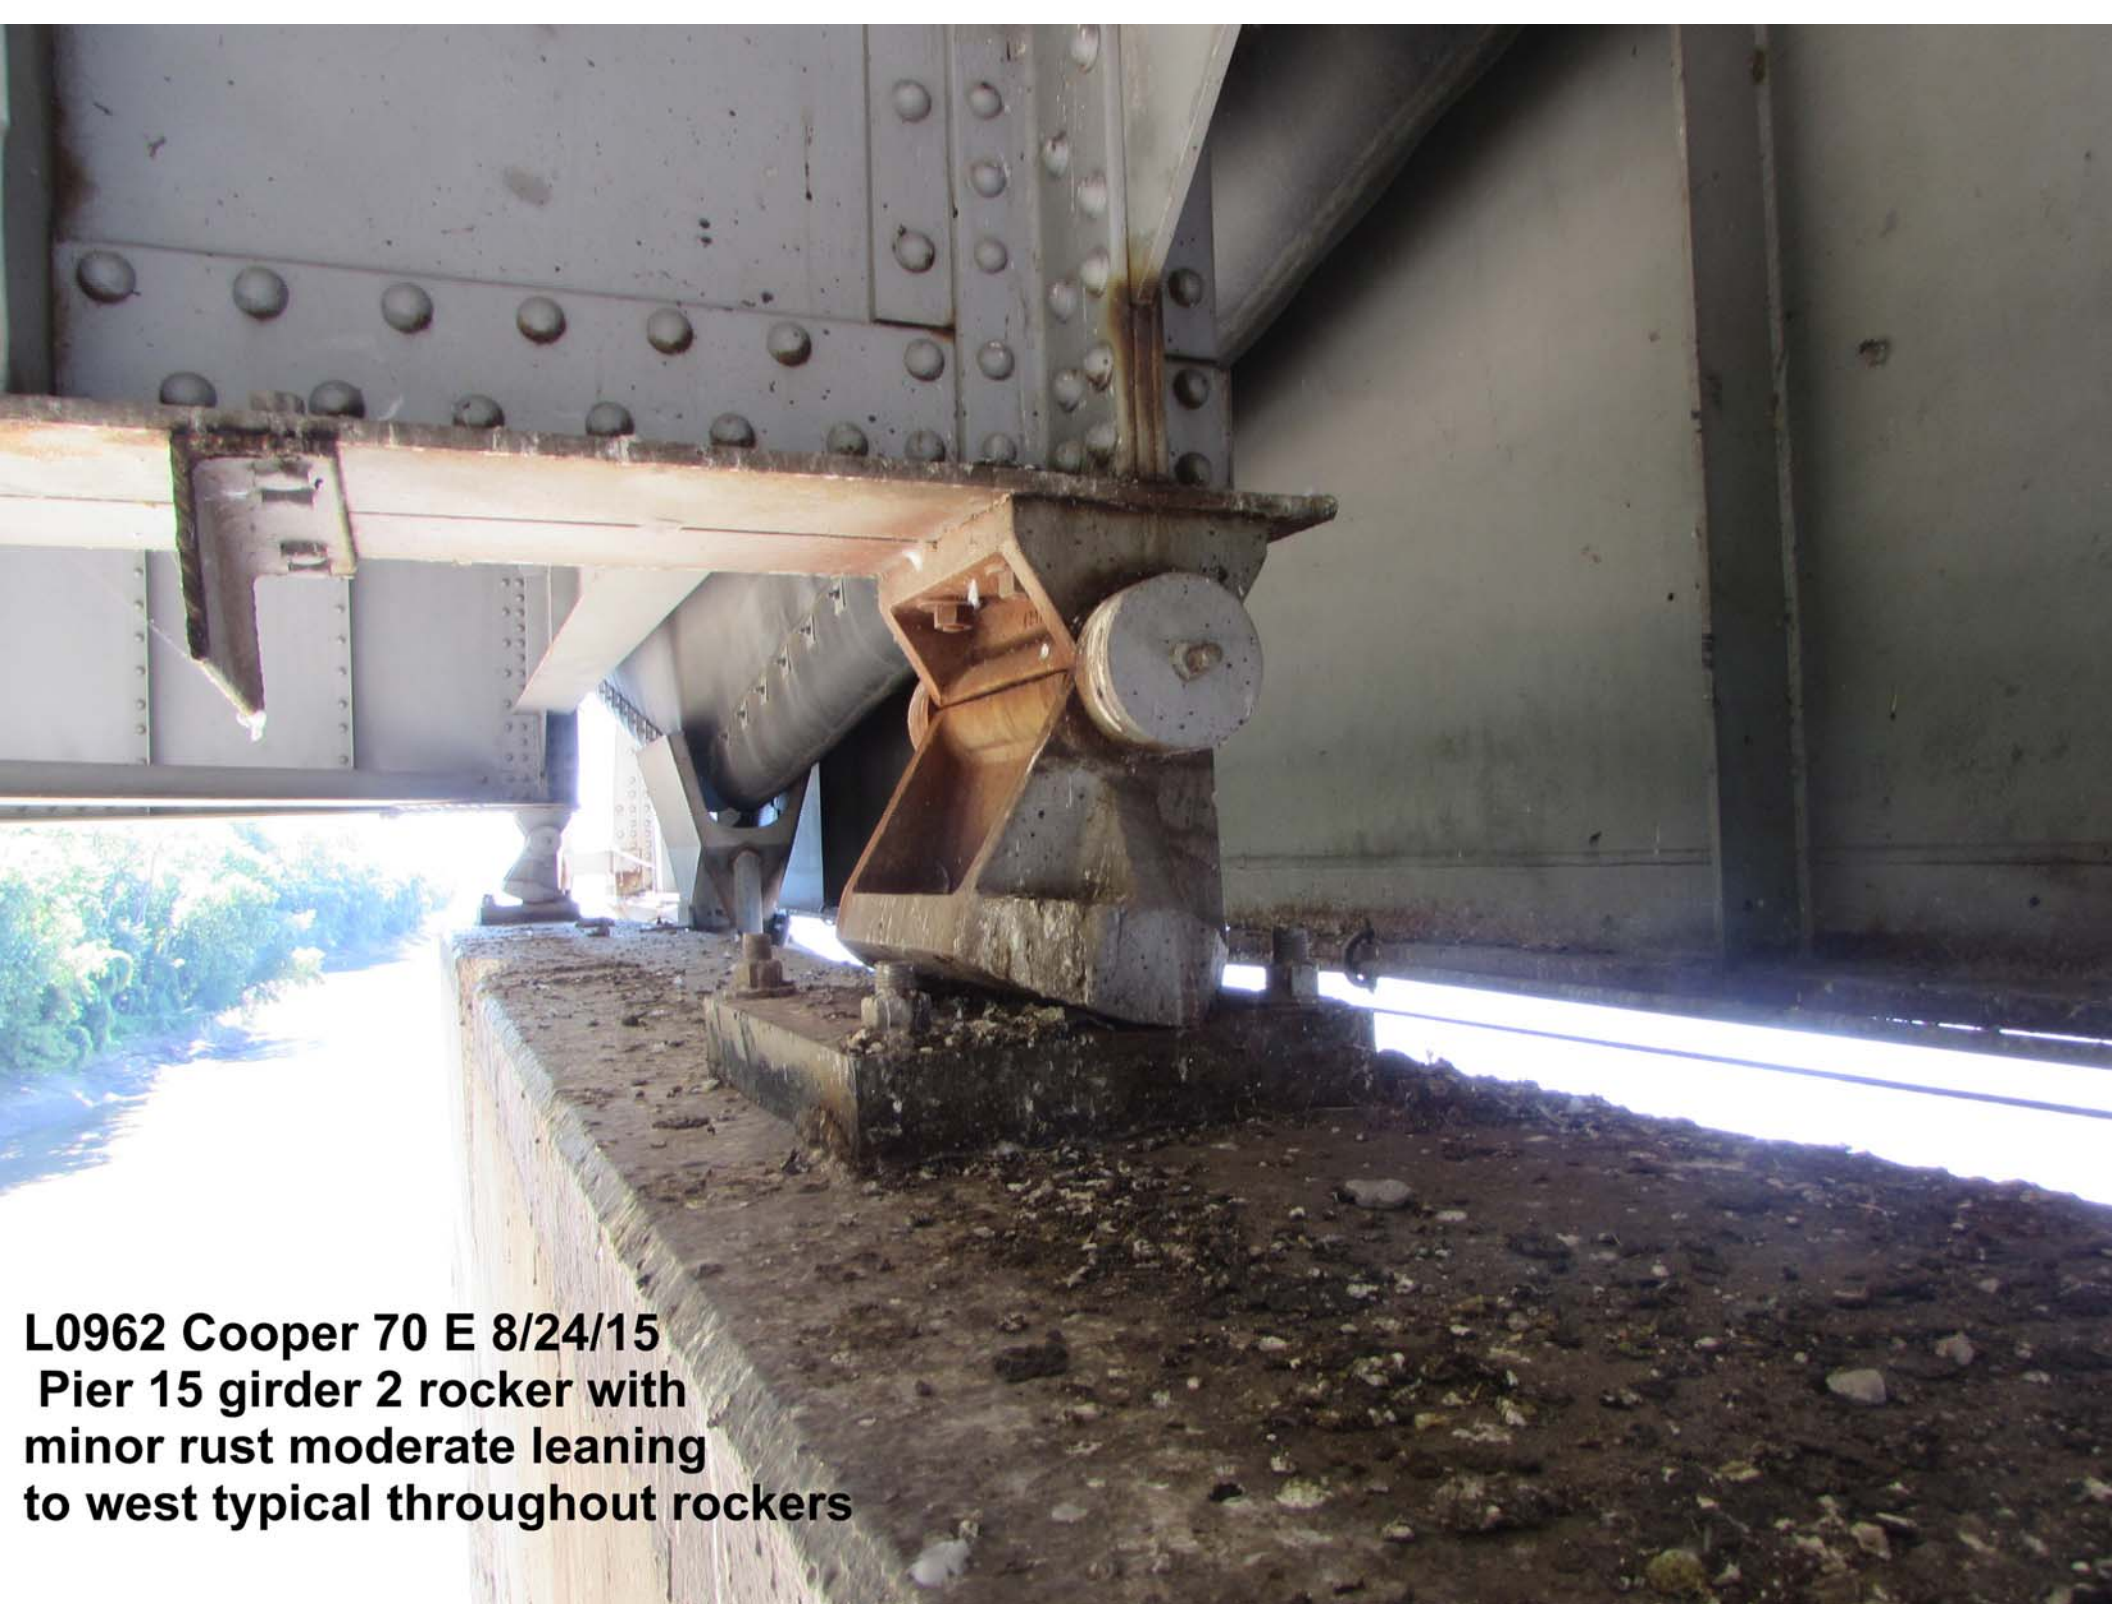
**L0962 Cooper 70 E 8/24/15
Pier 15 girder 2 rocker with
minor rust moderate leaning
to west typical throughout rockers**

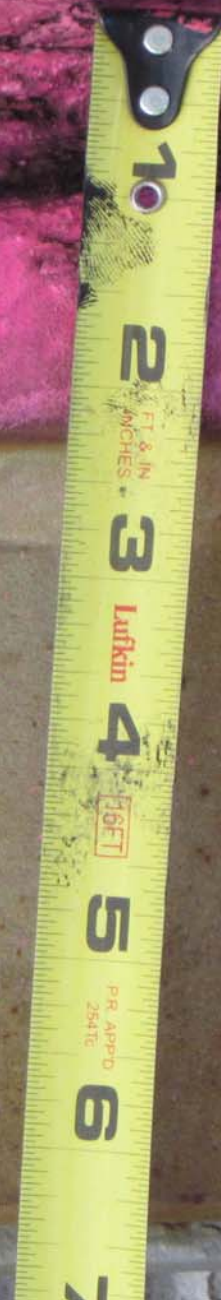
L0962 Cooper 70 E 8/24/15
Span 14 L4' floorbeam stringer 1
saddle bearing with hvy
pack rust lifting stringer 1 inch
