Appendix E:

MoDOT Bridge Inspection Report

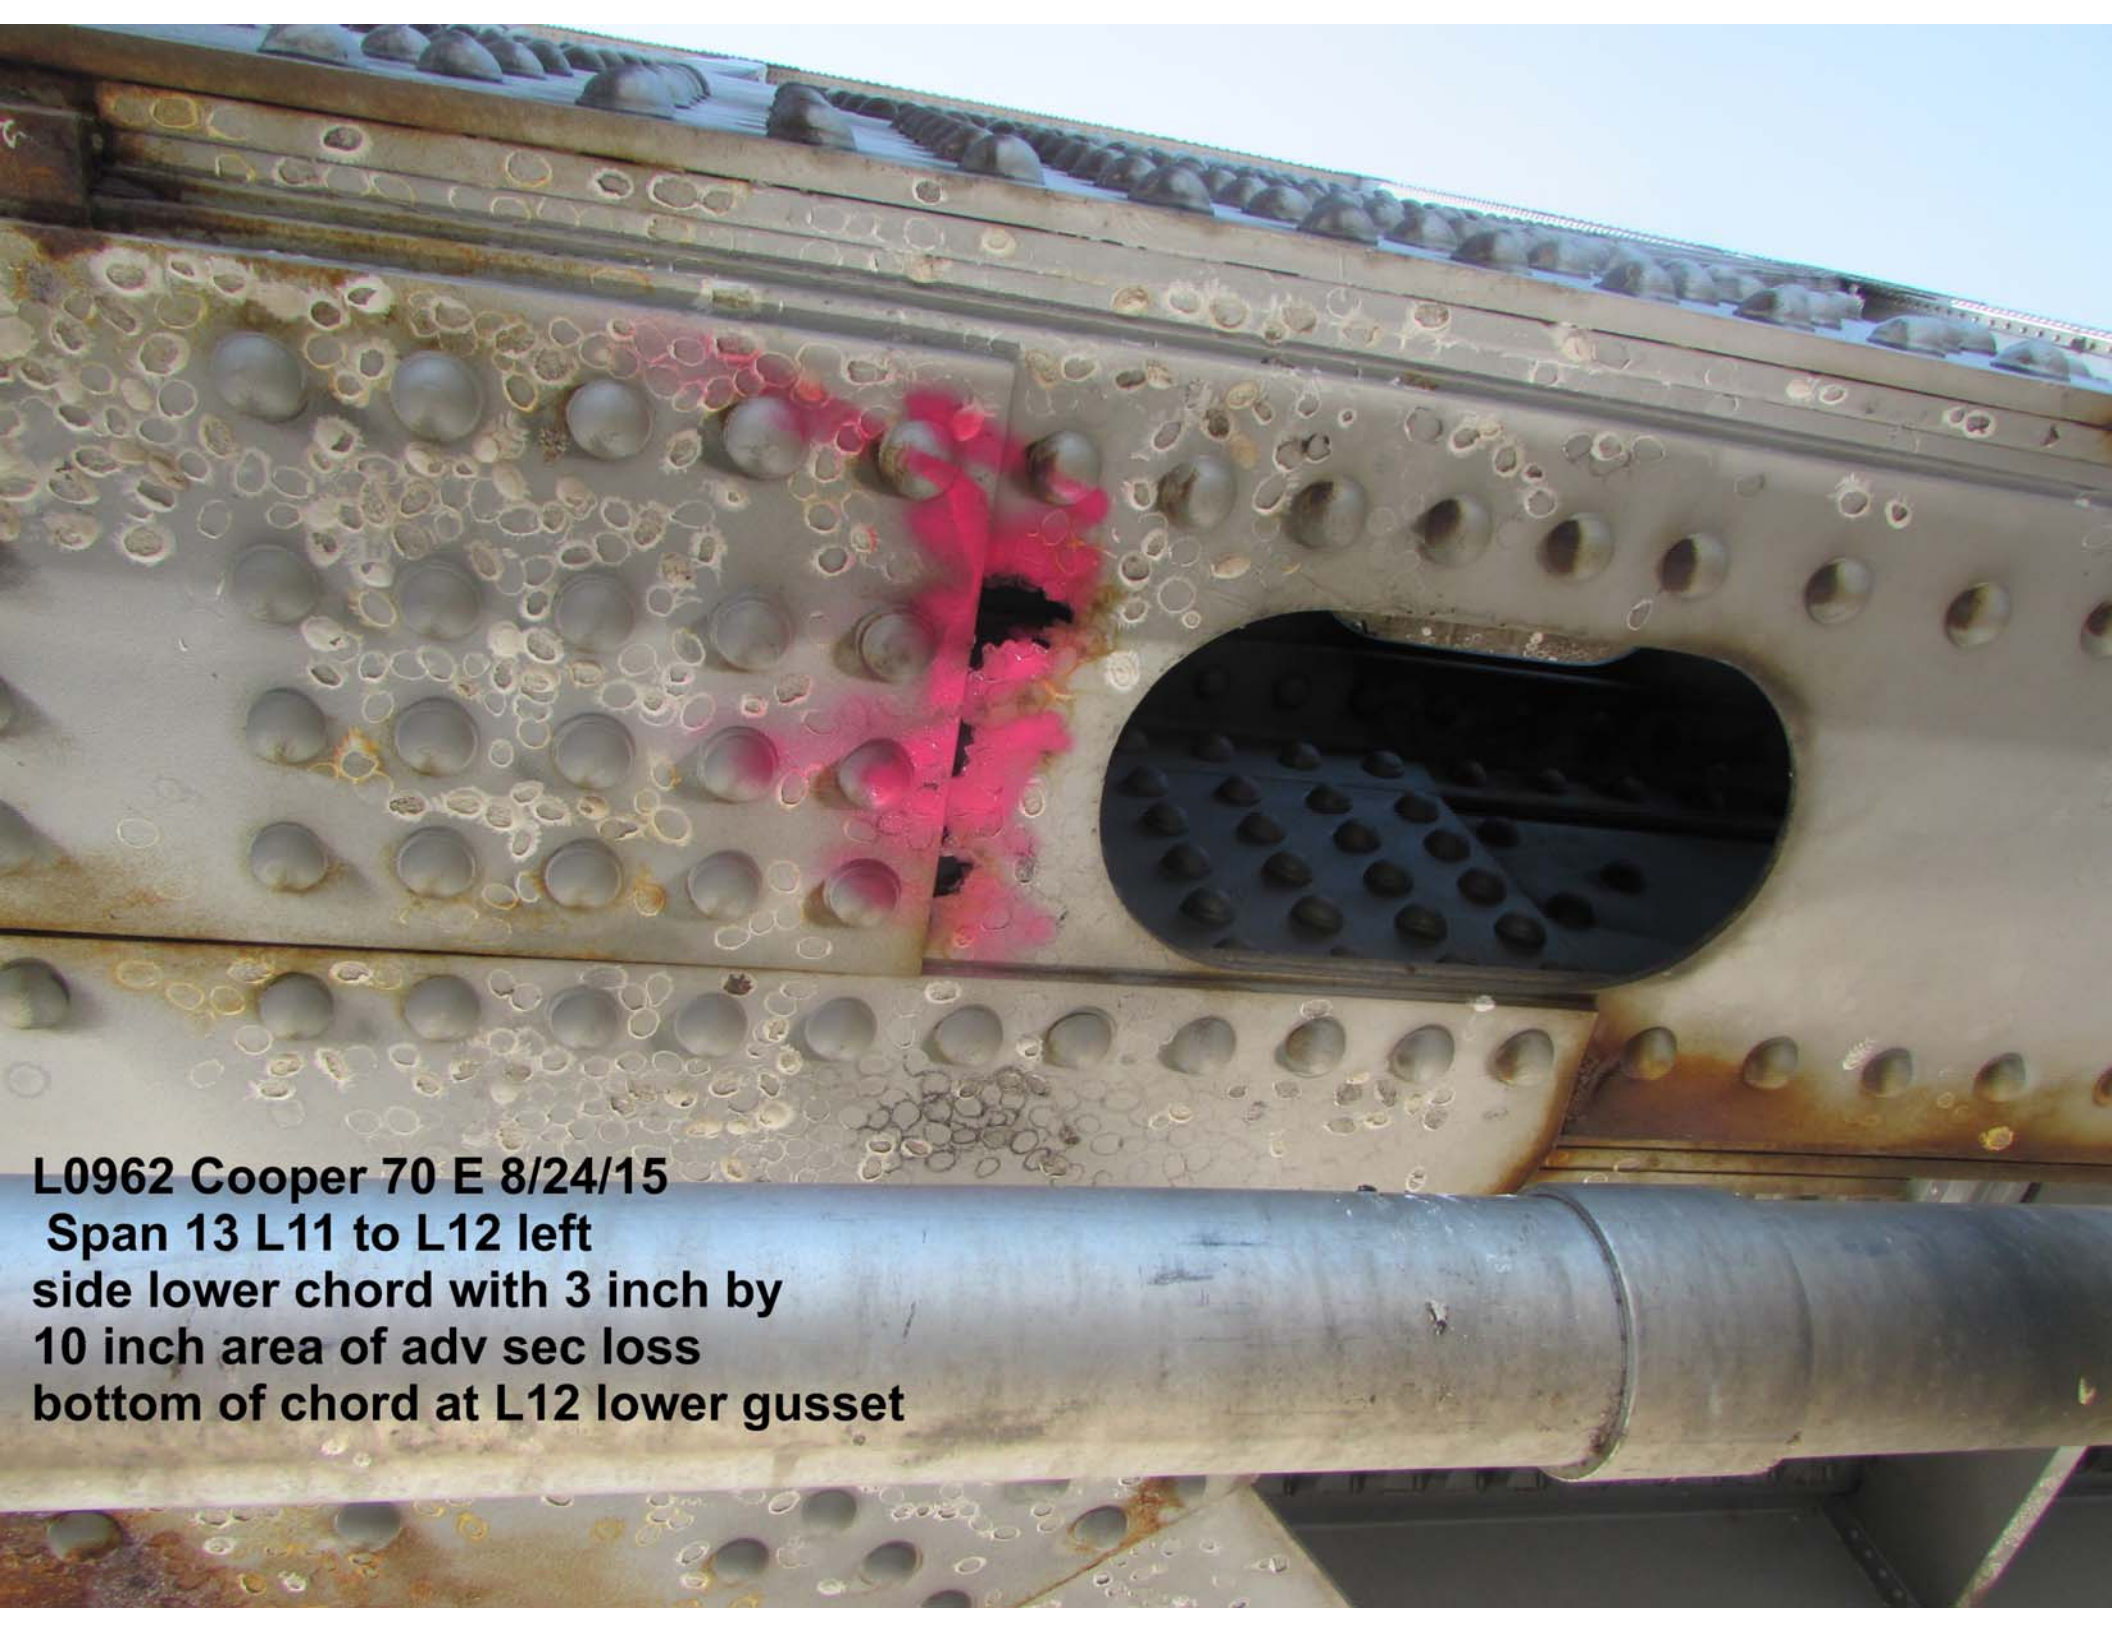
L0962 Cooper 70 E 8/24/15
Span 13 L11 to L12 left
side lower chord with 3 inch by
10 inch area of adv sec loss
bottom of chord at L12 lower gusset

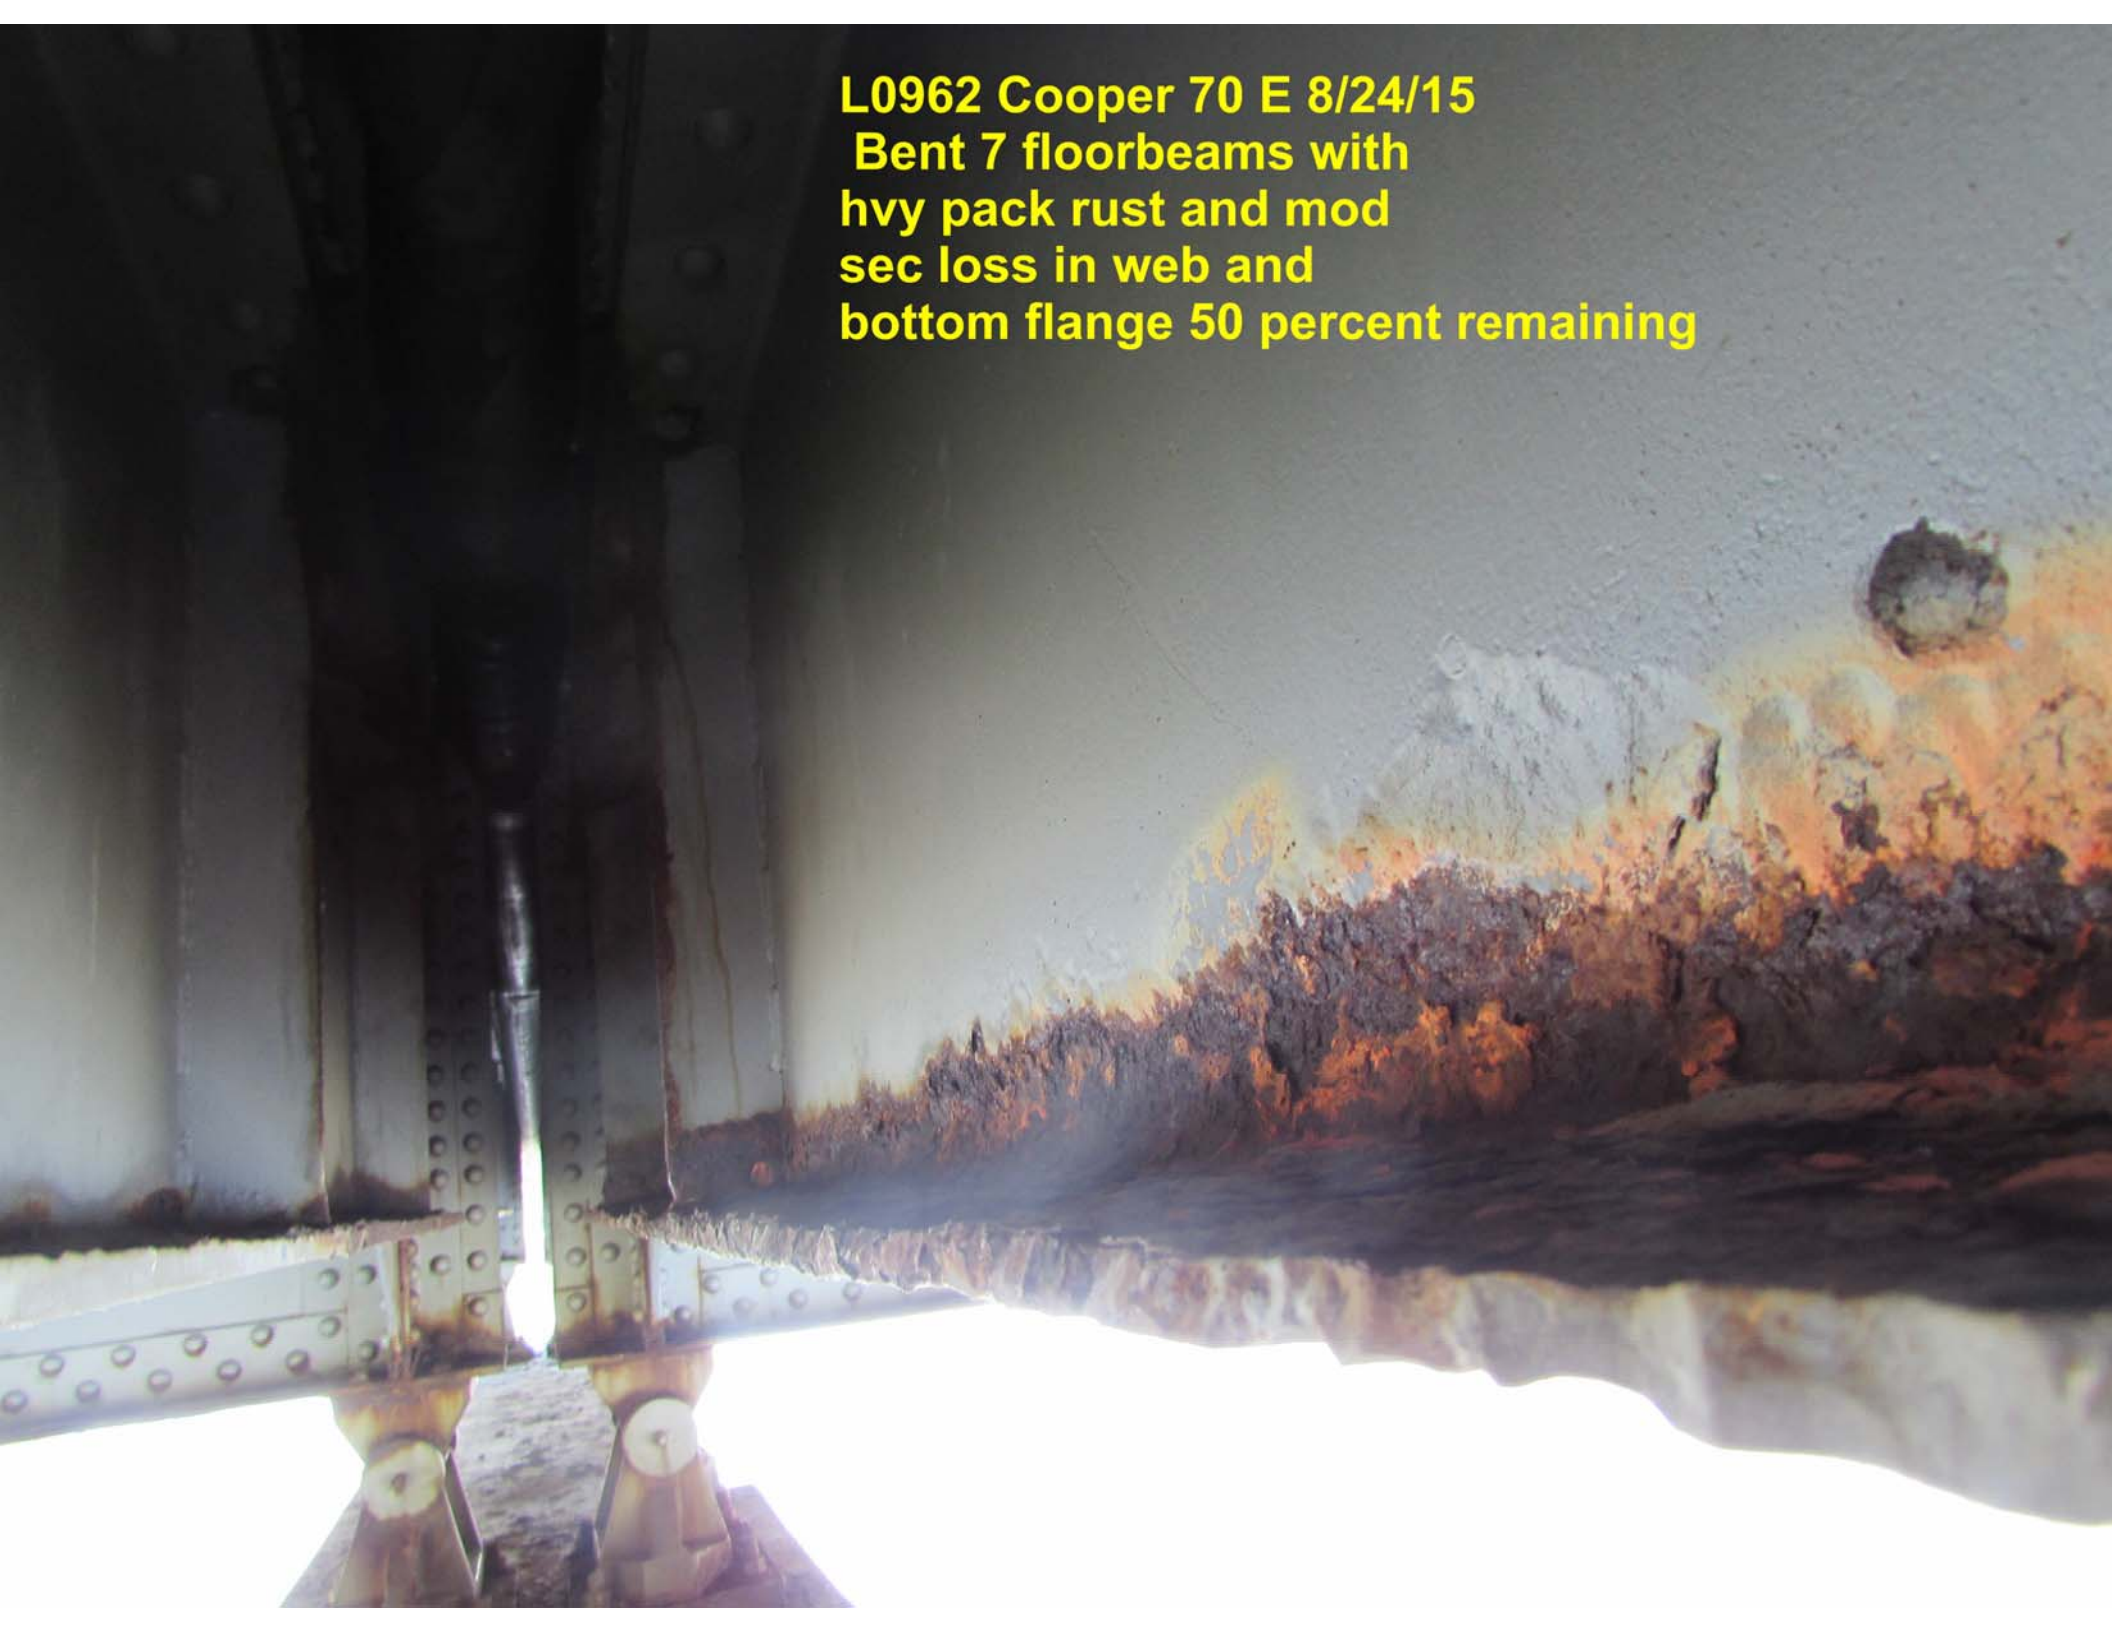
**L0962 Cooper 70 E 8/24/15
Bent 7 floorbeams with
hvy pack rust and mod
sec loss in web and
bottom flange 50 percent remaining**

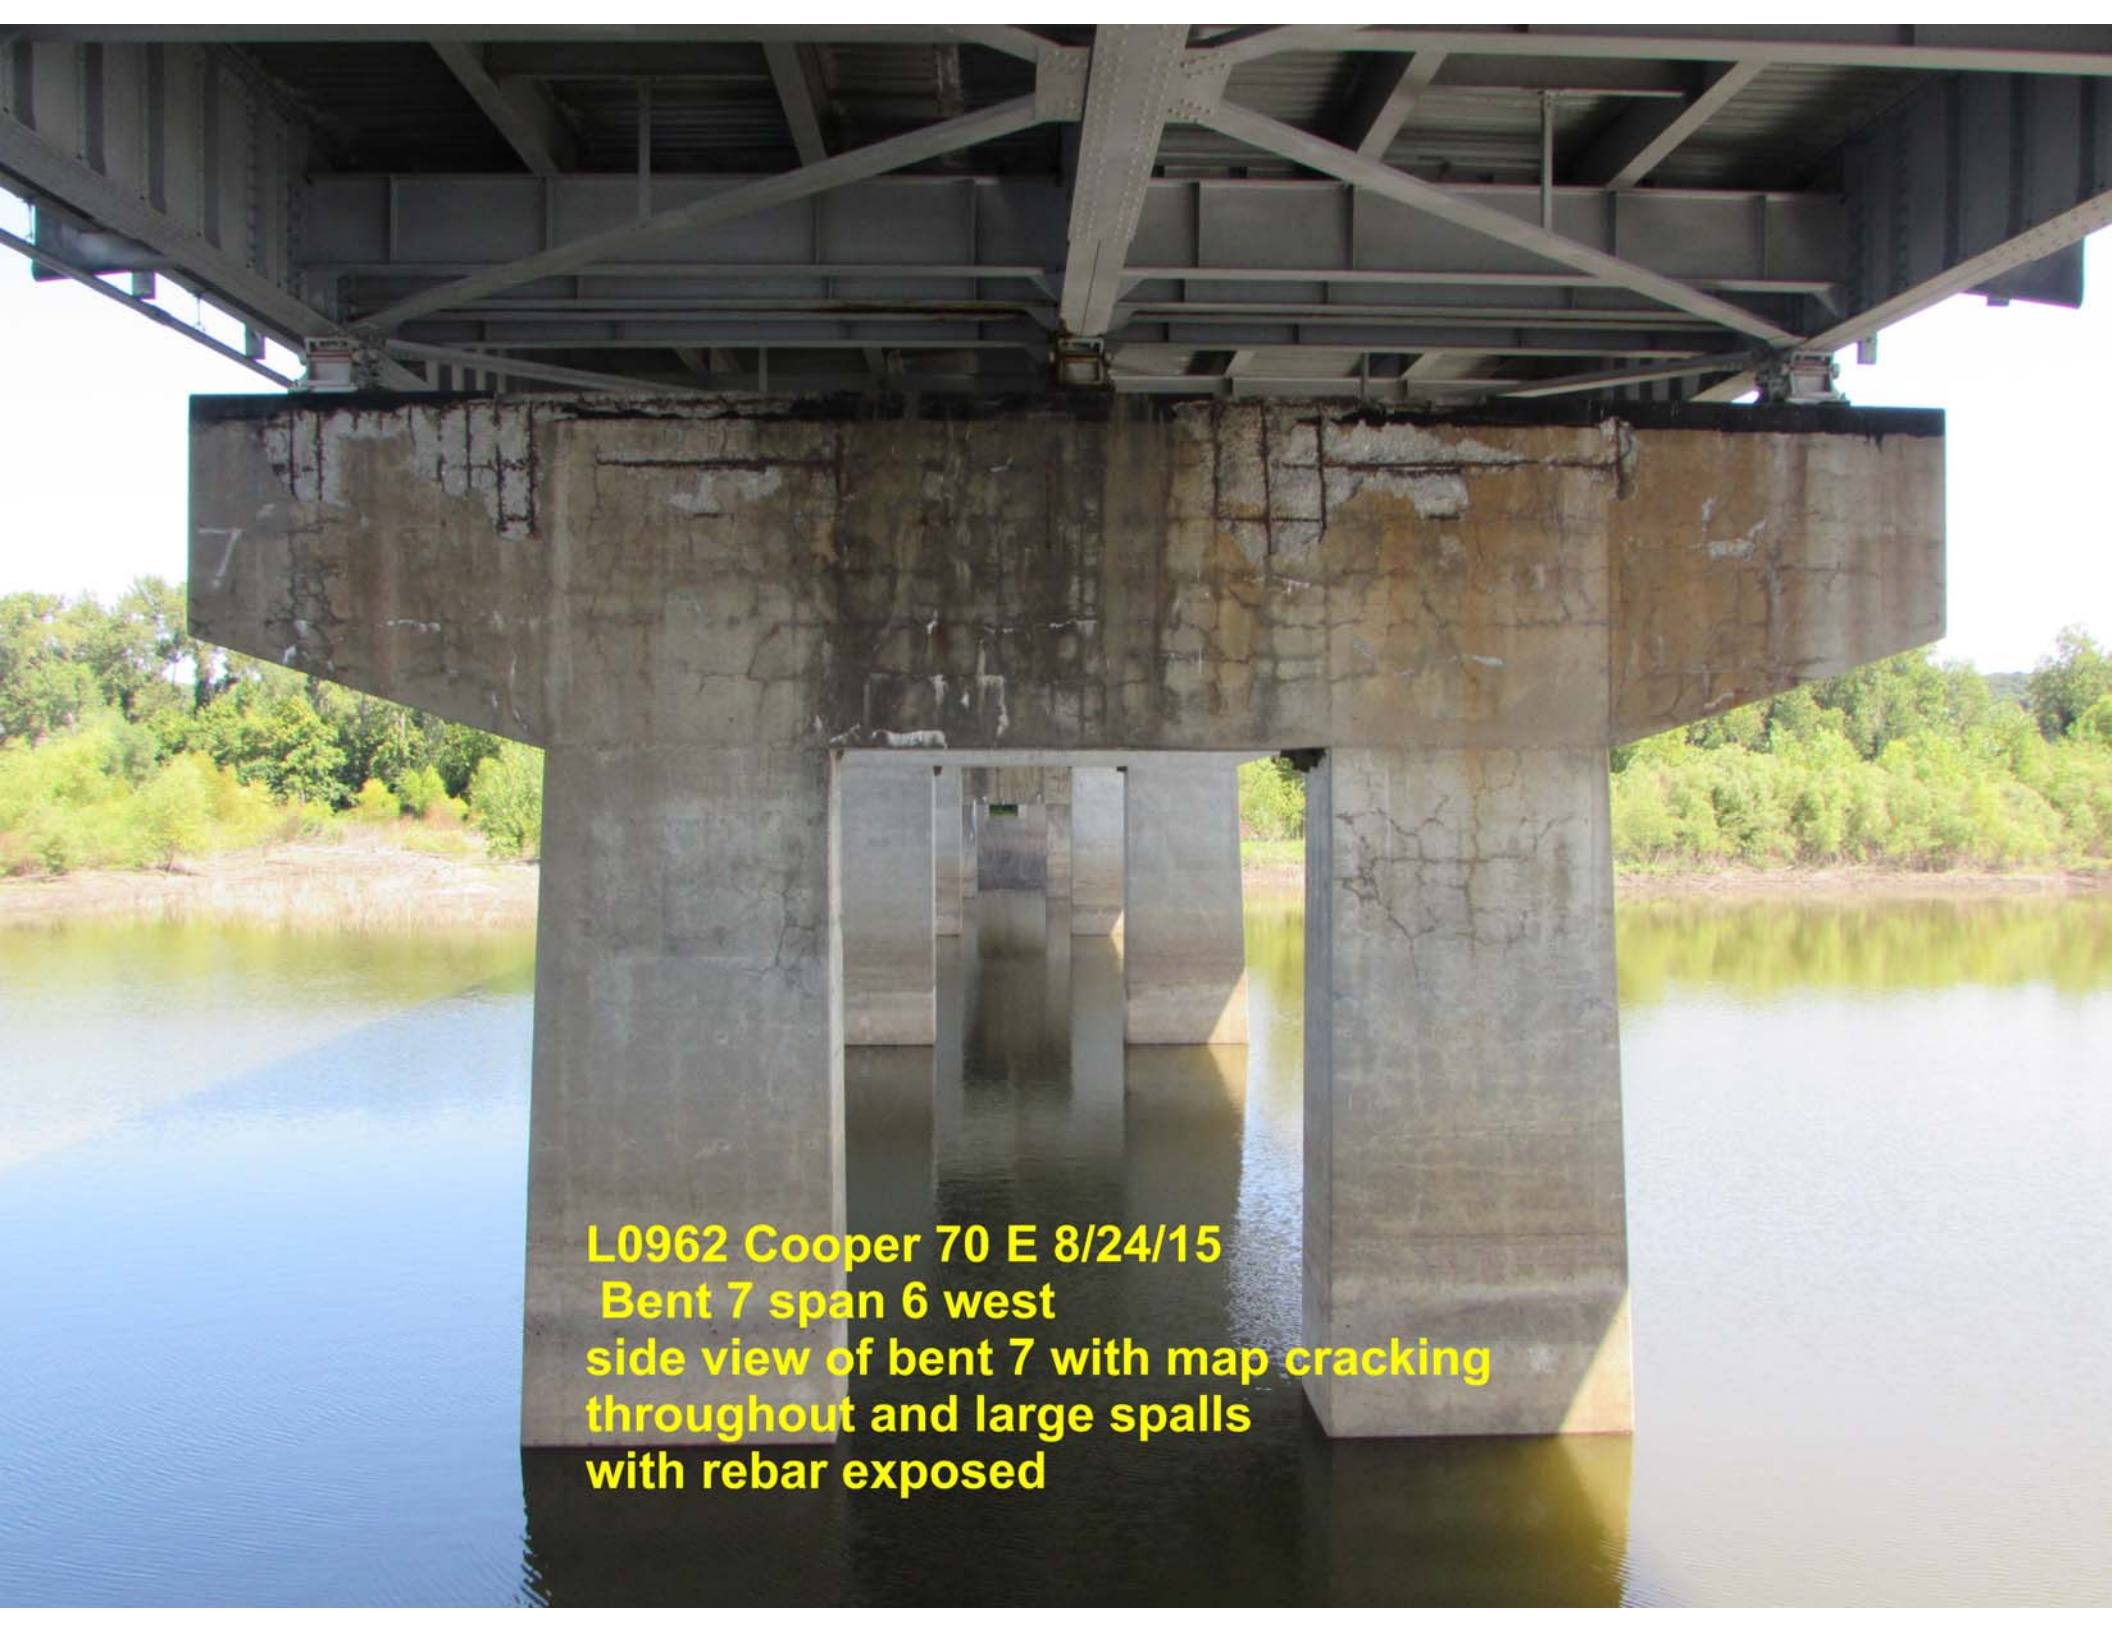
**L0962 Cooper 70 E 8/24/15
Bent 7 span 6 west
side view of bent 7 with map cracking
throughout and large spalls
with rebar exposed**

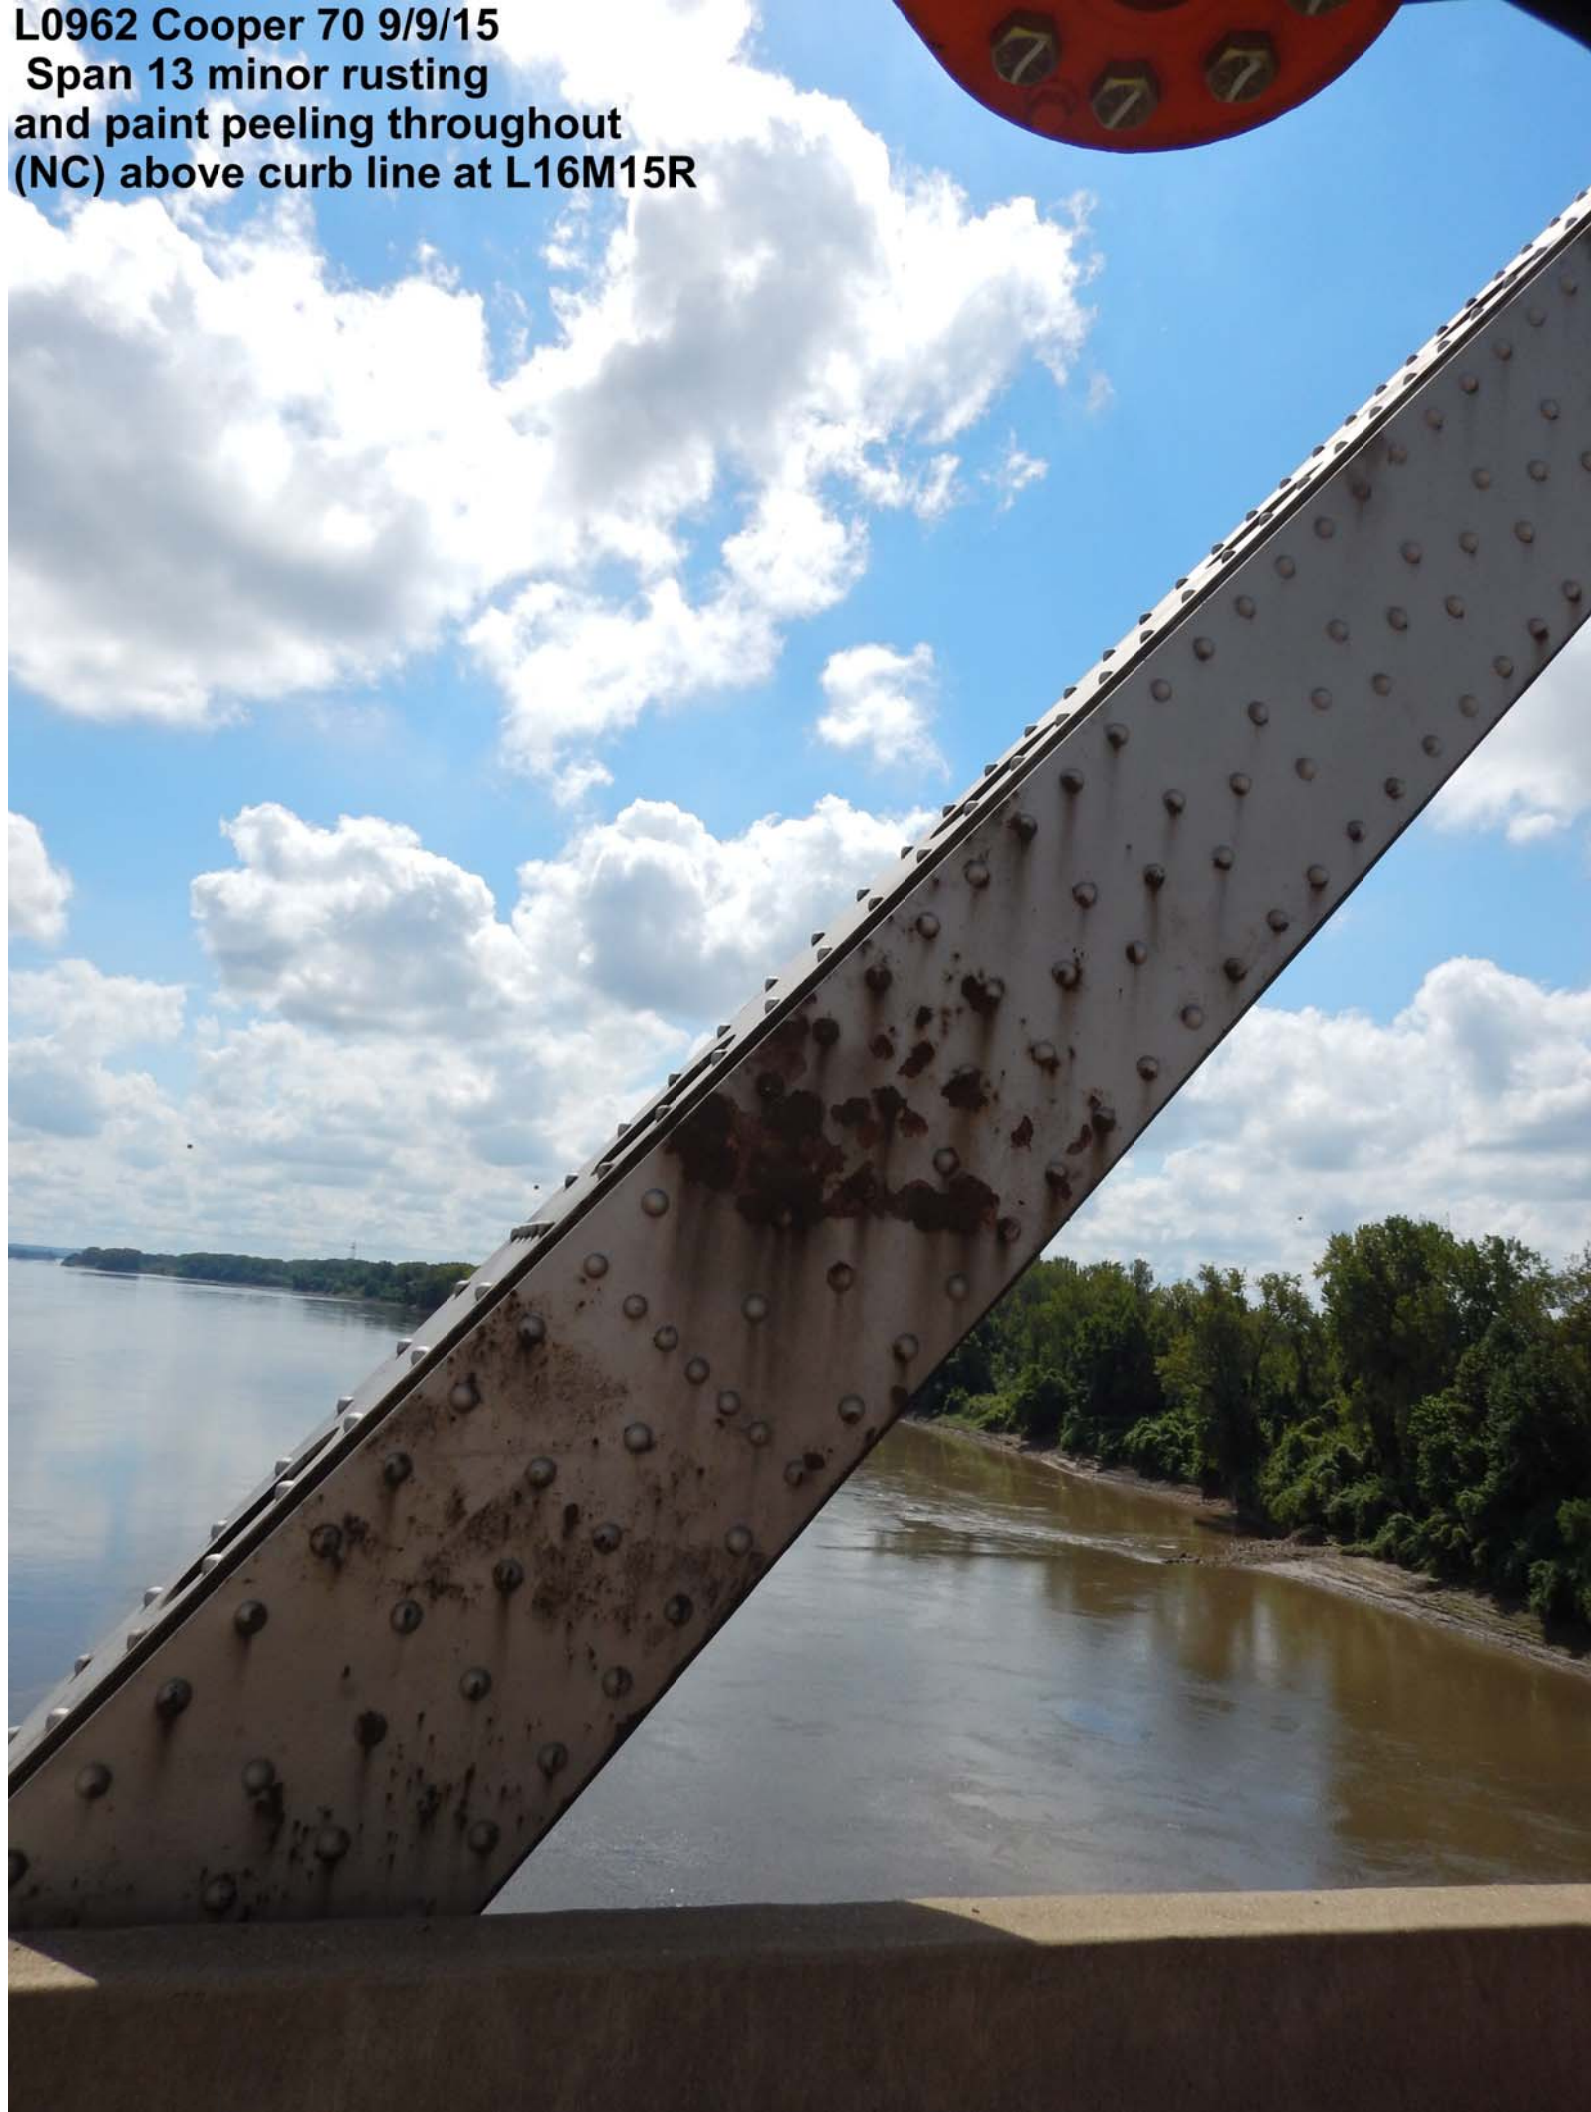
L0962 Cooper 70 9/10/15
Span 6 floorbeam at
bent 7 with moderate sec loss
in bottom web 60 percent remain

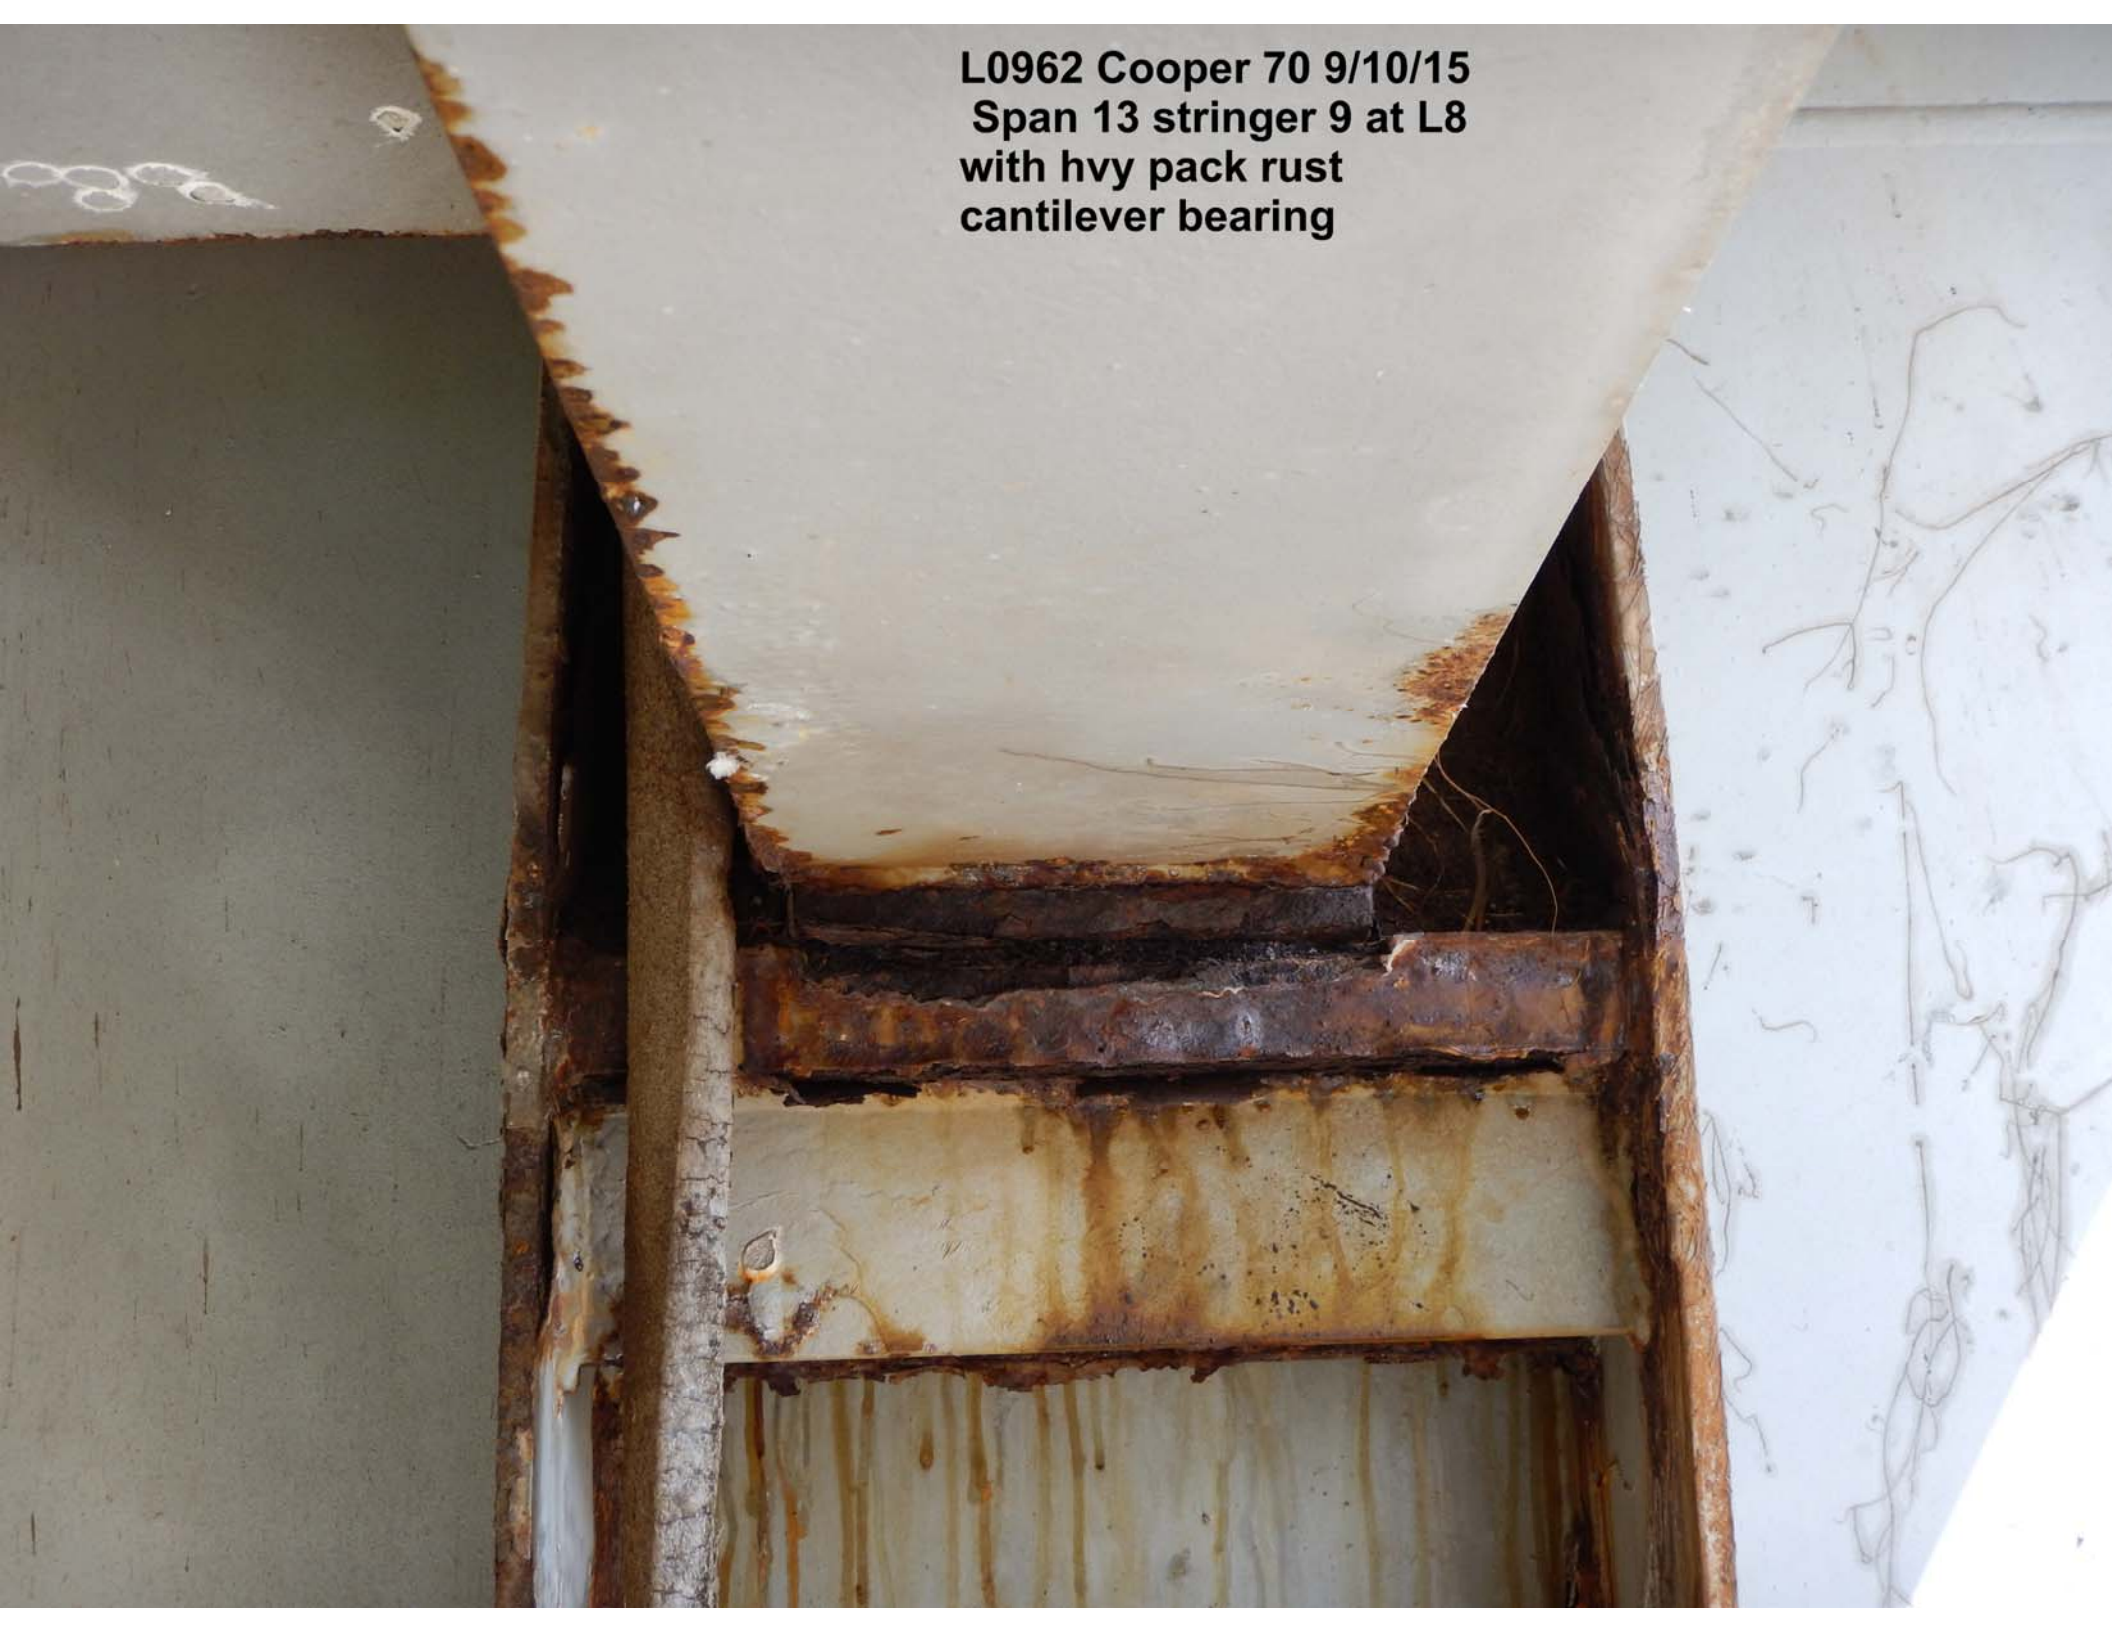
L0962 Cooper 70 9/10/15
Span 13 L16 right side
inner gusset with mod sec loss along
lower chord 50 percent remaining

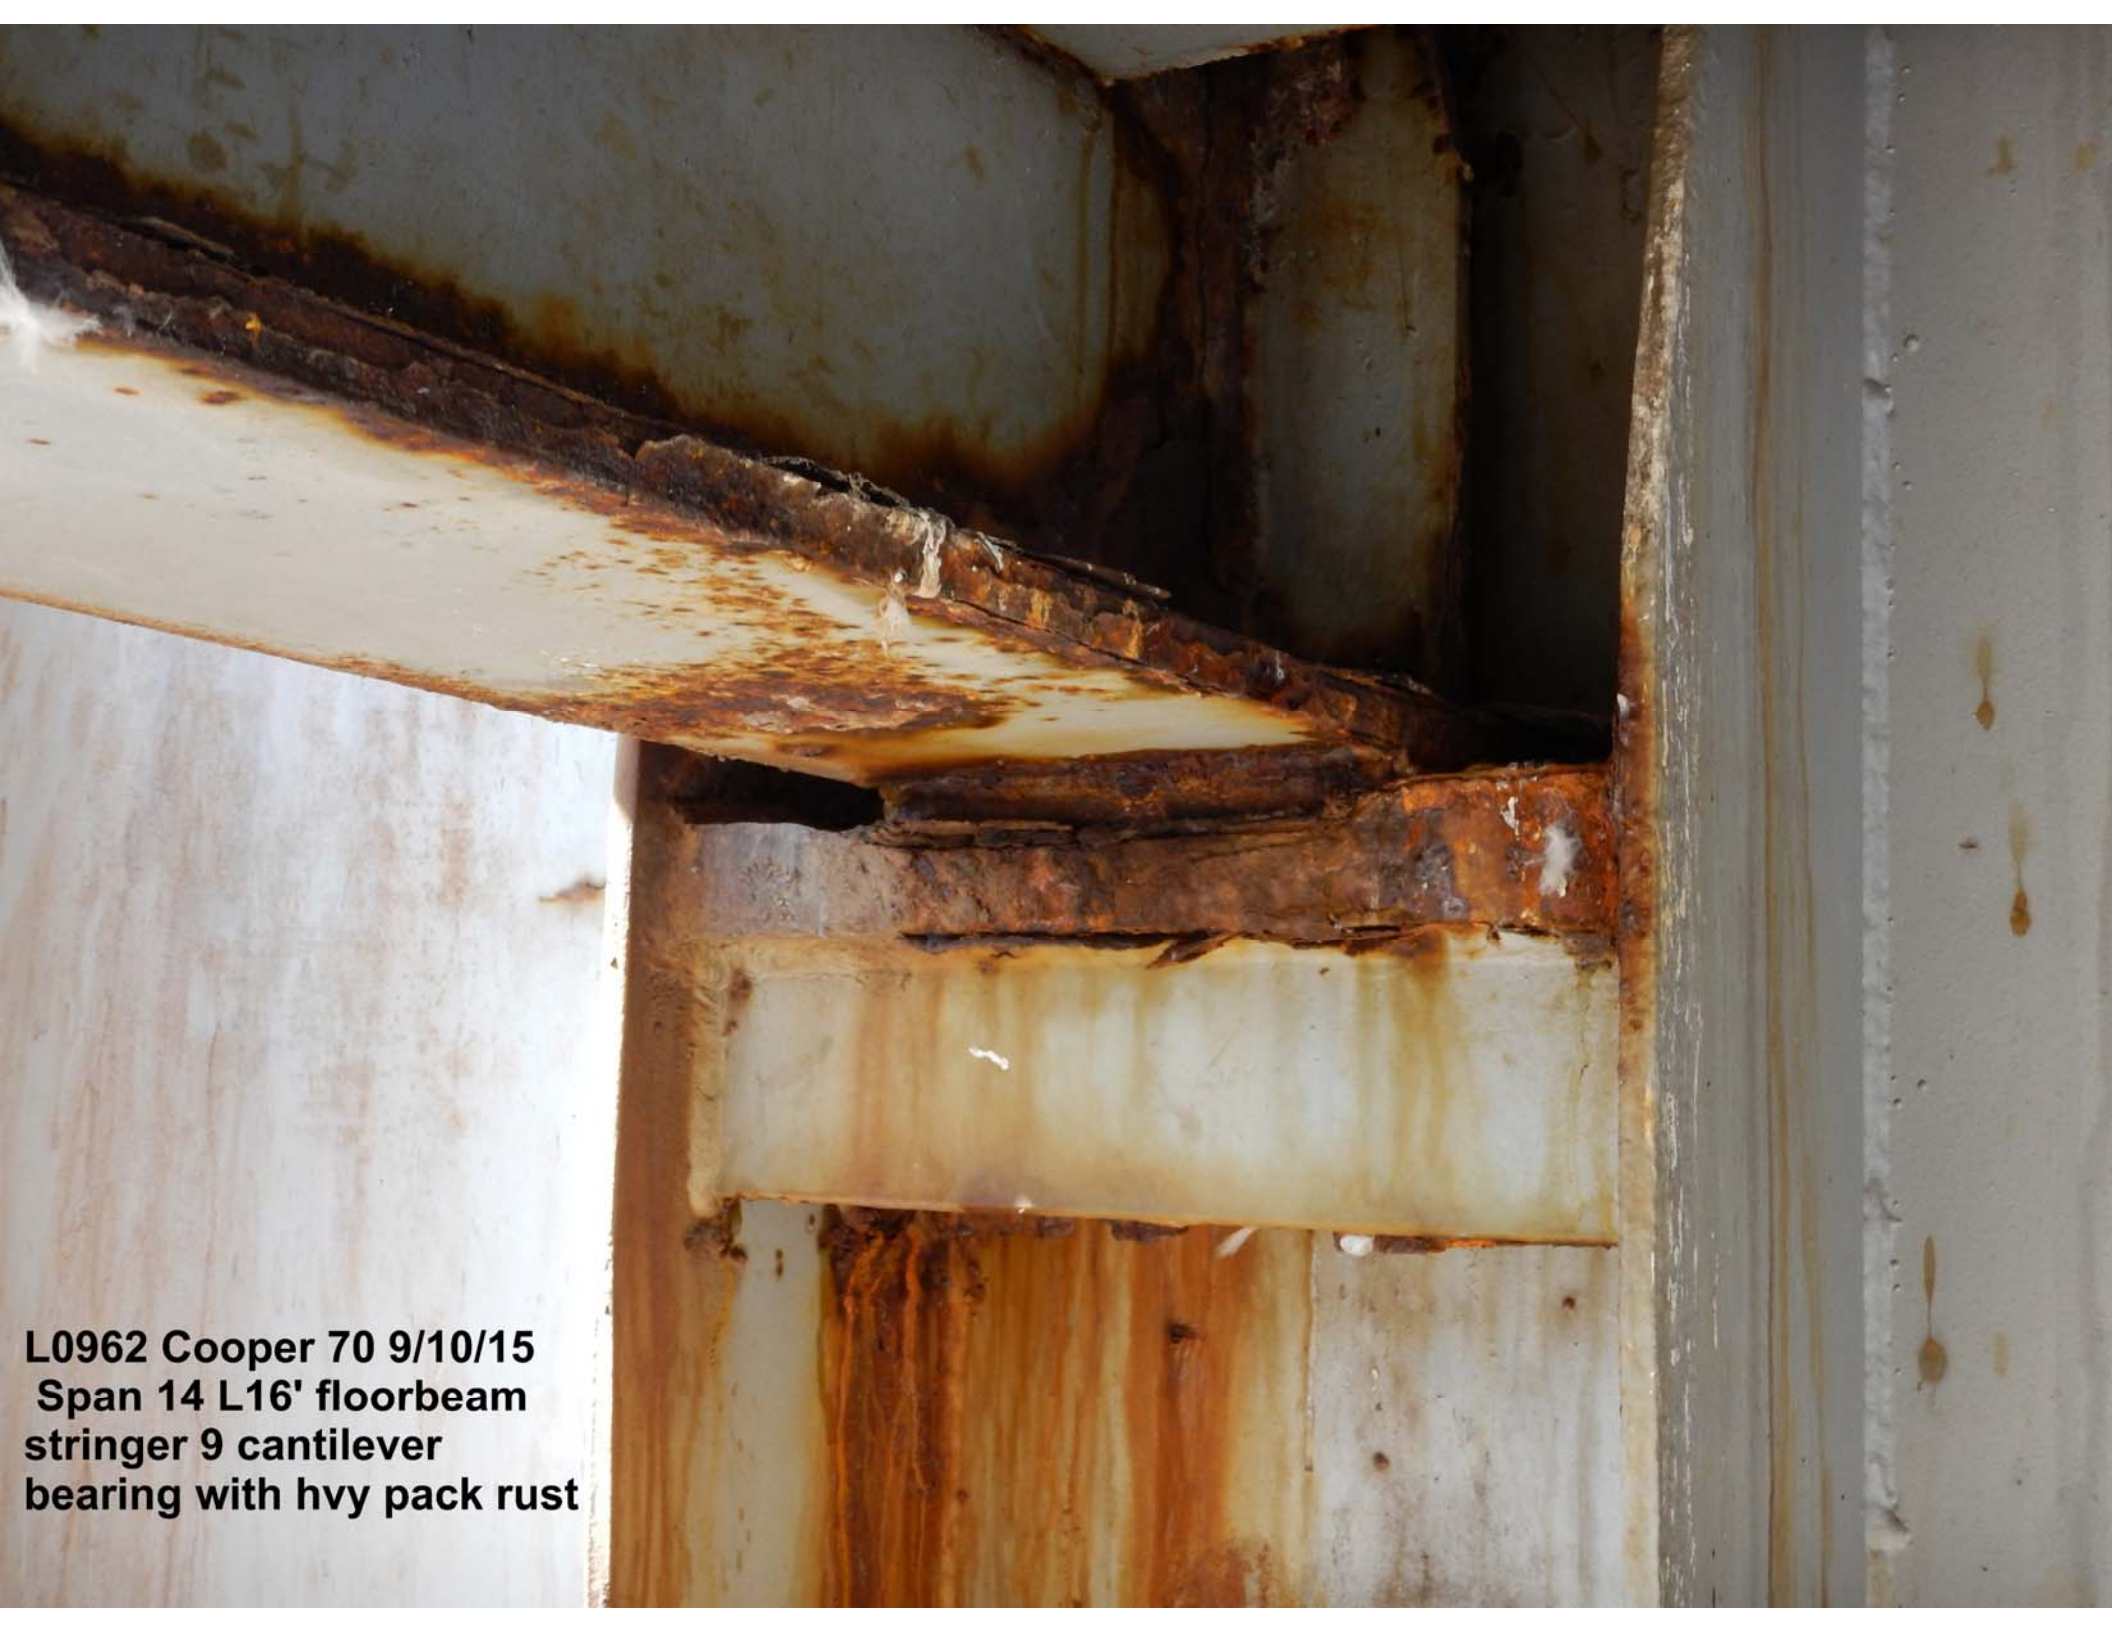
**L0962 Cooper 70 9/10/15
Span 14 L16' floorbeam
stringer 9 cantilever
bearing with hvy pack rust**
