Appendix E:

MoDOT Bridge Inspection Report

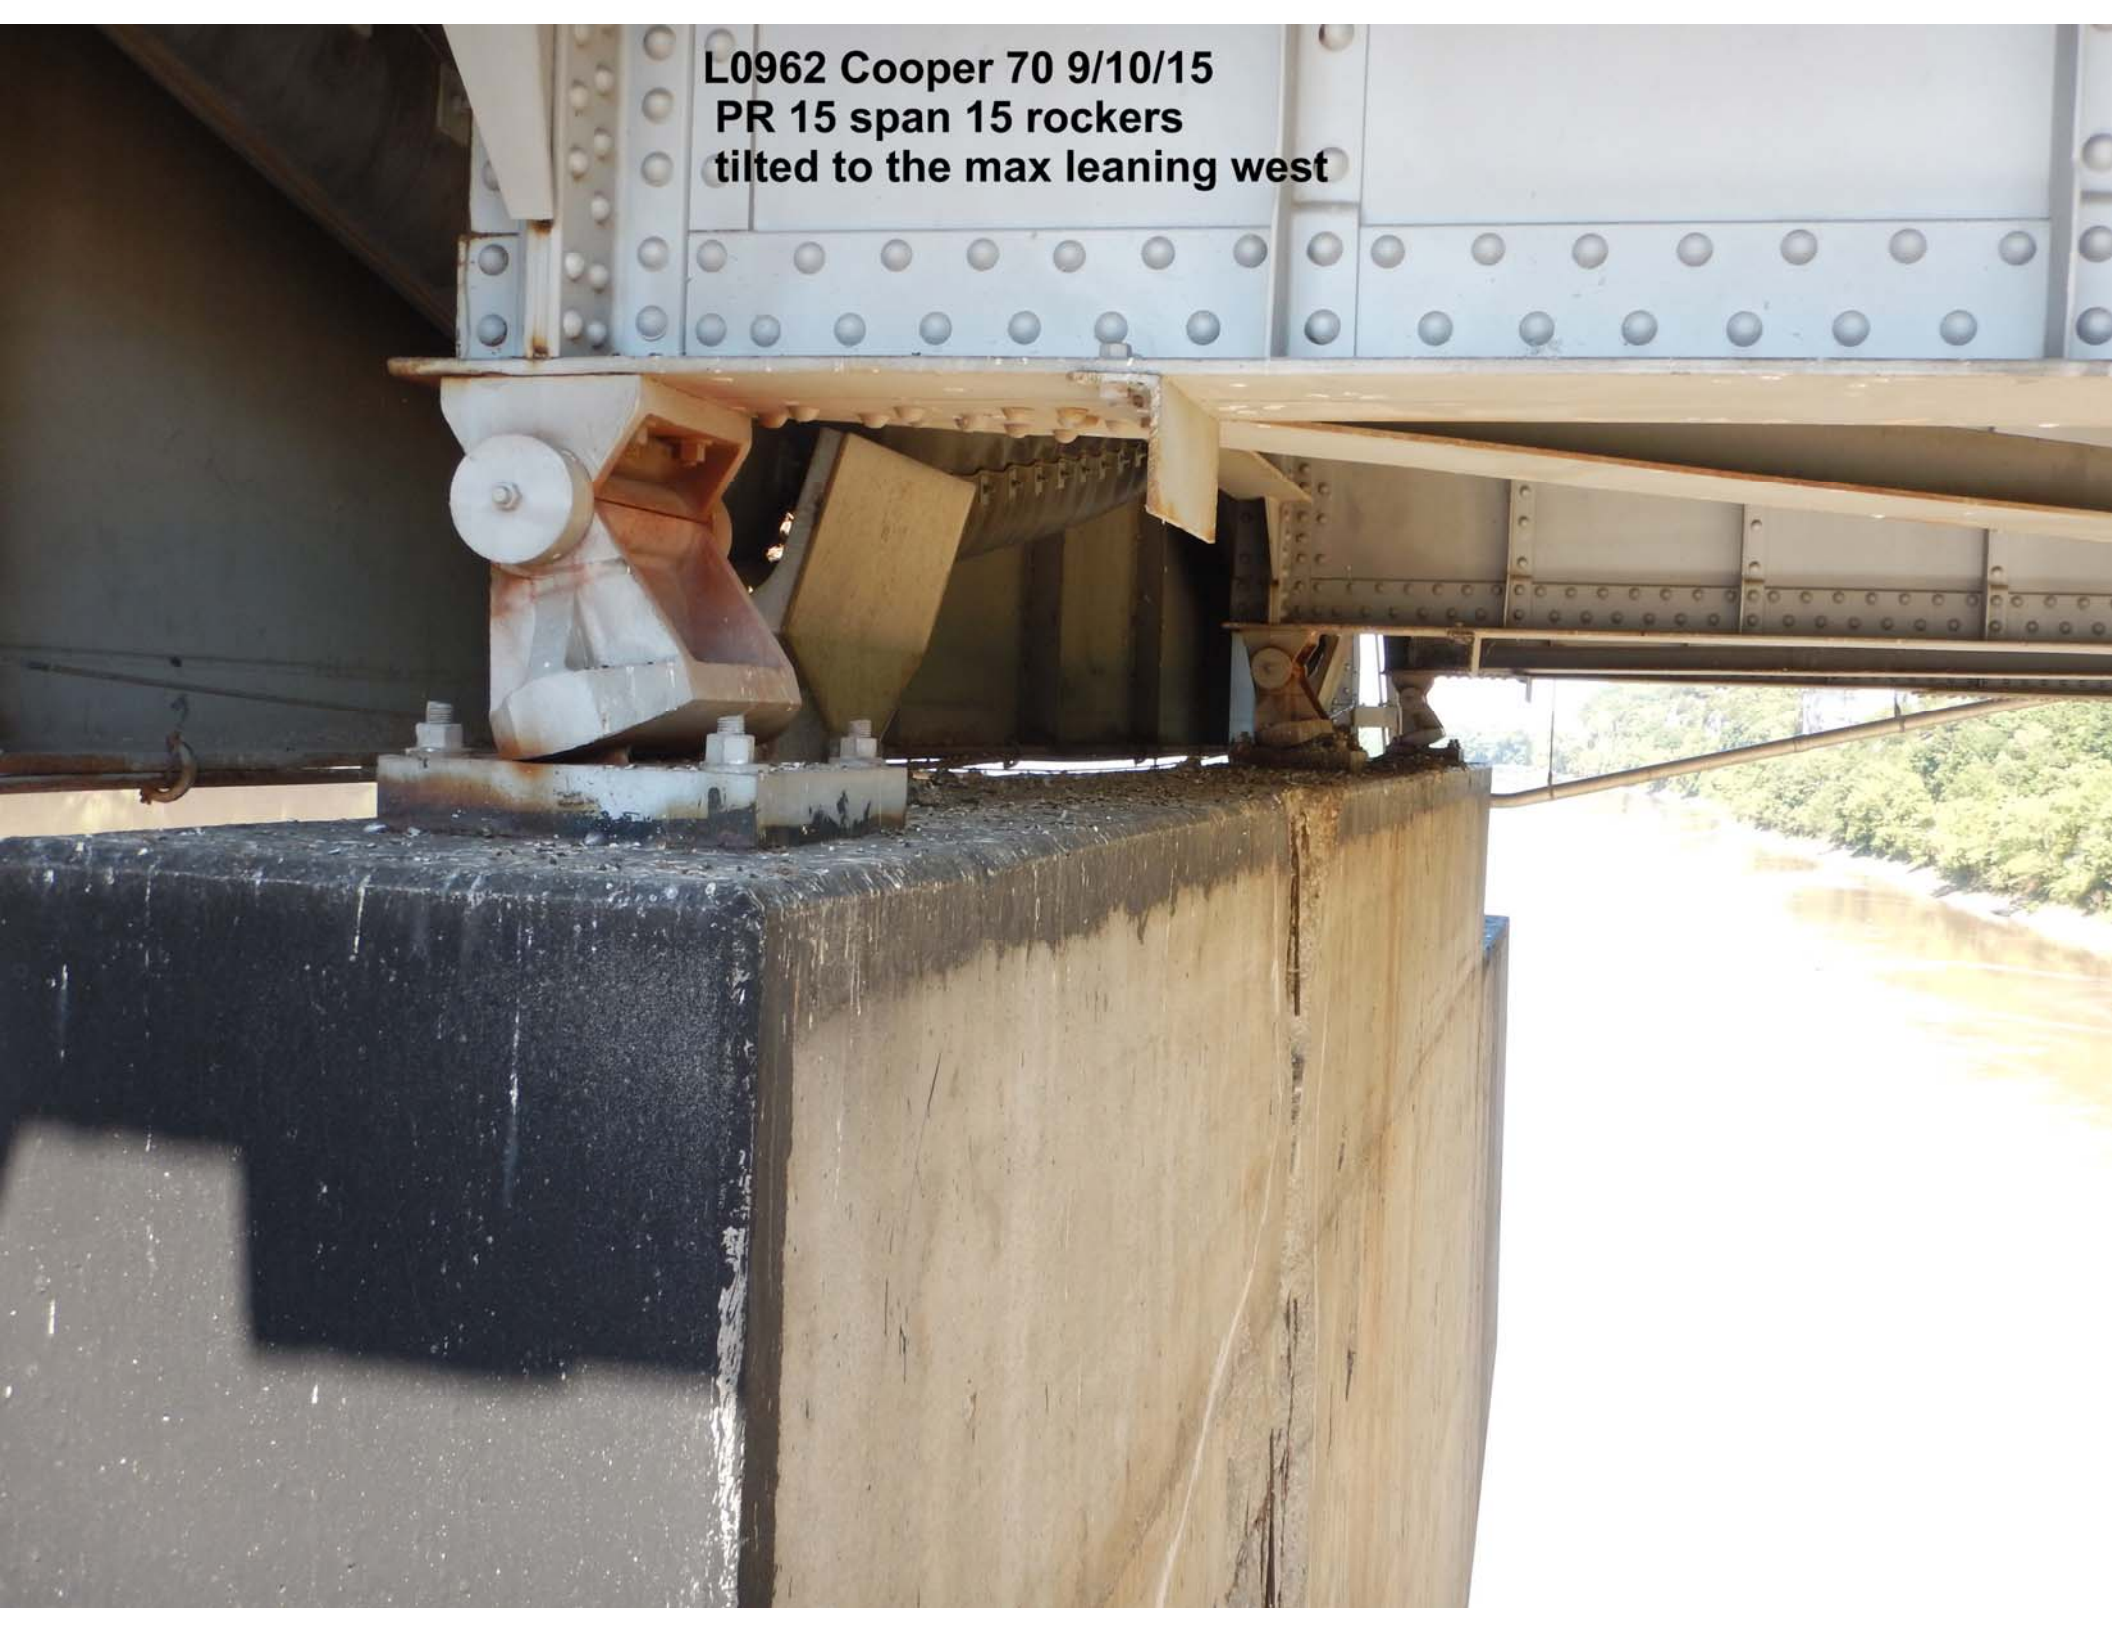
**L0962 Cooper 70 9/10/15
Bent 16 girder 3 with
mod pack rust between
plates and bottom flange**

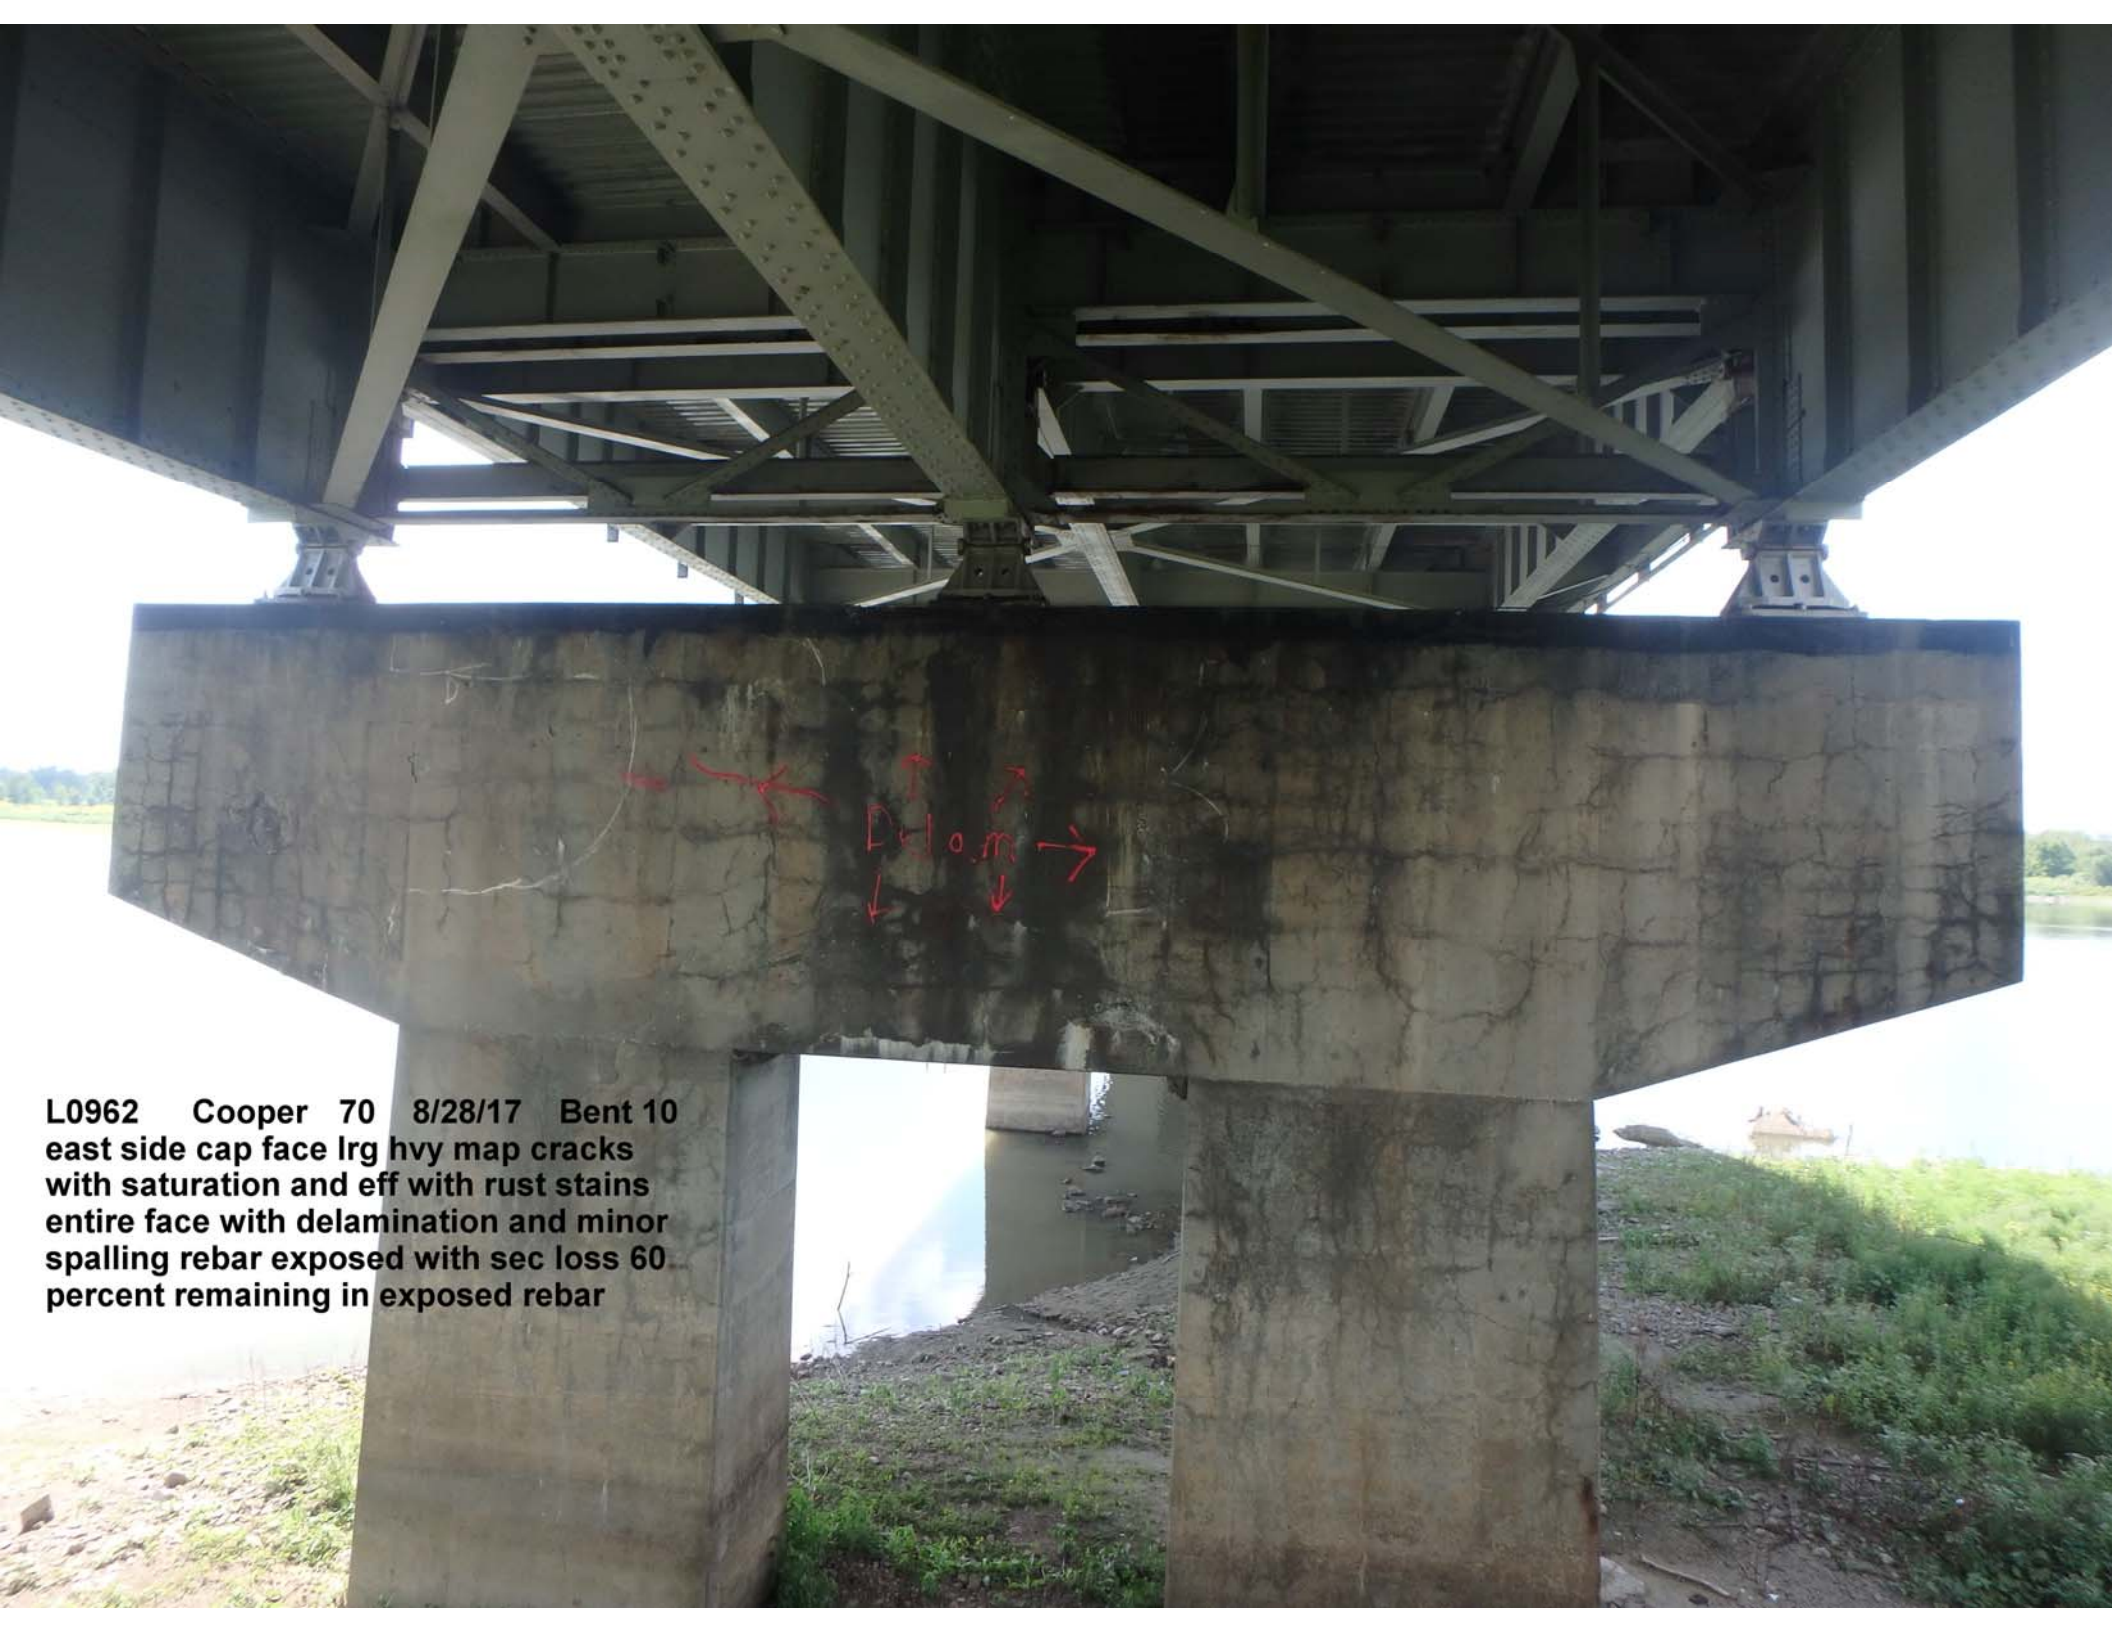
**L0962 Cooper 70 8/28/17 Bent 10
east side cap face lrg hvy map cracks
with saturation and eff with rust stains
entire face with delamination and minor
spalling rebar exposed with sec loss 60
percent remaining in exposed rebar**

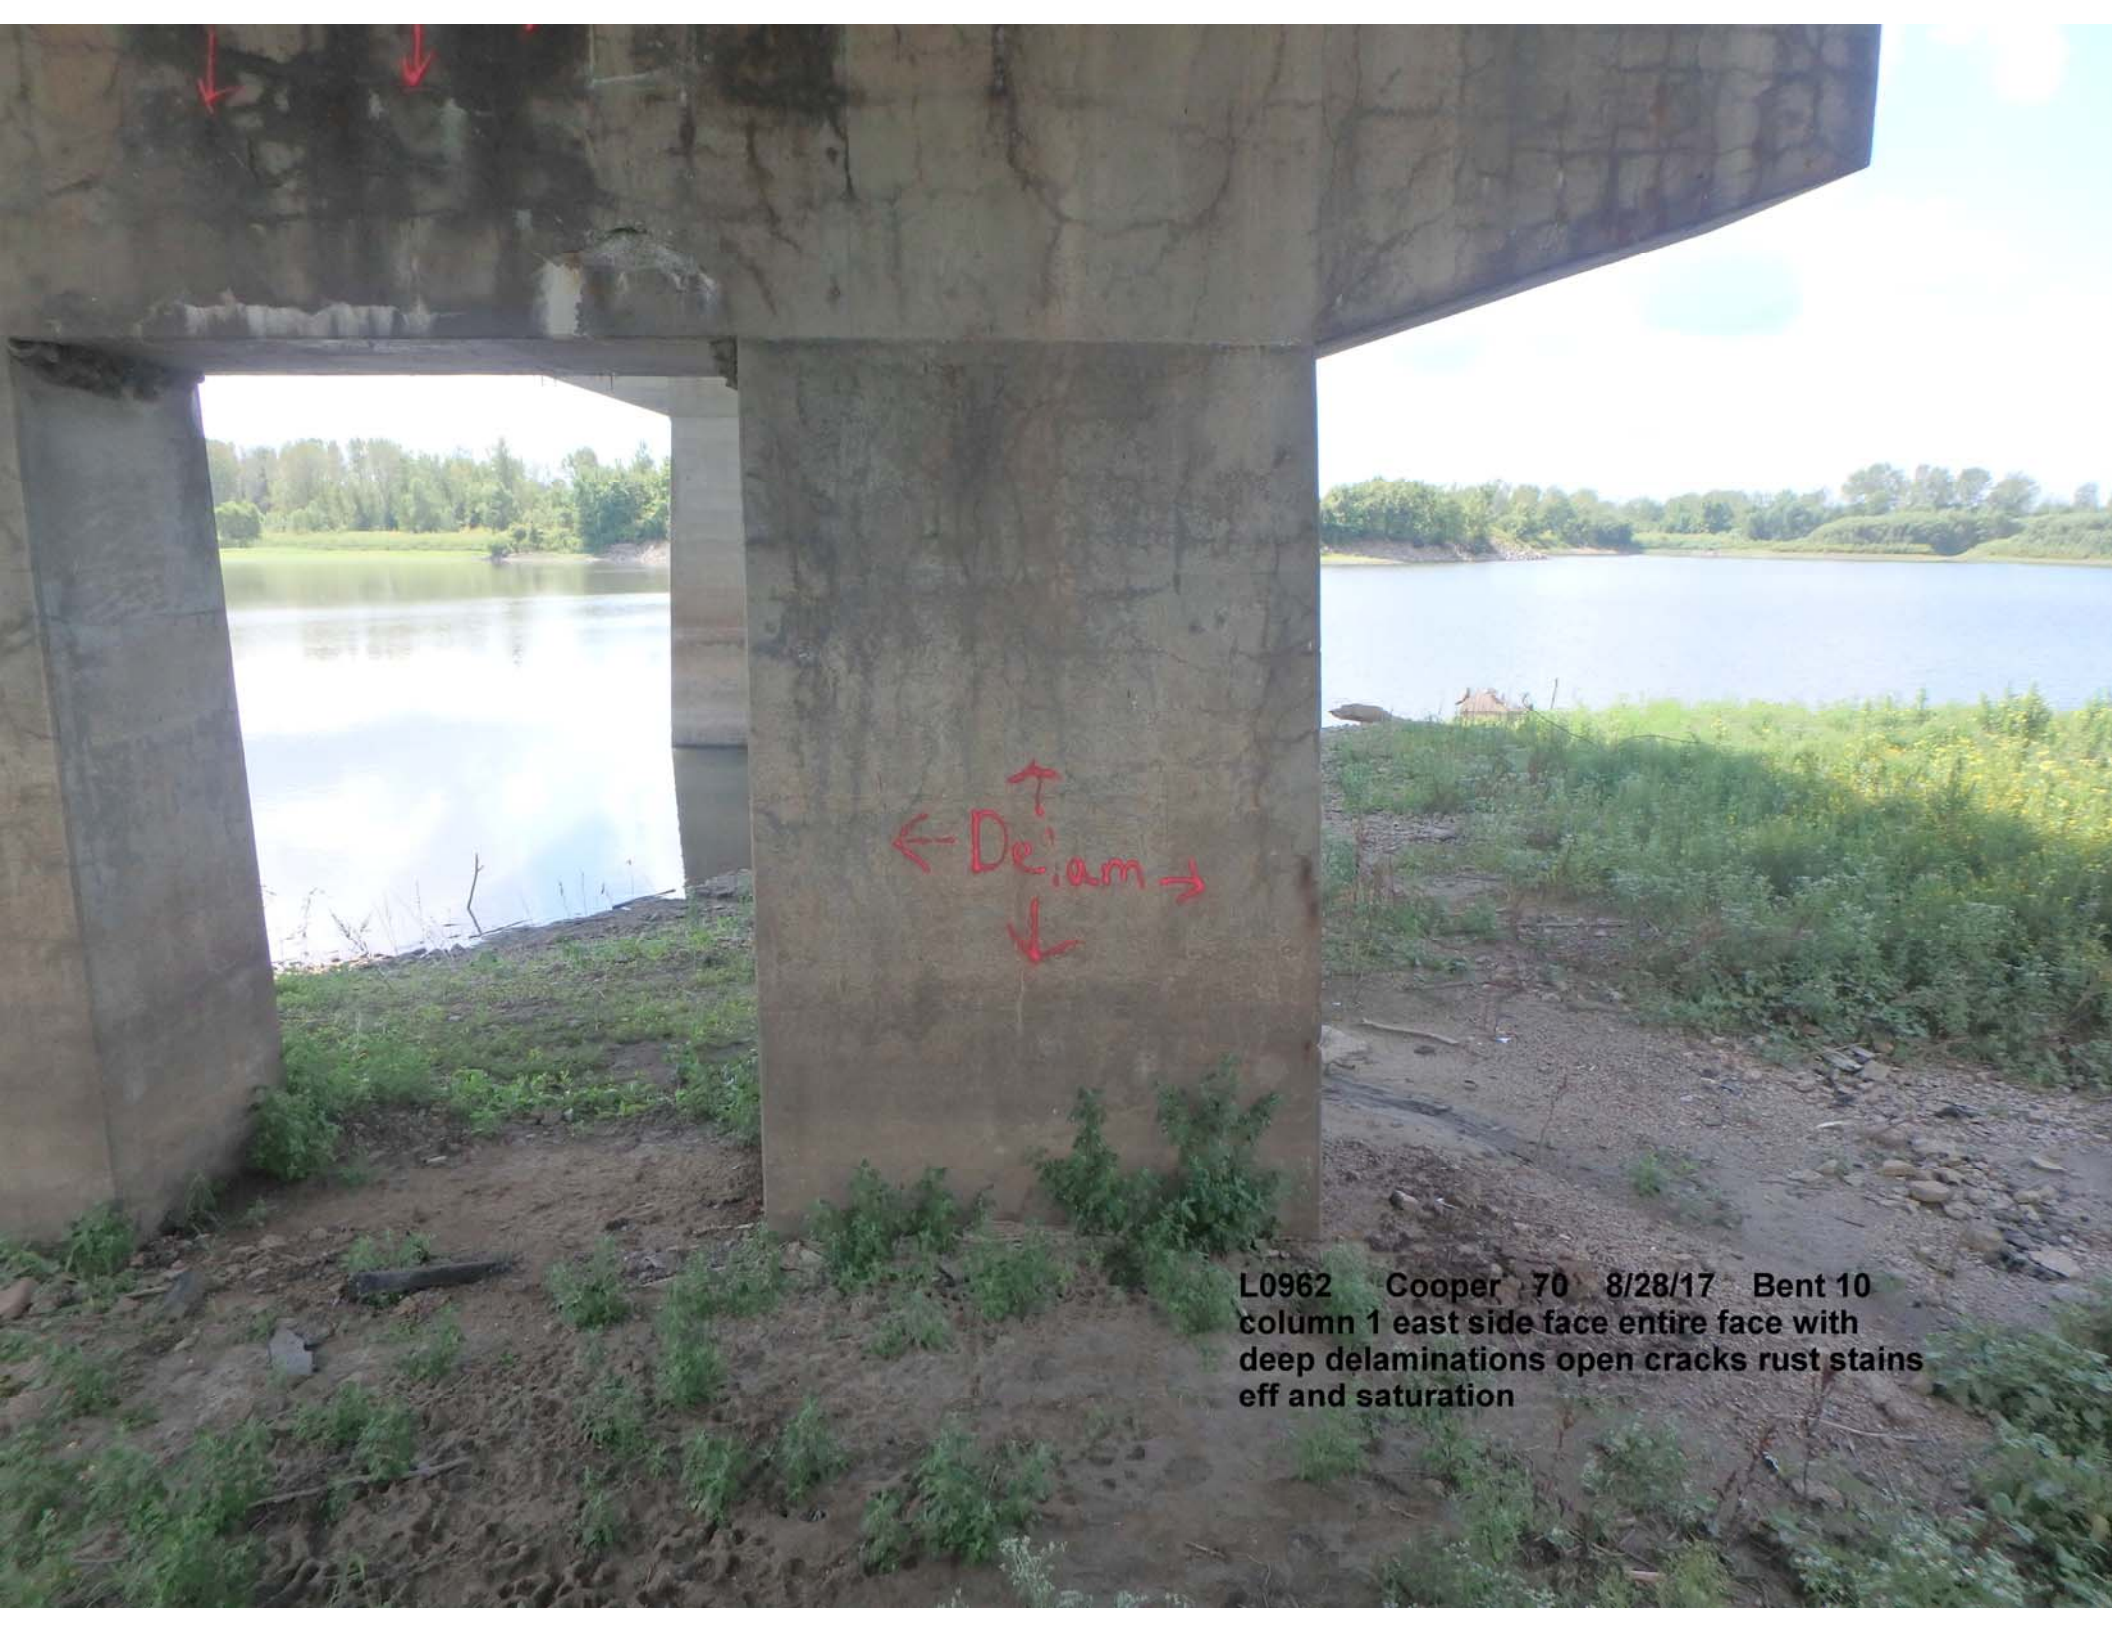
L0962 Cooper 70 8/28/17 Bent 10
column 1 east side face entire face with
deep delaminations open cracks rust stains
eff and saturation

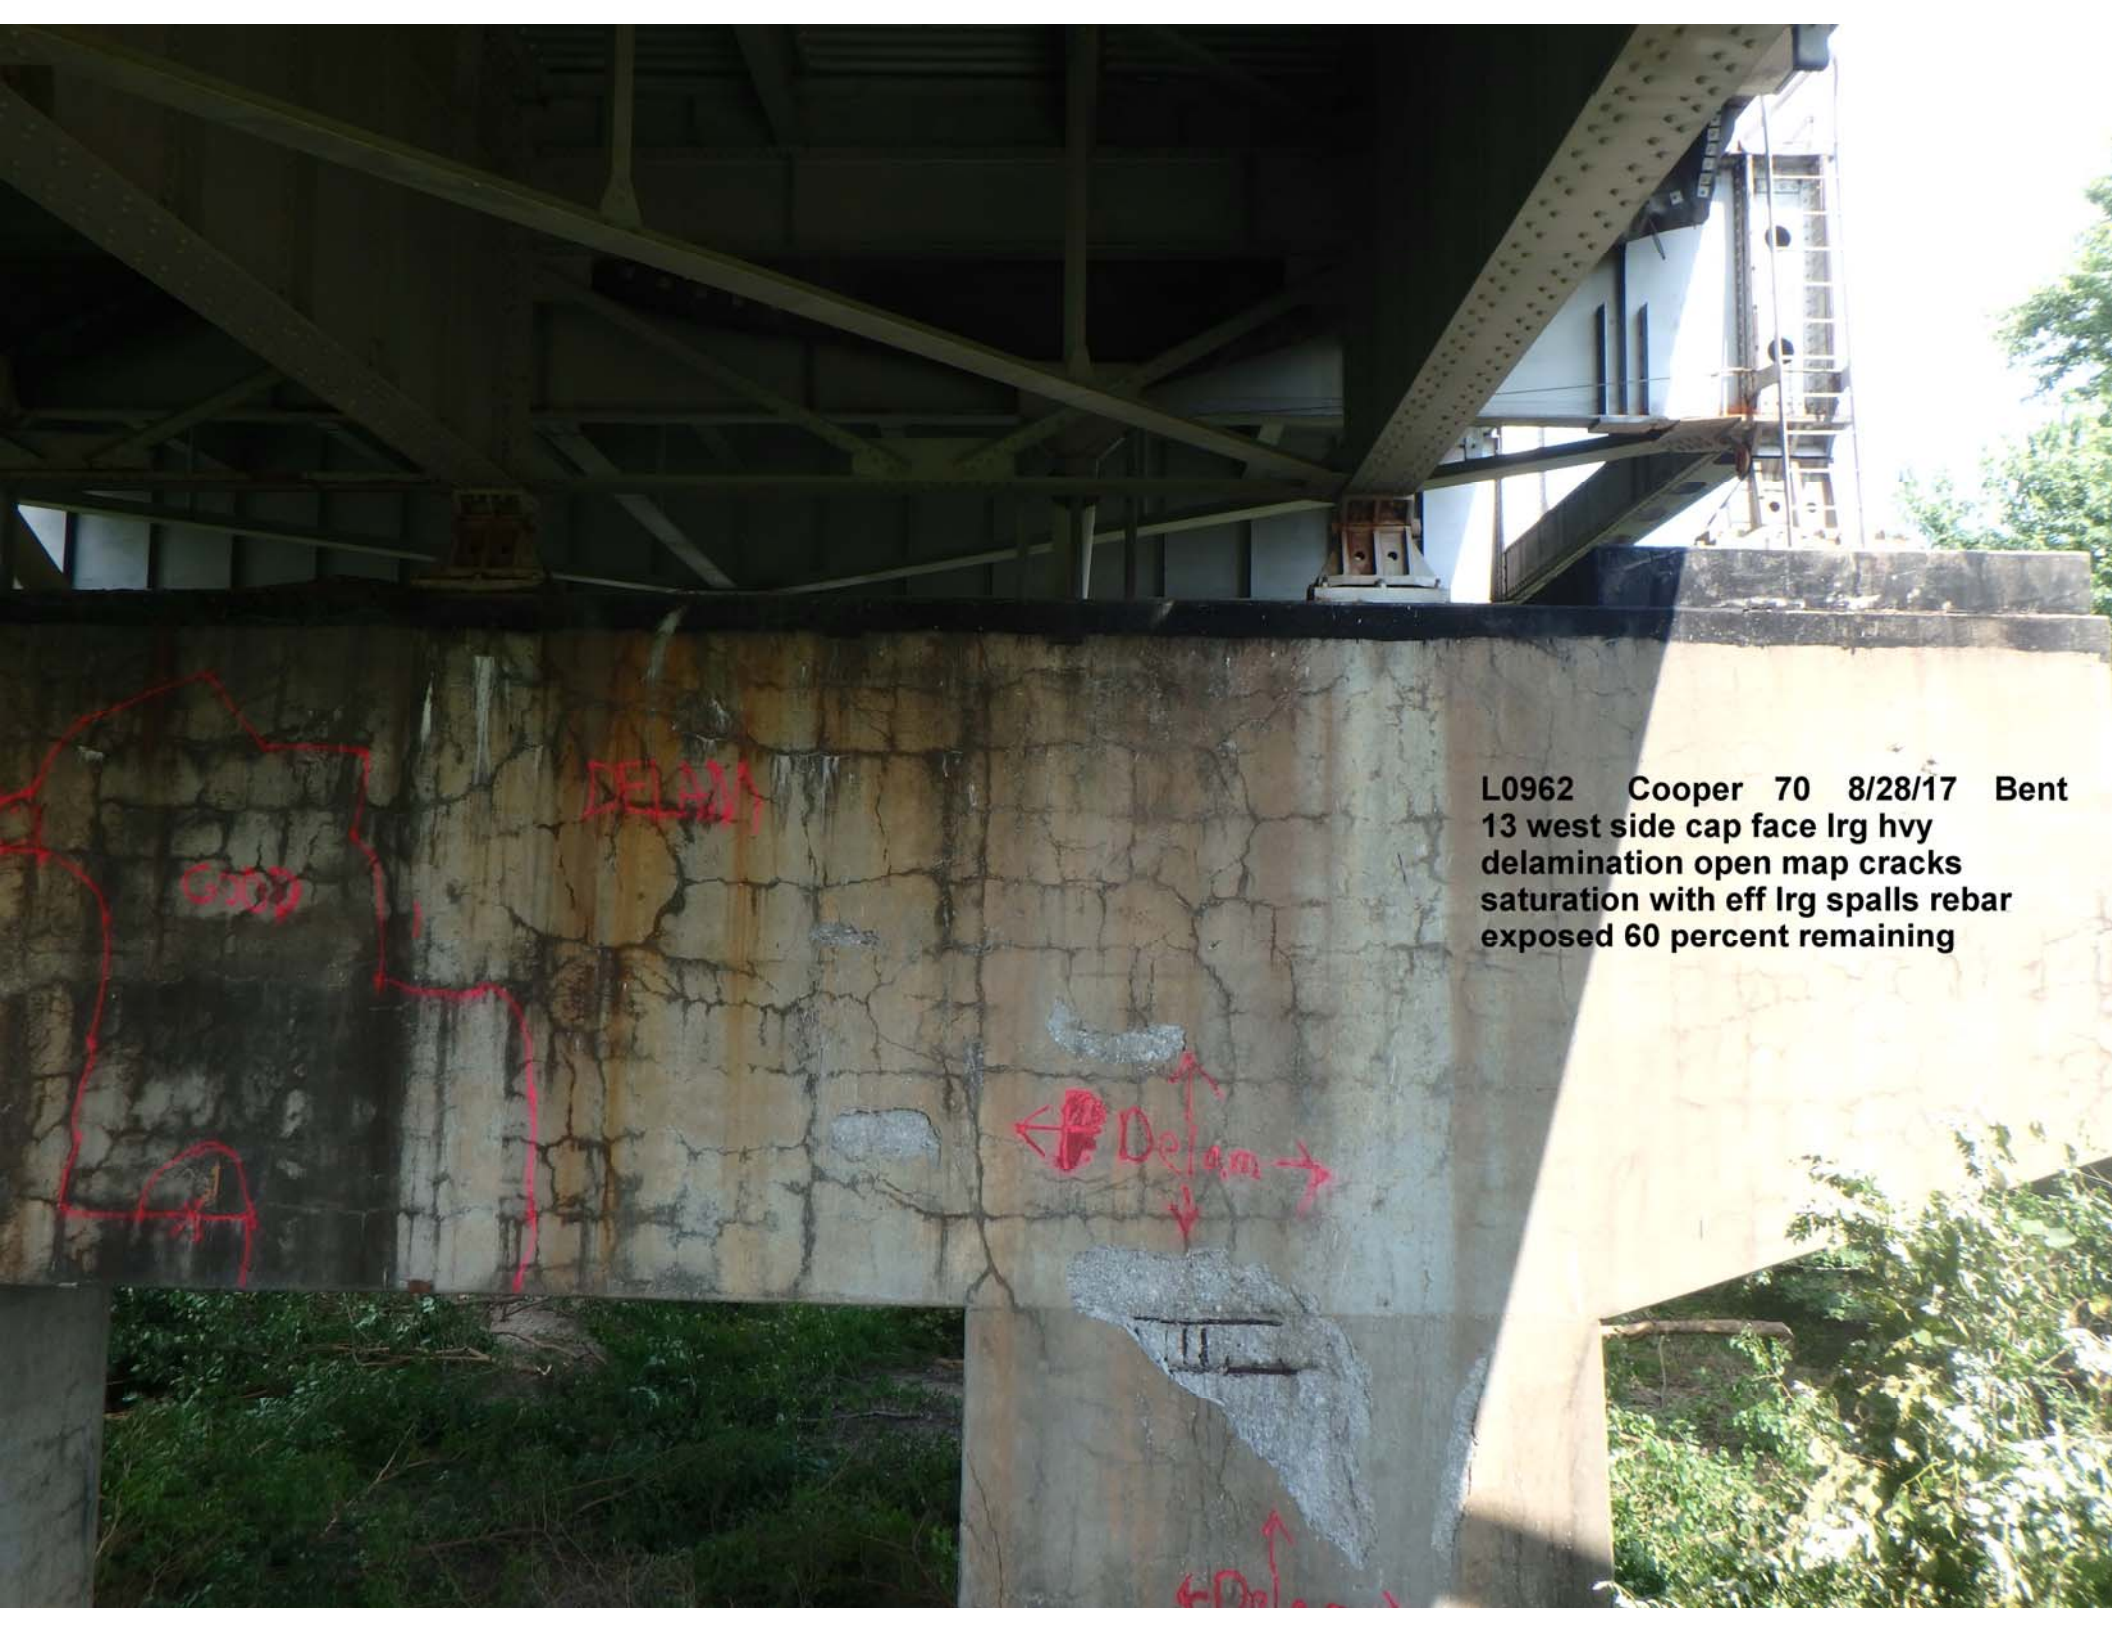
L0962 Cooper 70 8/28/17 Bent
13 west side cap face lrg hvy
delamination open map cracks
saturation with eff lrg spalls rebar
exposed 60 percent remaining

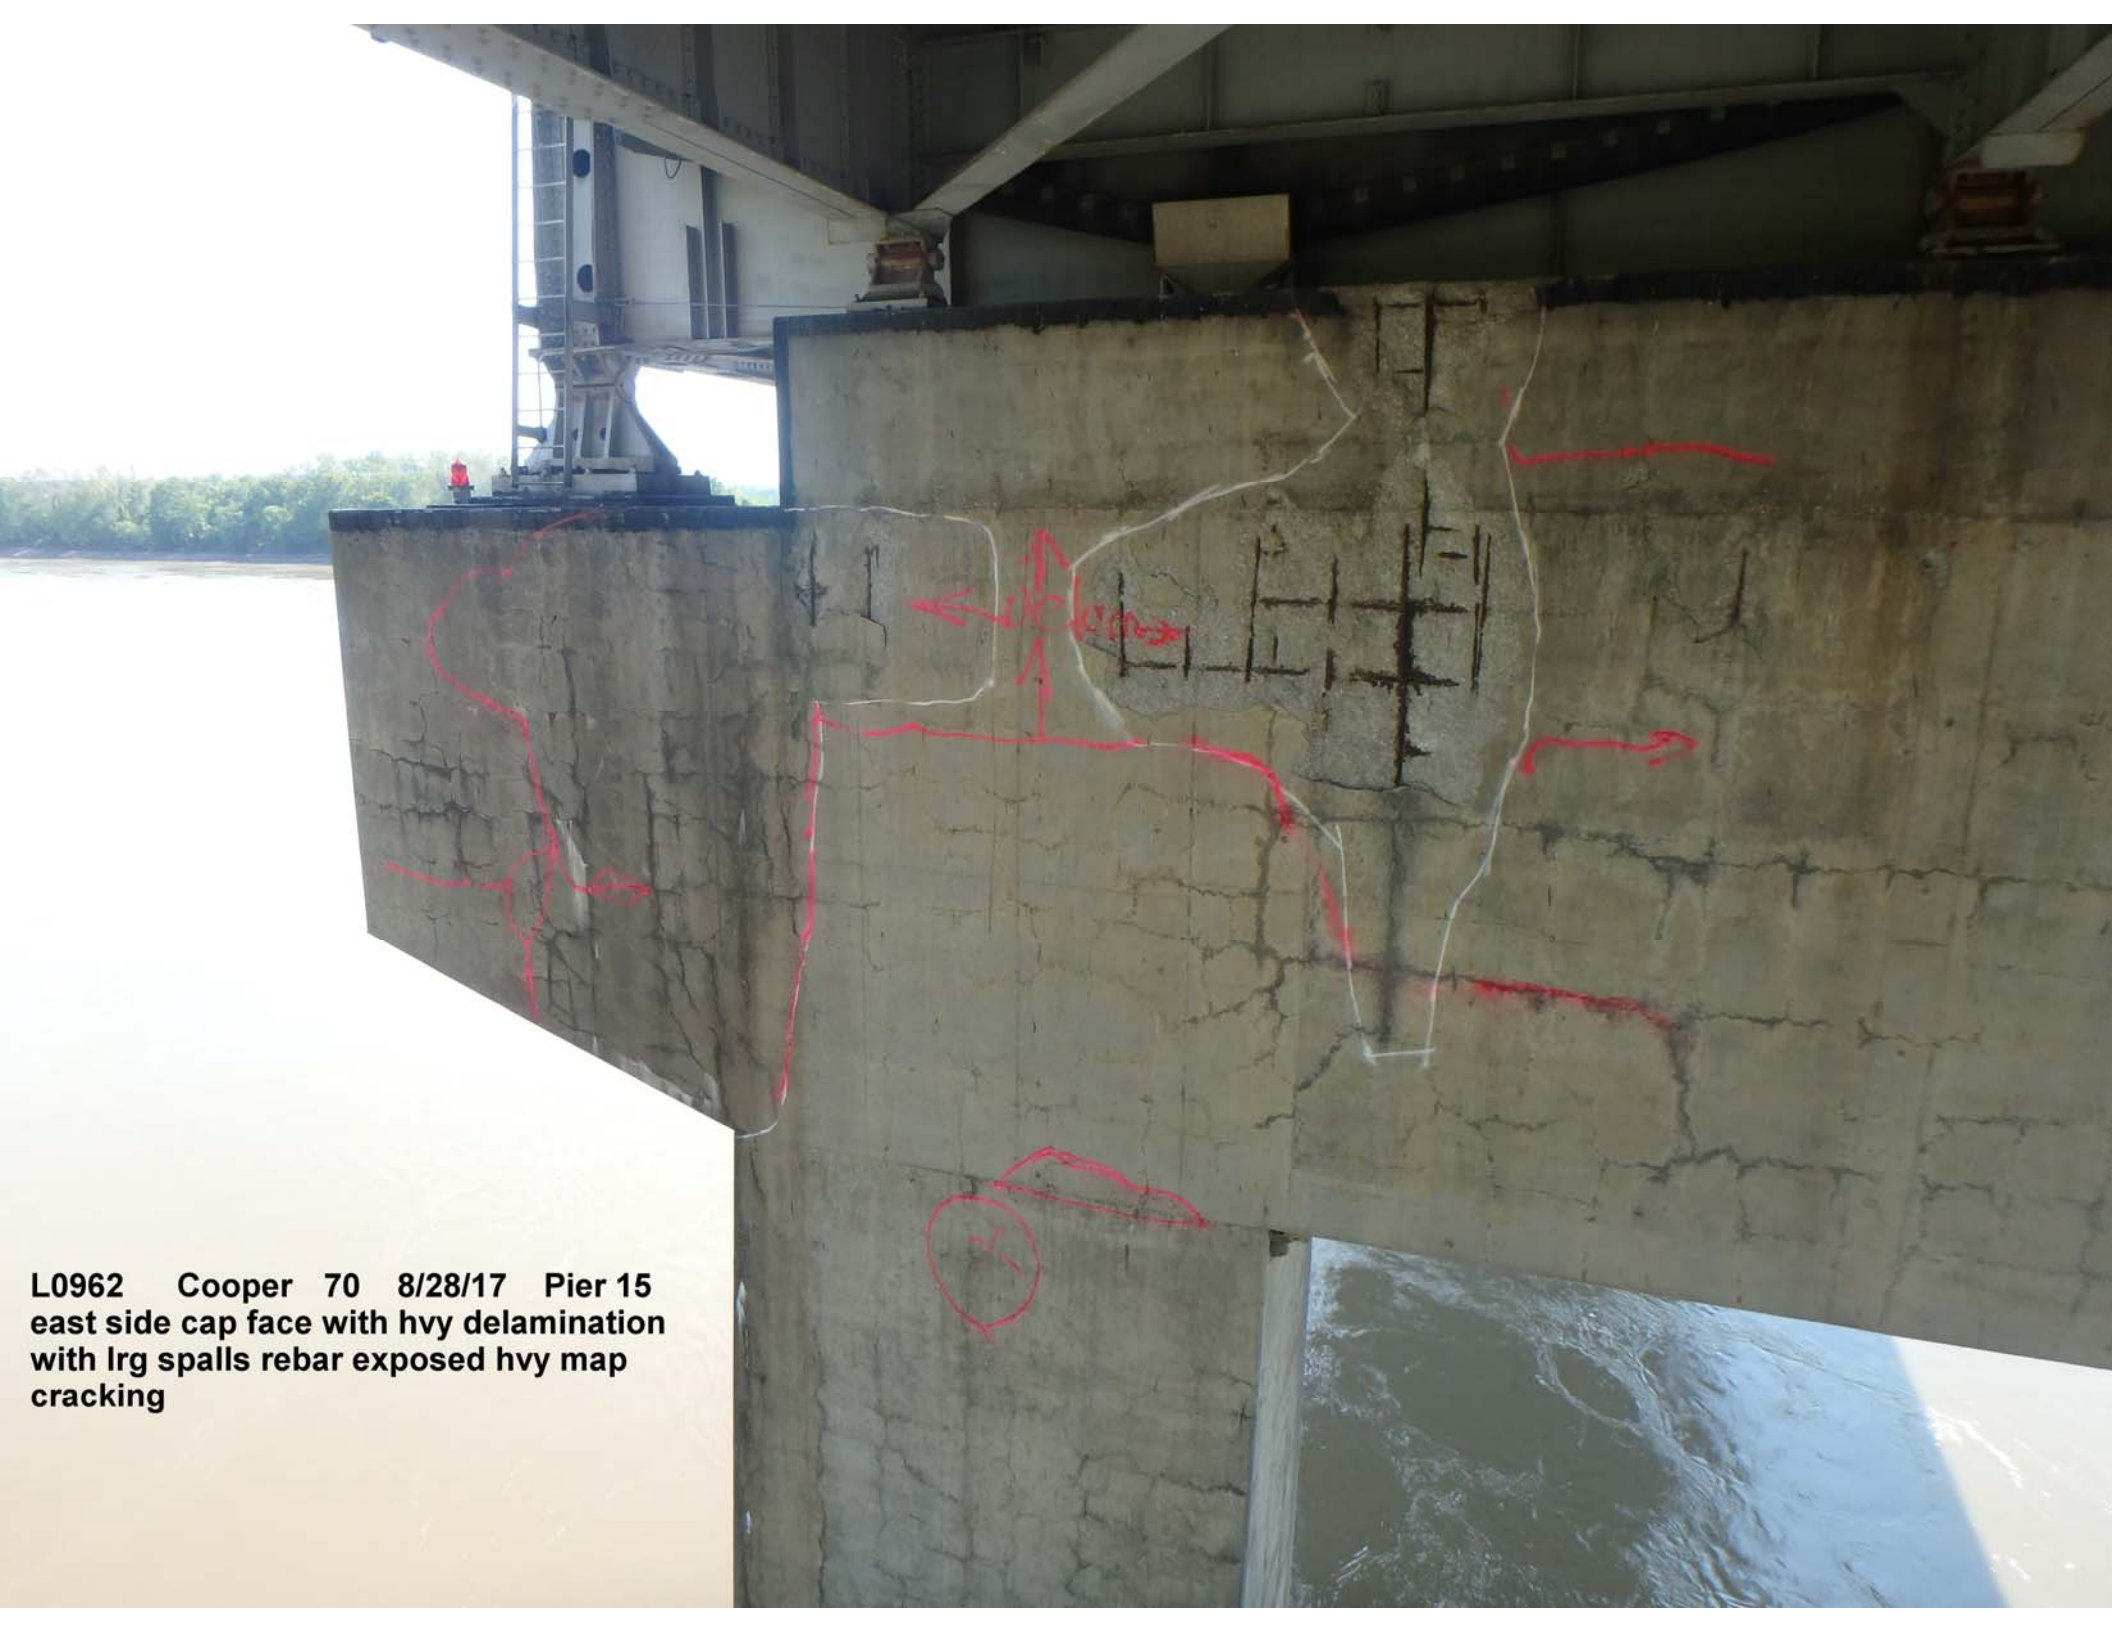
**L0962 Cooper 70 8/28/17 Pier 15
east side cap face with hvy delamination
with lrg spalls rebar exposed hvy map
cracking**

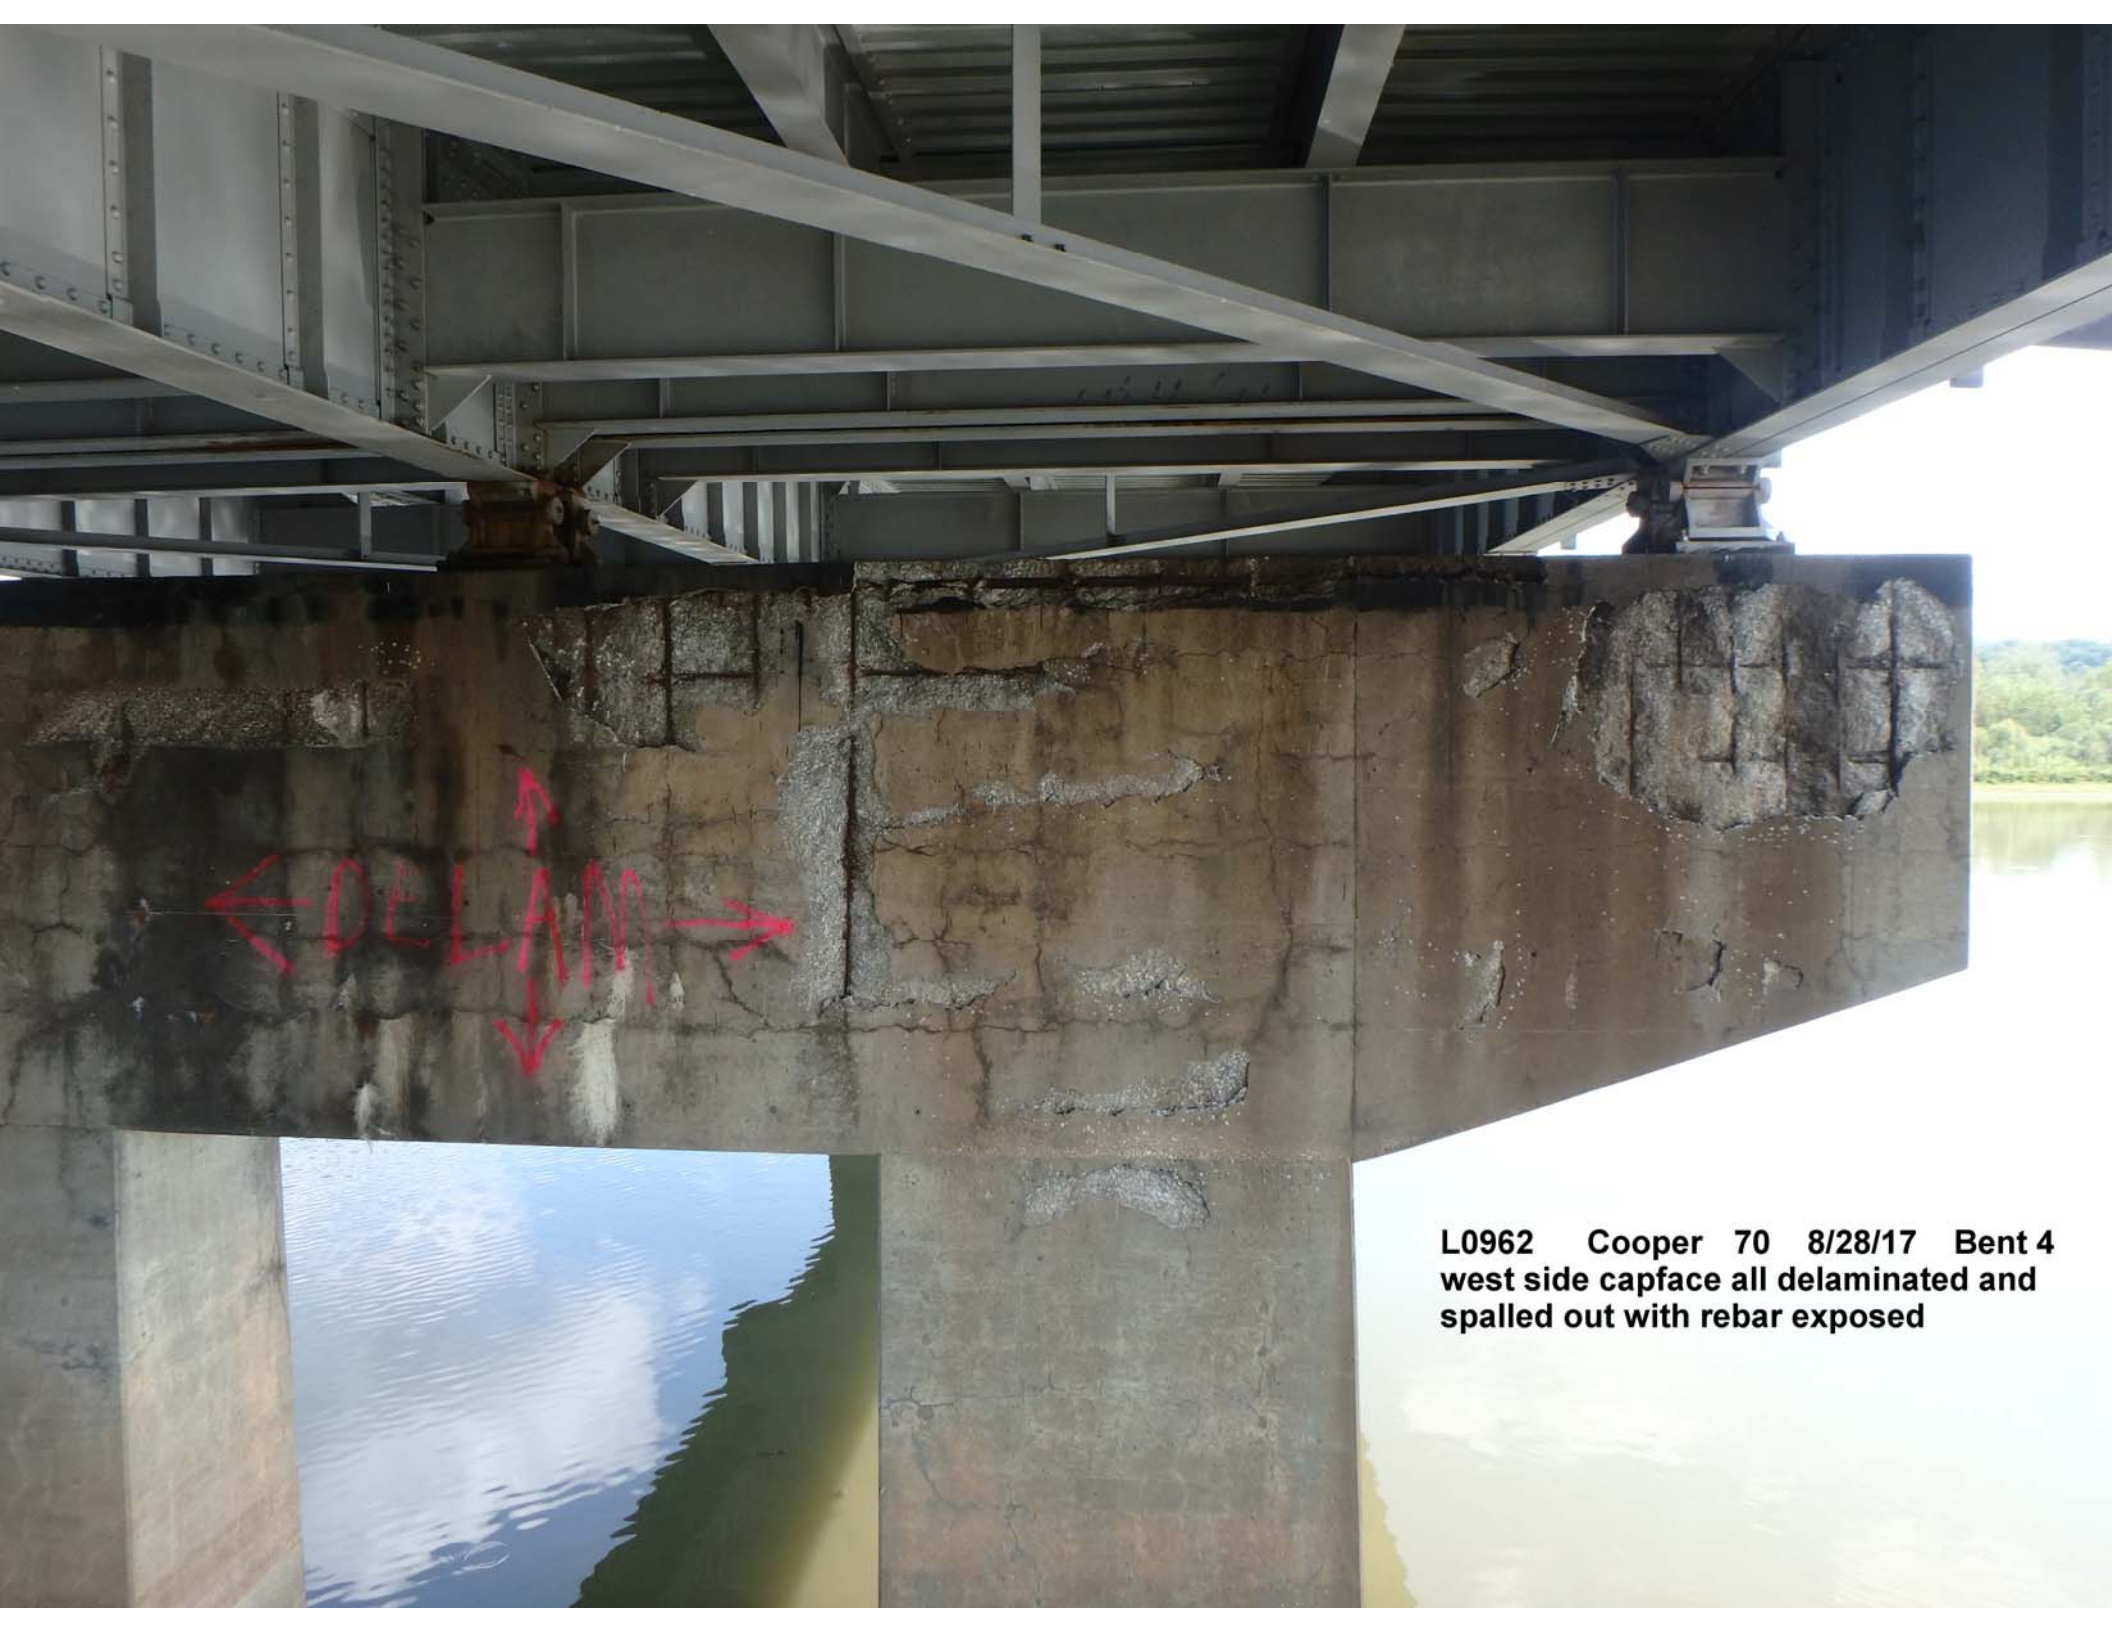
**L0962 Cooper 70 8/28/17 Bent 4
west side capface all delaminated and
spalled out with rebar exposed**
