Appendix E:

MoDOT Bridge Inspection Report

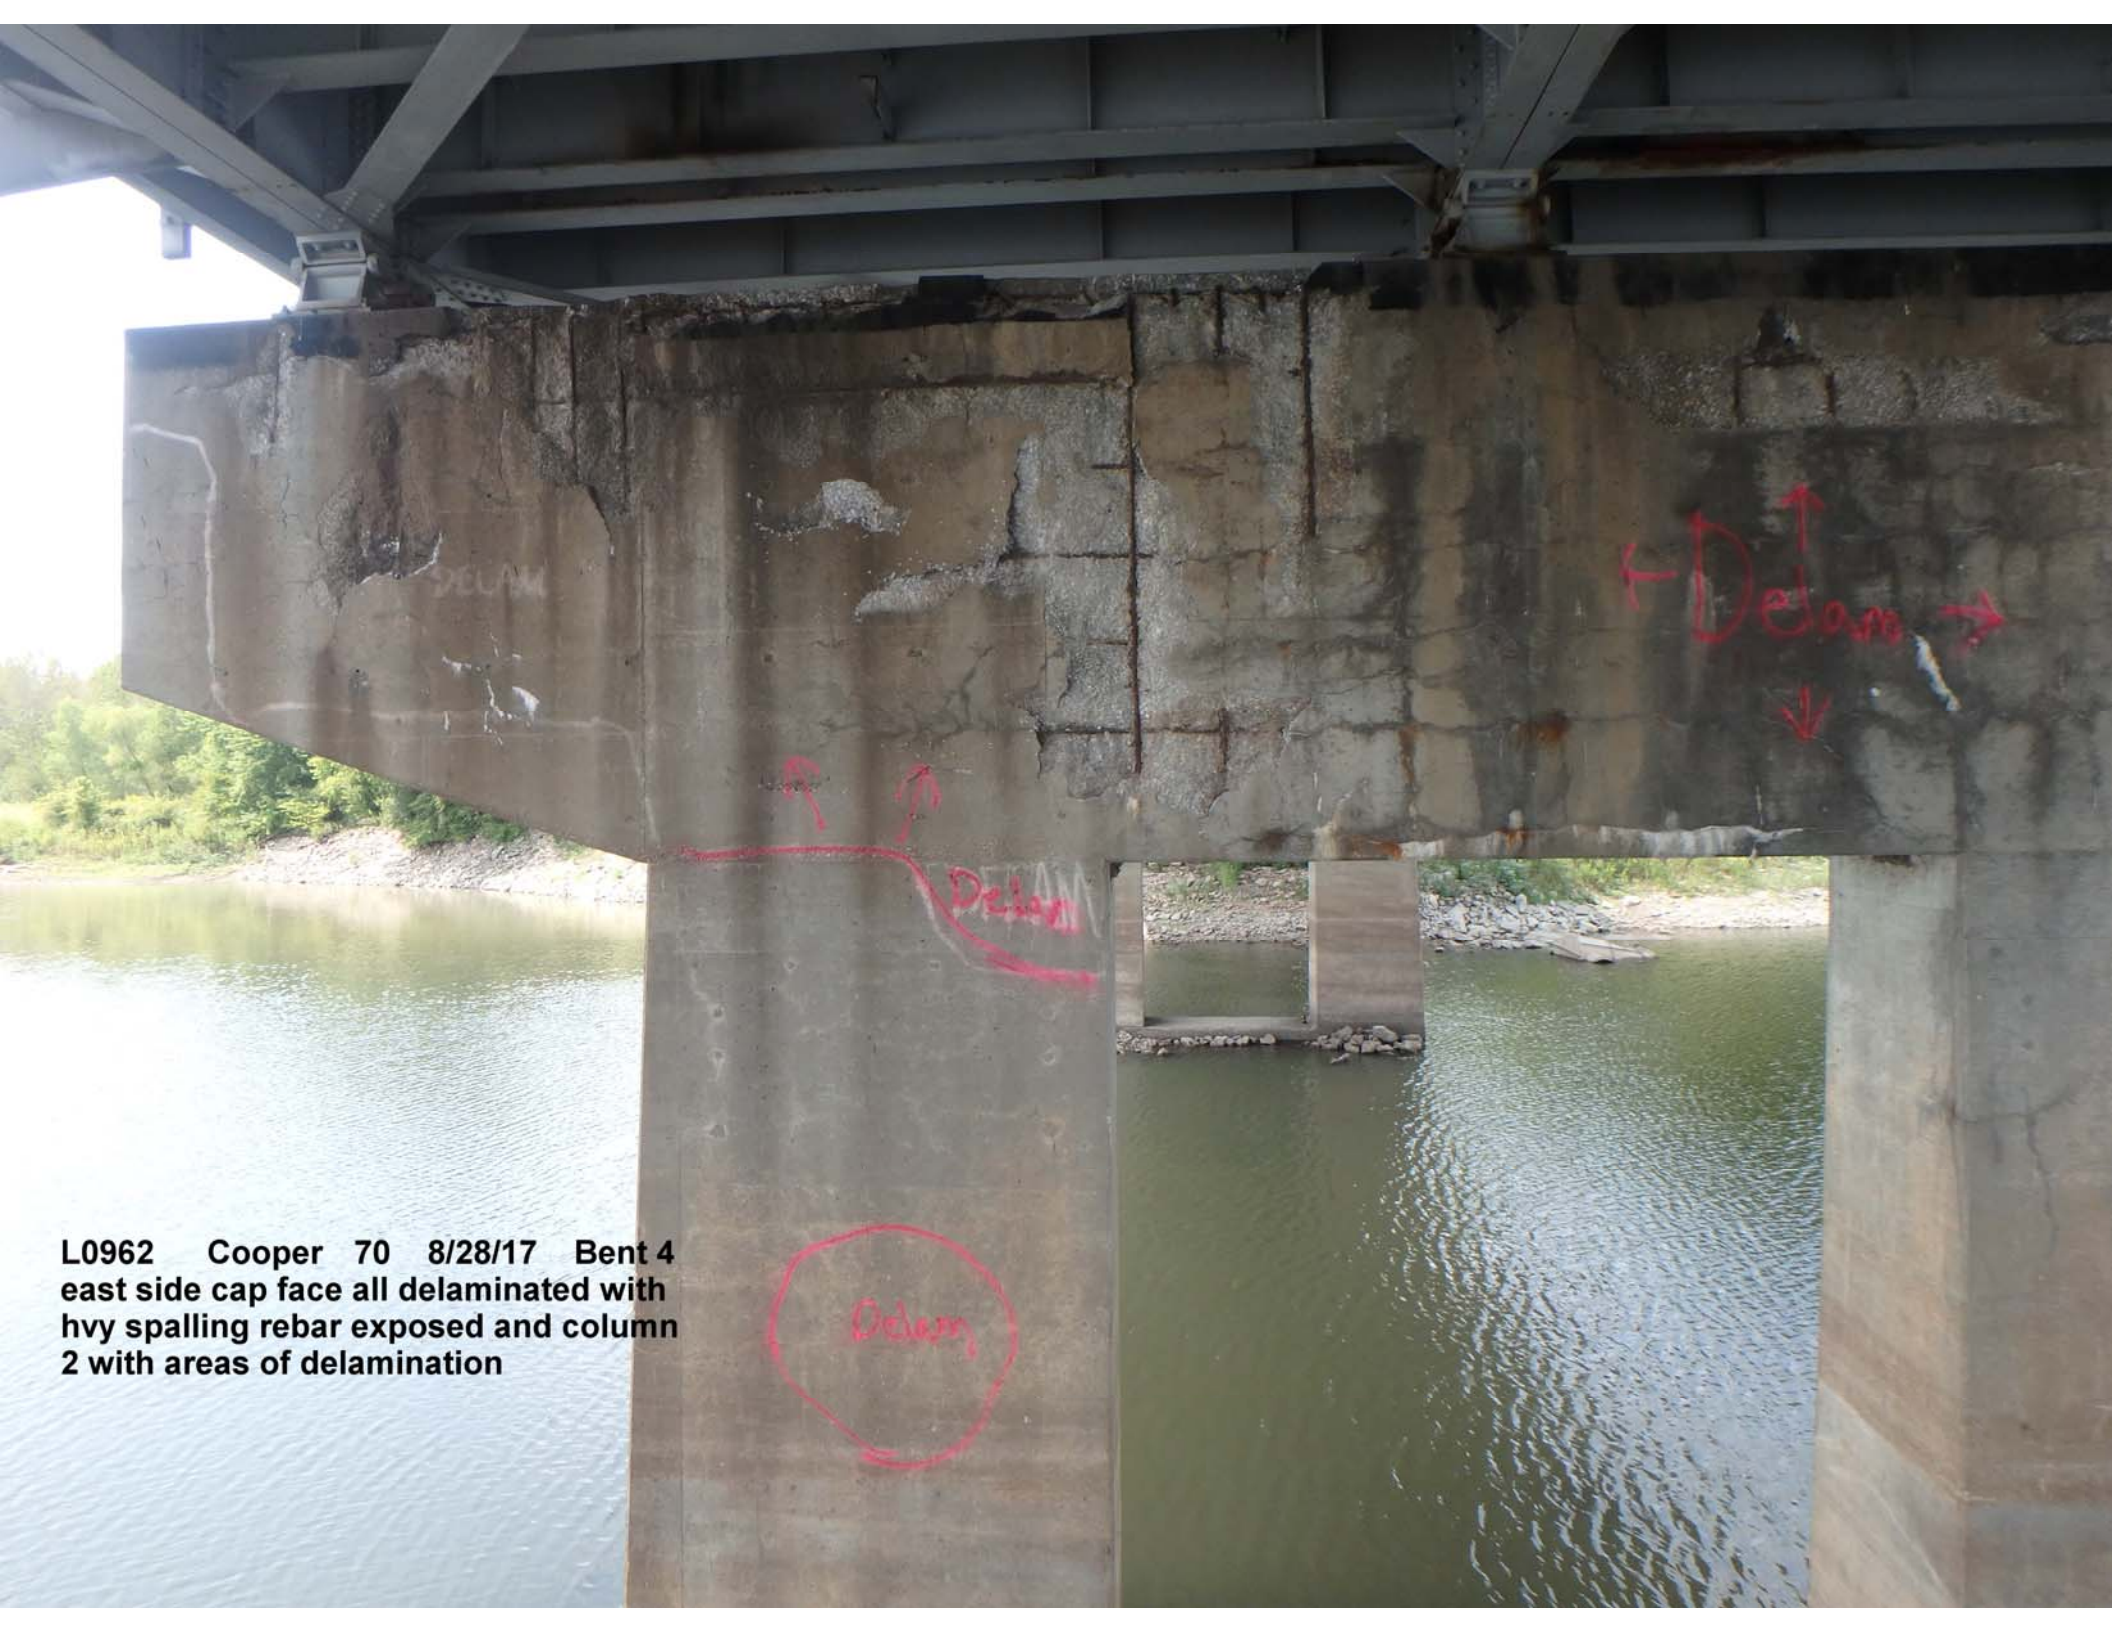
L0962 Cooper 70 8/28/17 Bent 4
east side cap face all delaminated with
hvy spalling rebar exposed and column
2 with areas of delamination

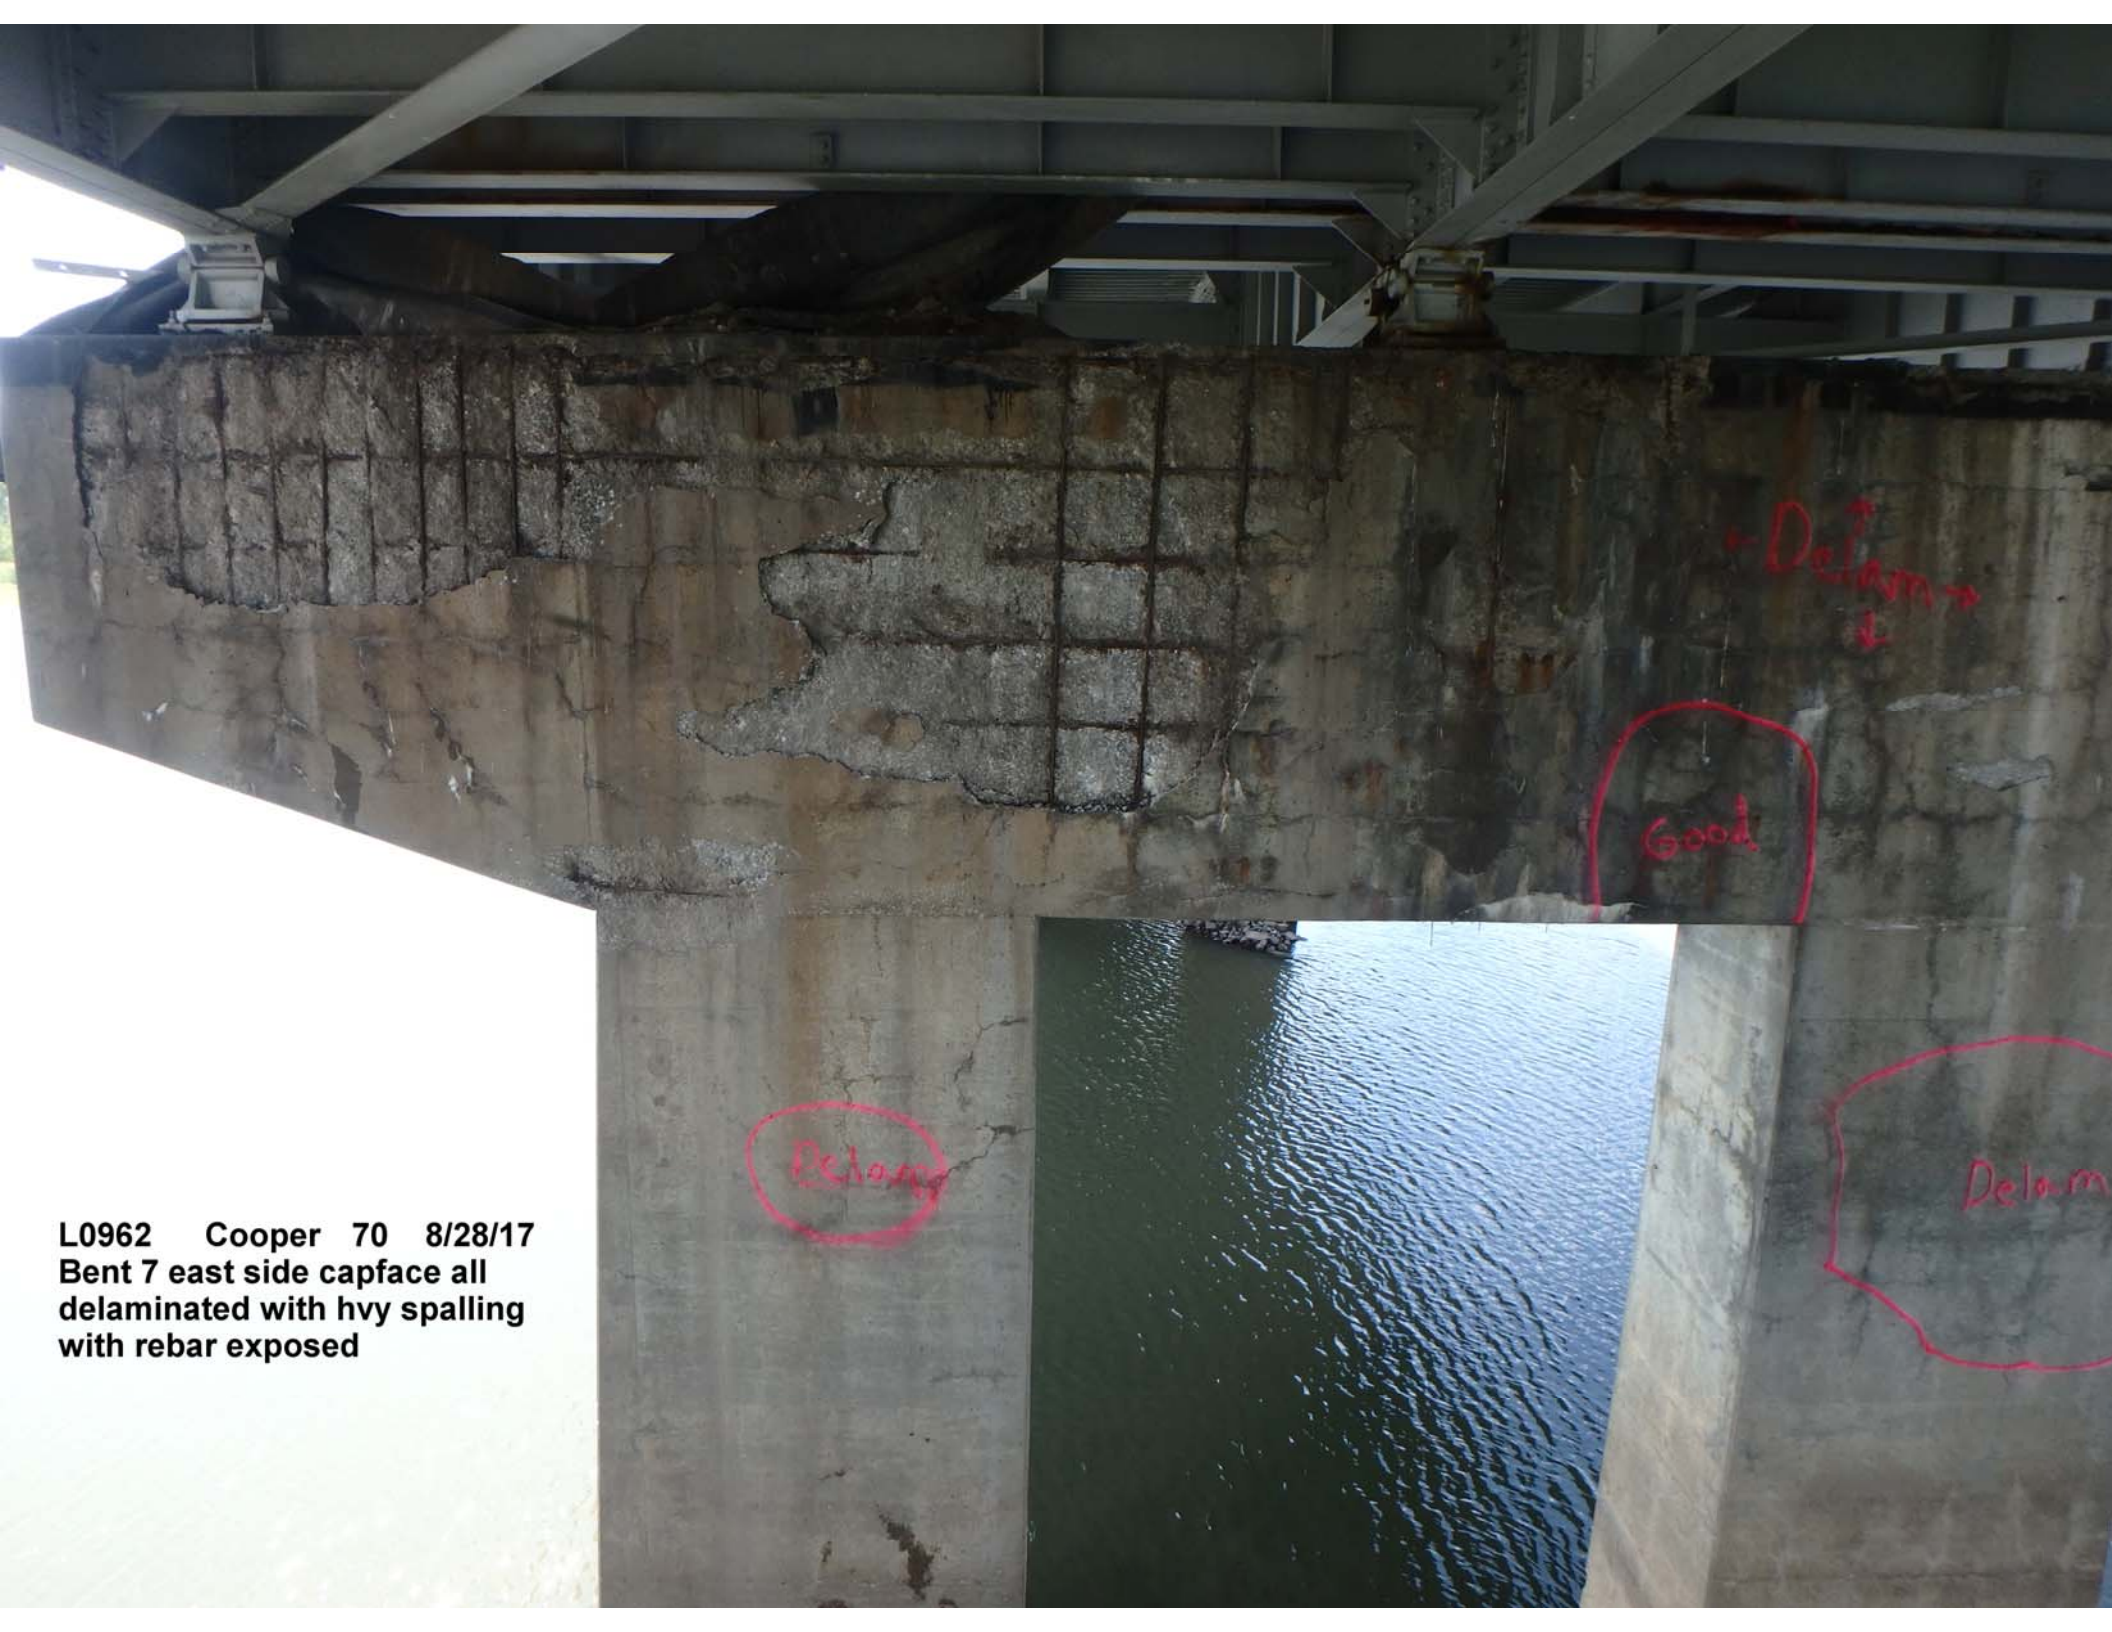
L0962 Cooper 70 8/28/17
Bent 7 east side capface all
delaminated with hvy spalling
with rebar exposed

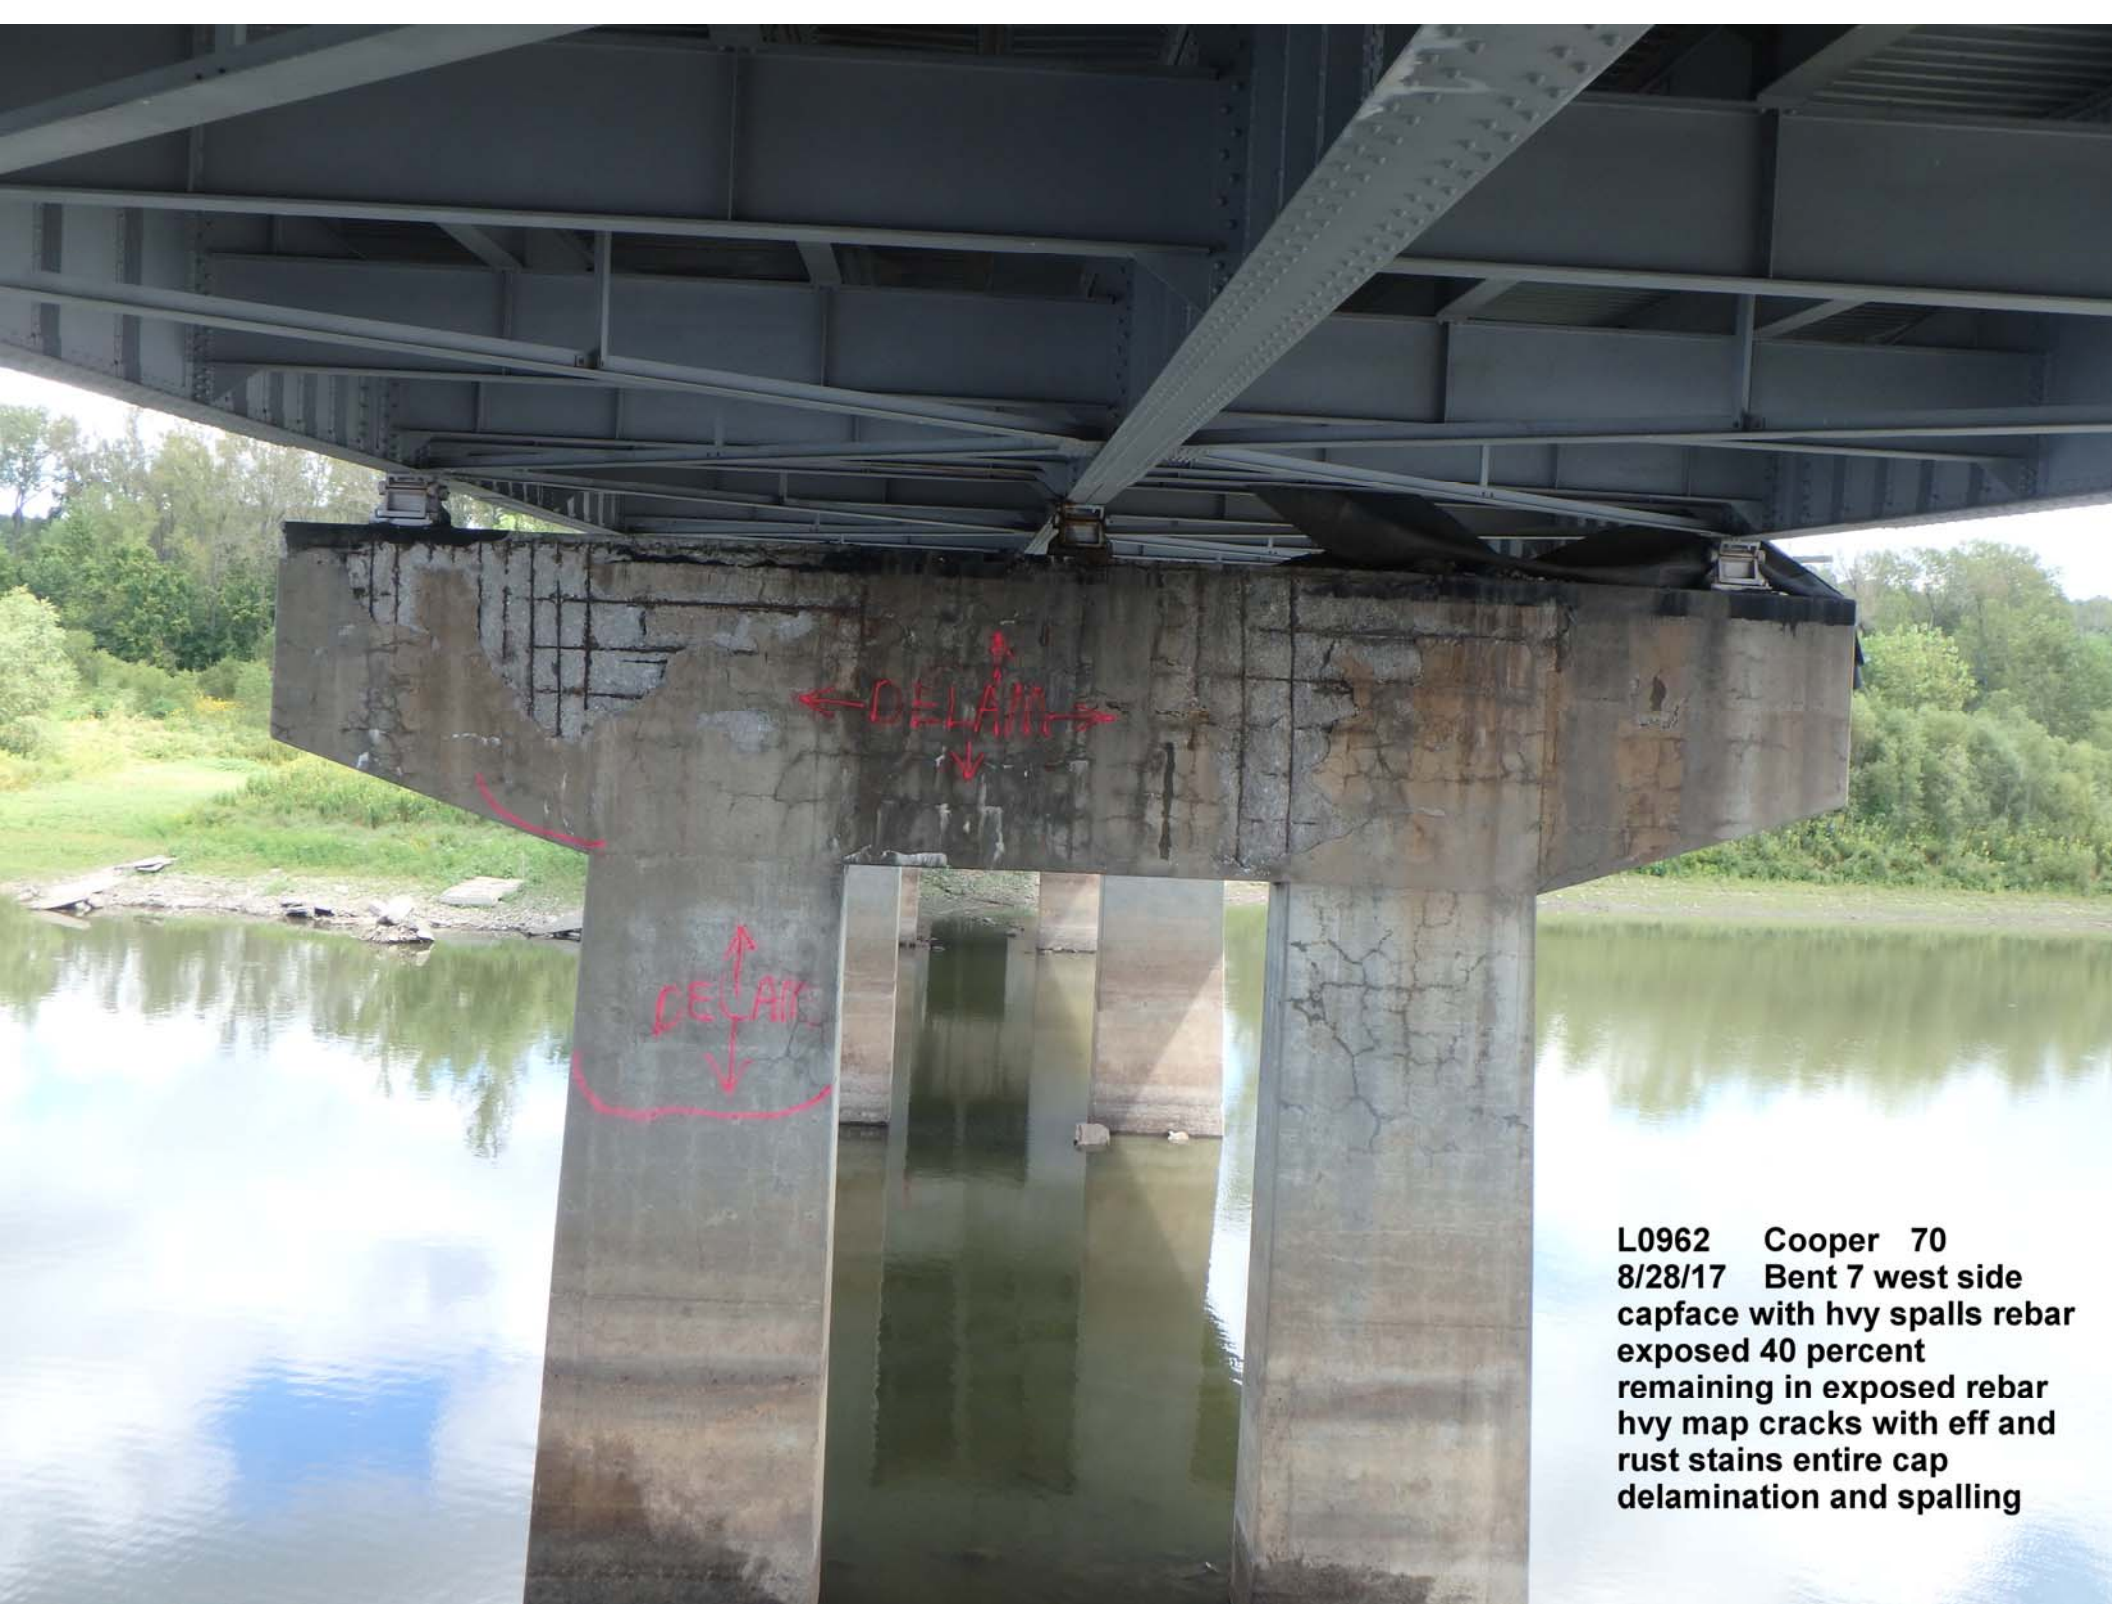
**L0962 Cooper 70
8/28/17 Bent 7 west side
capface with hvy spalls rebar
exposed 40 percent
remaining in exposed rebar
hvy map cracks with eff and
rust stains entire cap
delamination and spalling**
